EVALUATION OF THE IMPACTS OF HARBOUR ENGINEERING

ANIBARE BAY REPUBLIC OF NAURU (RON)

SOPAC Technical Report 316

This report presents the preliminary results of a coastal engineering, and environmental evaluation, of design parameters, for a fishing boat harbour facility at Anibare Bay, Republic of Nauru.

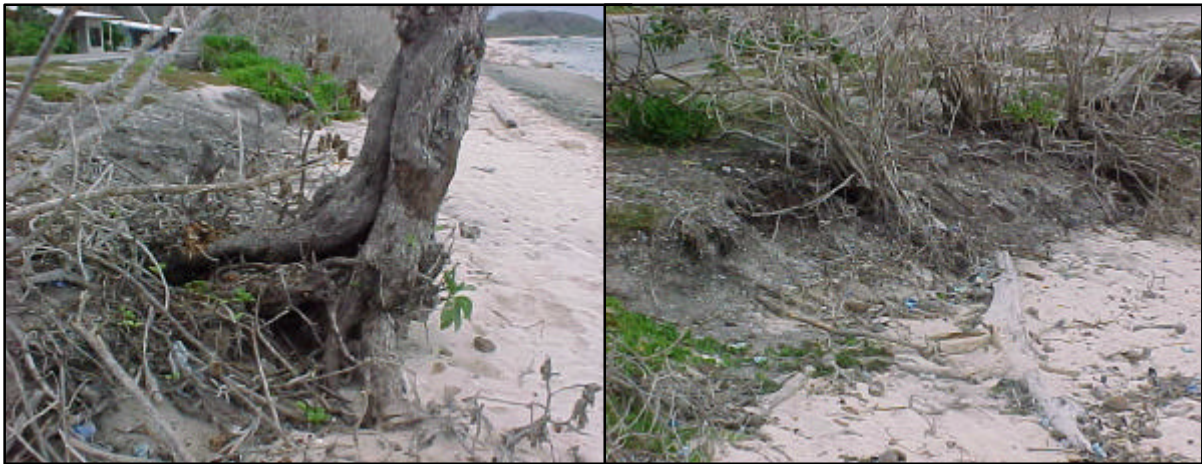
Figure 19. Erosion scarps and exposure of coastal soils and tree roots at the development site.

From Figures 12 and 17, one can see a clear erosion scarp, which has exposed plant roots at the upper beach/land interface. Coastal soils are also exposed here, as the scarp is a new one. Several shrubs fell on the beach at the site. Figure 21 shows typical scouring of the upper beach and beach-land interface, exposing the underlying in-situ limestone bedrock. This is common during high tides, especially EHWST, and are associated with large, Easterly approaching wind waves and plunging breakers. One can also observe the typical scoured surface of the exposed limestone bedrock, created by wave action (swash and backwash; Figure 21). This scouring became more pronounced after construction started at the site. To date, the sand which was eroded here has never recovered at this site.

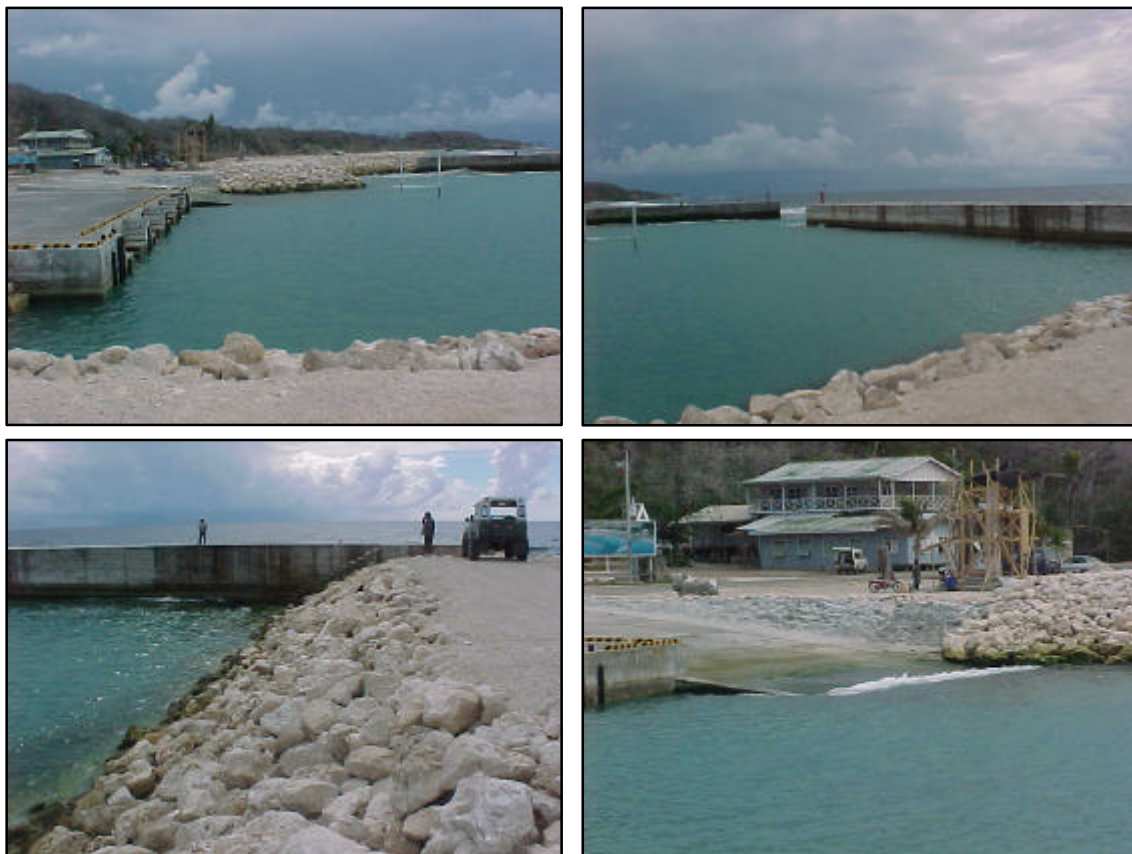
Figure 20. Characteristics of the new harbour facility. Top left – mooring basin/wharf, with quay wall and apron on left of the photo; top right –sub-breakwater and main concrete breakwaters (left and right respectively); lower left – rubble groin, with rip-rap and main concrete breakwater; and lower right – concrete boat ramp, with rip-rap pitched spending slope on the rear right.

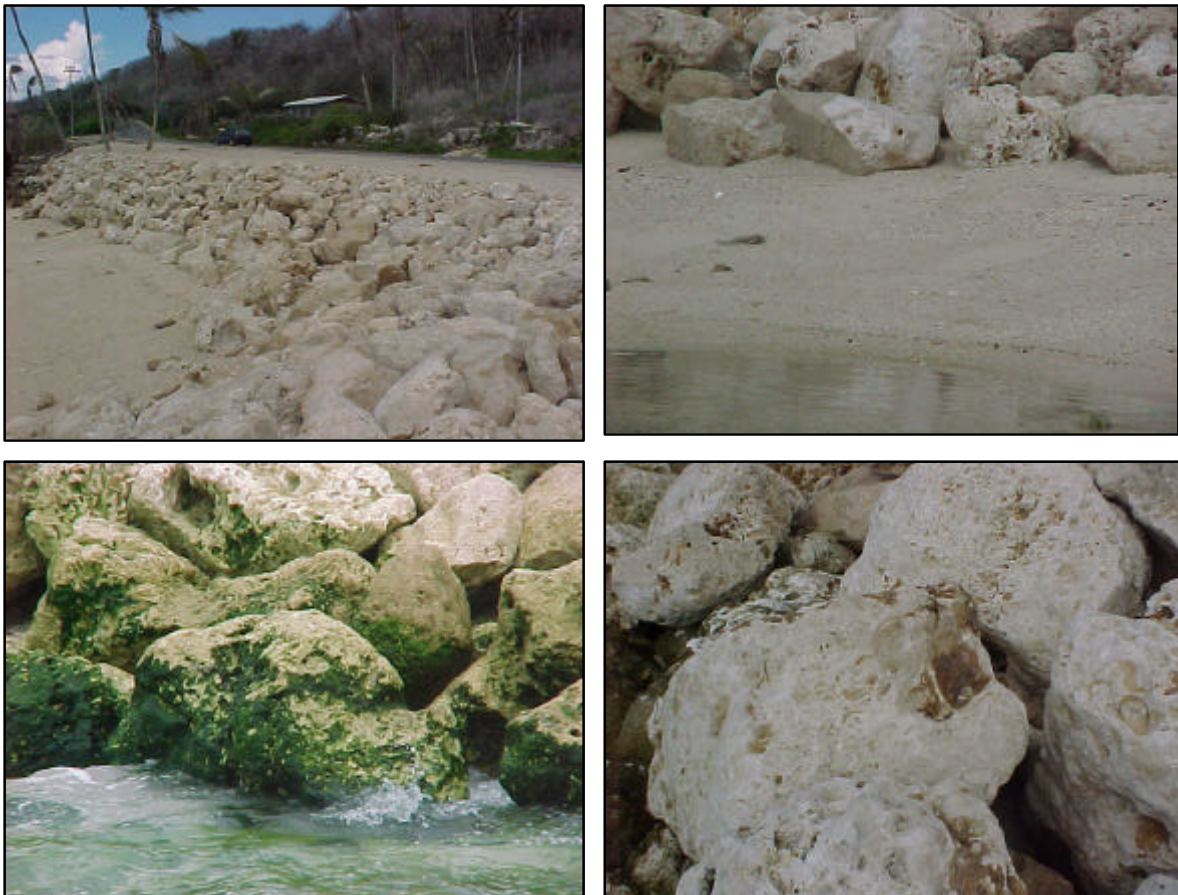
Figure 22. Rip-rap characteristics at the harbour site. Top left – a single-layered rip-rap, protecting an eroded segment of road, on the Southern side of the harbour; top right – rip-rap at the toe of the groin; lower left – algae-covered rip-rap at the toe of the groin, alongside the mooring basin; and lower right – note rip-rap boulder shape, angularity and pits.
