SCALING UP PACIFIC ADAPTATION (SUPA)

SNAPSHOT 2021:
**Coastal Protection Measures,
Tonga**

ASSESSING IMPACT AT INTERVENTION LEVEL

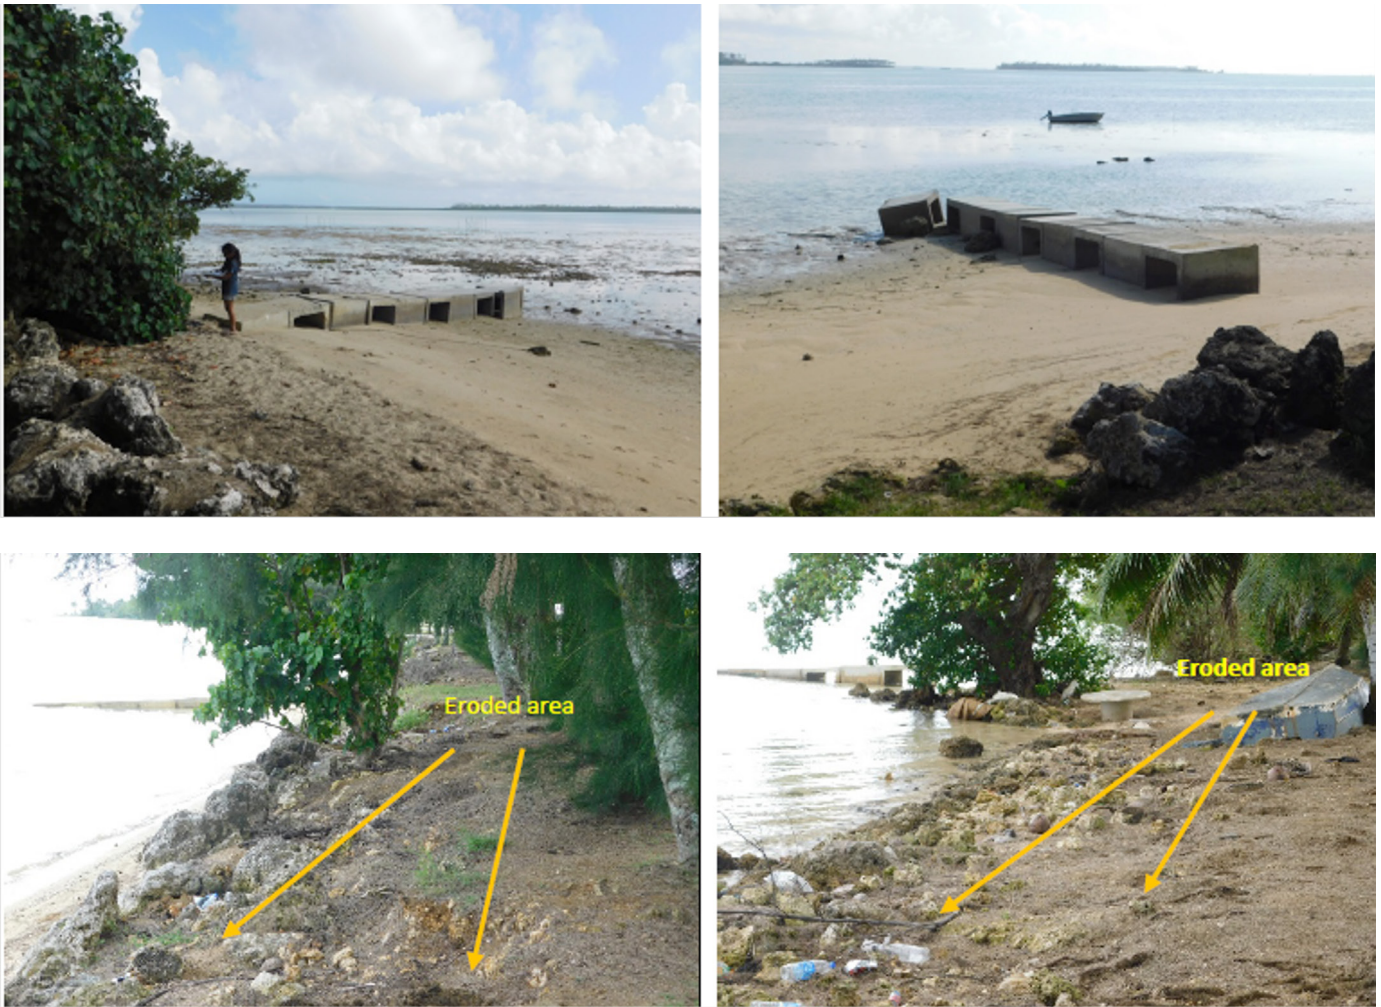
Field observations of groynes indicated the good condition of structures with some elements showing general signs of deterioration that require attention. Most of the groynes were placed below the high-water mark by about 1-2metres and obstructs the sand from the up-drift side of the groyne but allows sand to bypass atop of the groynes during high tide.

Figure 7. Photographs (top two) groyne structure showing sand accumulation at 50% permeability. (bottom) photographs show signs of erosion near groynes #11 and #12. Hahake along Makauga-Talafo’ou coastlines. July 2021.

The signs of coastal erosion noted along Makaunga was likely to occur during strong wind and stormy weather in recent past. However, signs of coastal erosion appear to decrease towards the Lighthouse. Field observations suggest that groyne structure is not protecting the Makaunga coastline like it does for the northern part of Talafo’ou where sand is supplied from the Lighthouse end. This maybe due to the interactions between the southerly longshore current and northerly tidal current as observed in the past with local knowledge.

Most of the people from the two communities accept that the two projects are protecting their lives and properties. However, defects from poor engineering needs to be addressed for the Ahau protection. The Makaunga Groyne structure may also need a new design/structure because sand is not accumulating. Coastal erosion is happening at this coastline.

Groyne structure- May need to be replaced with a rick revetment, especially the portion towards Makaunga village. Require adherent to detail of modern engineering and to be well supervised.

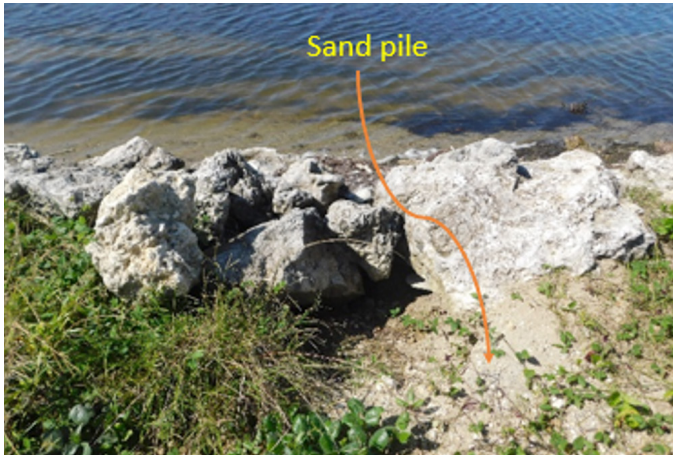
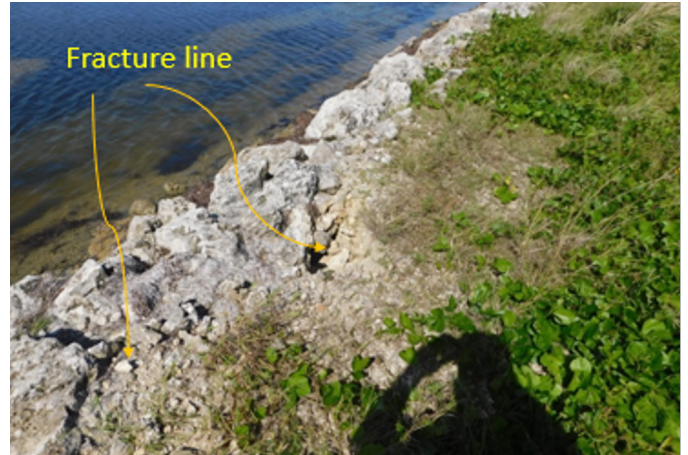
Field observations of revetment at Ahau. Core structure made of fine mud sediment being piled up to about 1.5meter high was now covered with thick coastal vegetation. Rock boulders of different sizes were laid on the seaward side with

no impermeable mat laid underneath the rocks. This suggested that with no matting, this made it easier for the seawater to seep through causing various lineal fractures on the rocks’ barrier. This was a recently built structure (6-months since it was completed) but showing signs of deterioration however, with overgrown vegetation seem stable.

The structure was constructed with two open ends at the northern and southern ends, allowing sea water to escape to frontline areas during spring tides and stormy weather.

Figure 10. Fracturing along the Barrier structure.

Rock Barrier - Supervision of project activities for such intervention is required to ensure that proper engineering is adhered to. The slope of the structure needs to be shallower to allow wave energy dissipation. Impermeable carpet should have been used to cover the fine sediment from being washed away by waves. Both ends of the structure need to be closed to protect the frontline families. Heavier rocks should have been used at the top of the structure.

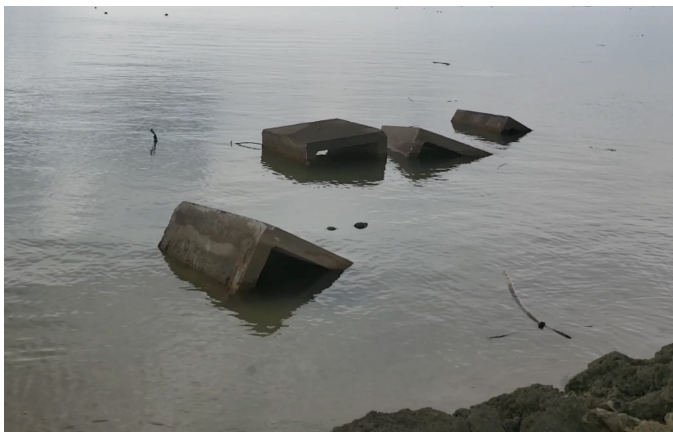
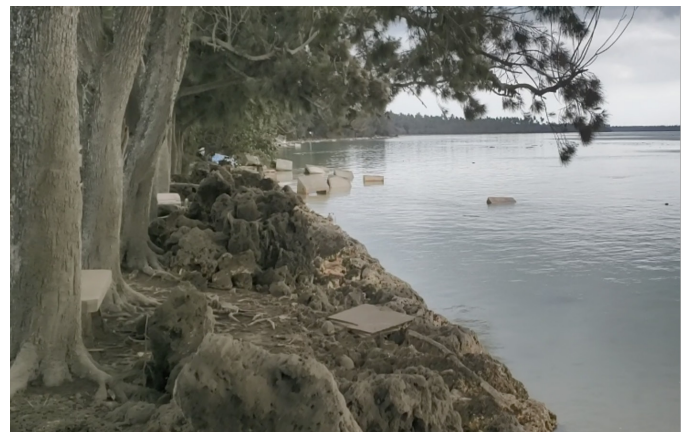
Figure 11. Groyne structure at Hahake completely disfigured by the recent Tsunami, 15th January 2022.
