Survey of the Regional Distribution and Status of Asbestos-Contaminated Construction Material and Best Practice Options for its Management in Pacific Island Countries

Report for the Federated States of Micronesia

**Prepared for the Secretariat of the Pacific Regional
Environment Programme (SPREP)**

May 2015

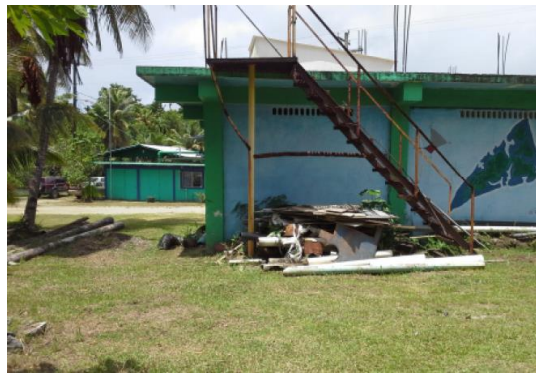
Photo 6 – Yap Water Treatment Plant

Sample No	Location	Type	Results	Area (m2) or Amount
Pohnpei	Antonia Dosolua's Shade House,	AC Pipes as roof supports	Probably 12% Chrysotile	10 Pipes
Yap	Yap Water Treatment Plant	Old AC Pipes lying around	Probably 12% Chrysotile	About 10 Pipes
Kosrae	Former Kosrae Hospital	AC Pipes as Posts (not used)	Probably 12% Chrysotile	4 pipes
Pohnpei	Kolonia Public Reserve	Old Sheets and some broken pieces	Unknown but reputed to be asbestos cement	3m2 and 40 m2 Ground Contaminated
Kosrae	FSM Telecom, Kosrae	Suspect lagging (branded Selkirk Metalbestos)	Unknown	2
Pohnpei	Kuniora Gallen's House	AC Pipes as Roof supports and some broken asbestos	Probably 12% Chrysotile	Numerous Posts (75m2) and about 3m2 contaminated soil
Yap	Mr Atal's House	Damaged AC Pipes and some broken asbestos	Probably 12% Chrysotile	About 4 damaged pipes and about 2m2 contaminated soil
Kosrae	Mrs Torendra Jona's House	Damaged AC Pipes and some broken asbestos	Probably 12% Chrysotile	About 4 damaged pipes and about 2m2 contaminated soil

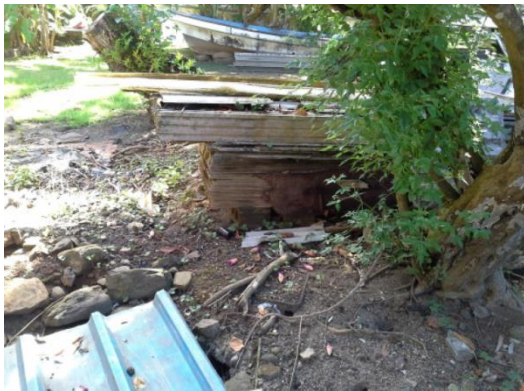
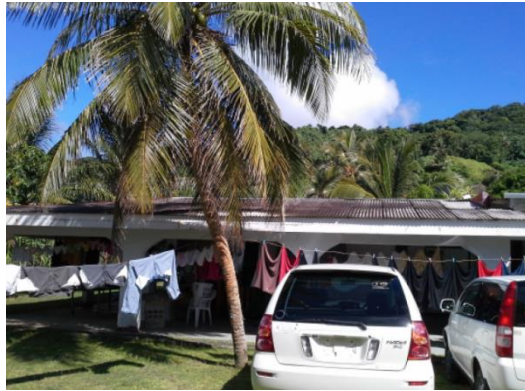
Photos 11 and 12 – Mr Mori’s House, Stacked Sheets and Roof

Site	ACM	Risk Score	Recommended Remedial Actions	ACM Area (m ²)	Estimated Cost (US\$)
Mr Mori's private residence, Chuuk	Chrysotile 15%	19	Remove the asbestos cement roof and replace with an alternative roof.	150	10,500 to 27,000
	Chrysotile 15%	19	Pickup and disposal of a stockpile of asbestos cement boards.		\$250
Immaculate Heart of Mary Church, Chuuk	Chrysotile 10% Amosite 15%	16	Remove the asbestos cement roof and replace with an alternative roof.	525	36,750 to 94,500
Chuuk State Court	Chrysotile 20%	13	Paint ceiling tiles	30	\$630
Kosrae					
FSM Telecommunications Corporation, Kosrae Branch	Not tested	13	Remove the existing generator exhaust and replace with an alternative product.	2	?
Former Kosrae Hospital and Mrs Torenda Jona's Residence, Kosrae	Chrysotile 15%	10	Pickup and disposal of asbestos cement pipes.	9	\$285

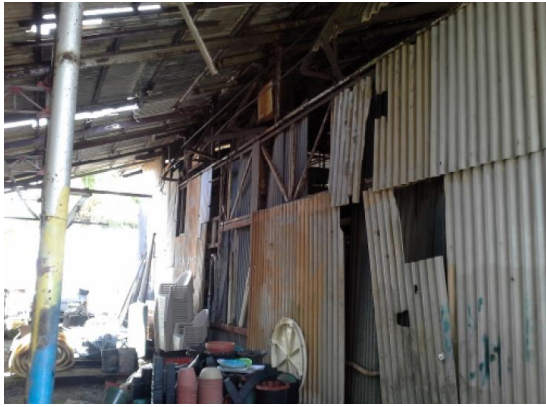
Photo 15 – LPG Corporation

Pohnpei	Pohnpei LPG Corporation	Badly Damaged AC roofing material used as cladding	Unknown	1625
Pohnpei	Pohnpei Public Market	Damaged AC Roofing Material used as a fence	Unknown	50

Site	ACM	Risk Score	Recommended Remedial Actions	ACM Area (m ²)	Estimated Cost (US\$)
Pohnpei					
LP Gas Corporation, Pohnpei	Chrysotile 15% Amosite 2%	23	Remove the asbestos cement cladding and replace with an alternative product.	1,625	113,750 to 292,500
Kuniora Gallen's private Residence, Pohnpei	Chrysotile 15%	18	Paint asbestos cement columns.	75	1,665
	Chrysotile 15%	18	Pickup and disposal of asbestos cement pieces.	2	85
Johnny P. David's private residence, Pohnpei	Chrysotile 15% Amosite 2%	16	Pickup and disposal of a stockpile of asbestos cement boards.	1,000	250
Pohnpei Fishing Corporation generator shed, Pohnpei	Chrysotile 15% Amosite 2%	16	Remove the asbestos cement cladding and replace with an alternative product.	200	14,000 to 36,000

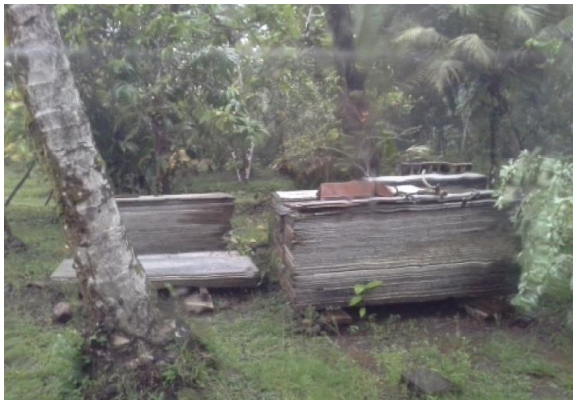
Photo 17 – Residence – Stacked Sheets

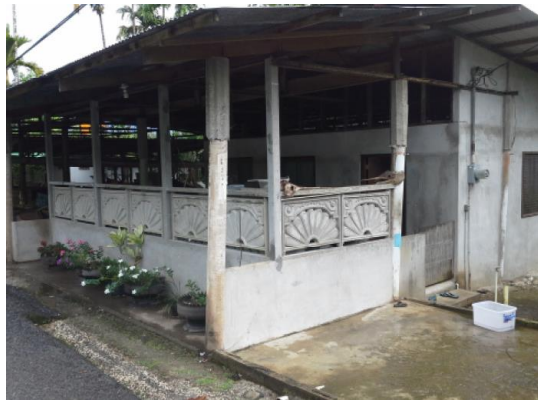
Photo 18 – Residence – AC Pipe Columns

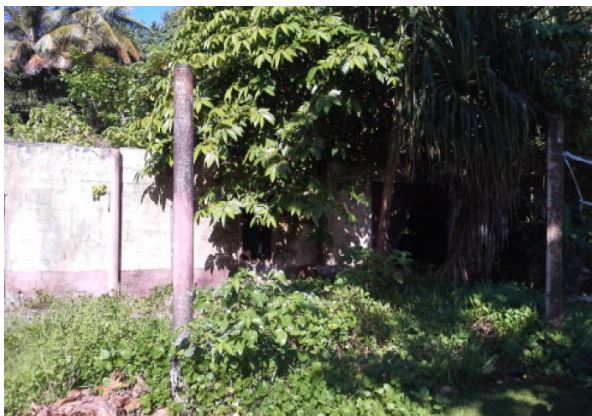
Photo 19 – Hospital – Old AC Columns

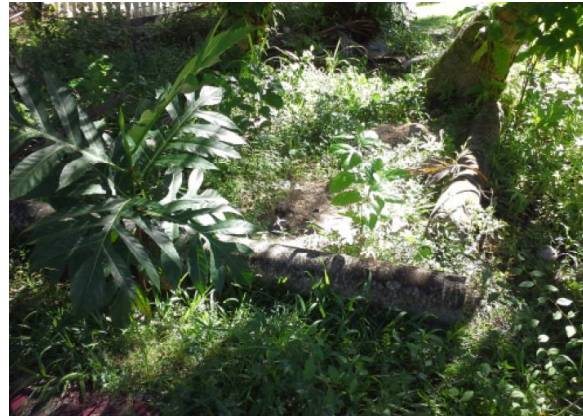
Photo 20 – Residence – Old Pipes
