Survey of the Regional Distribution and Status of Asbestos-Contaminated Construction Material and Waste - Best Practice Options for its Management in Pacific Island Countries

Report for Niue

**Prepared for the Secretariat of the Pacific Regional
Environment Programme (SPREP)**

July 2015

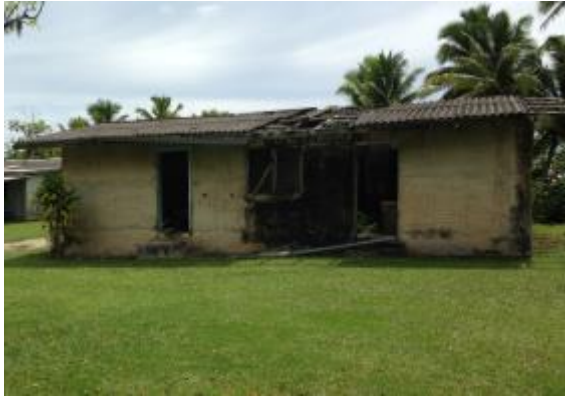
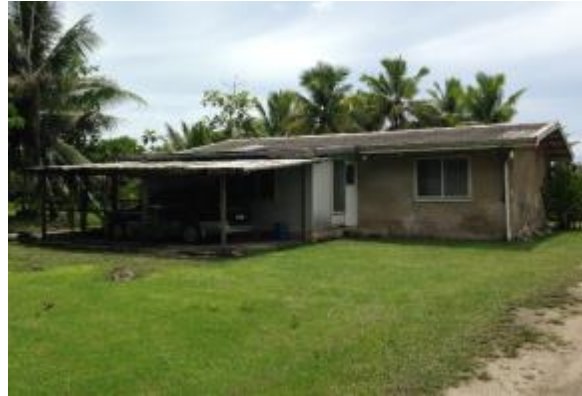
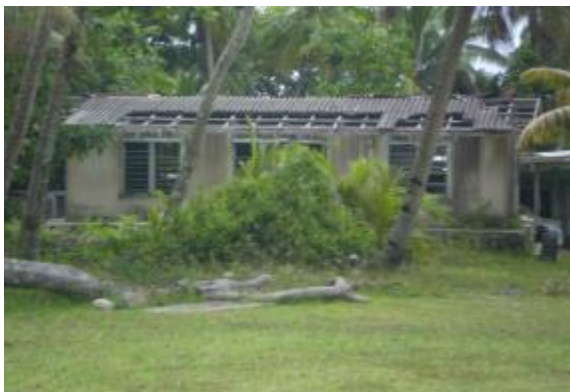
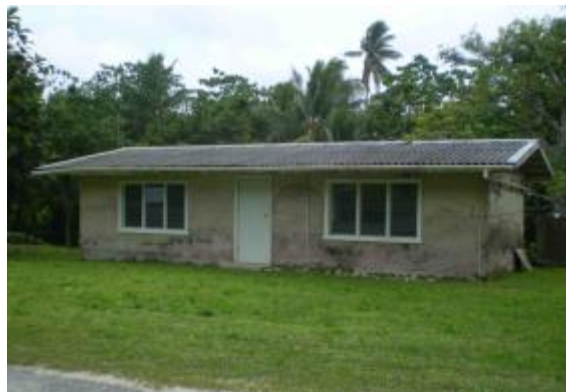
Photos 1-4 below show some typical houses with asbestos roofs, two of which are in very poor condition.

Photos 1-4: Houses with Asbestos Roofs

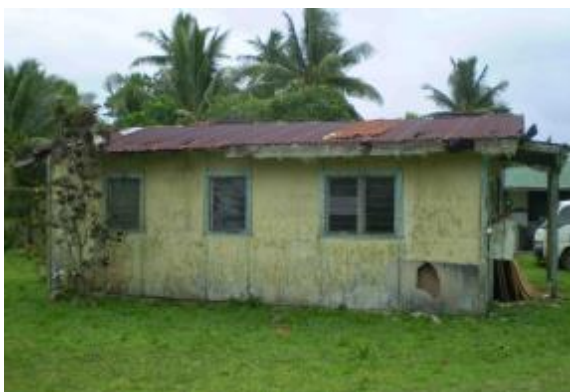
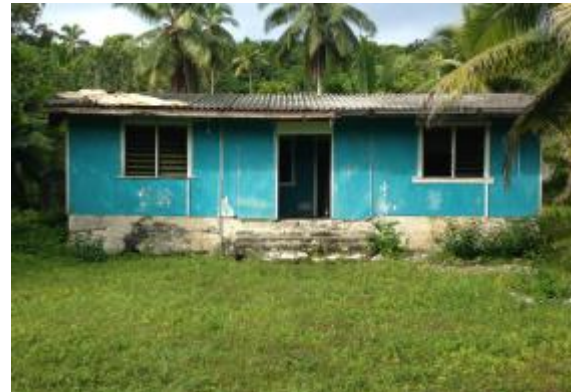
Photos 5-6 below show houses with asbestos cladding (and roof in one case). This cladding is also in bad condition.

Photos 5-6: Houses with Asbestos Cladding

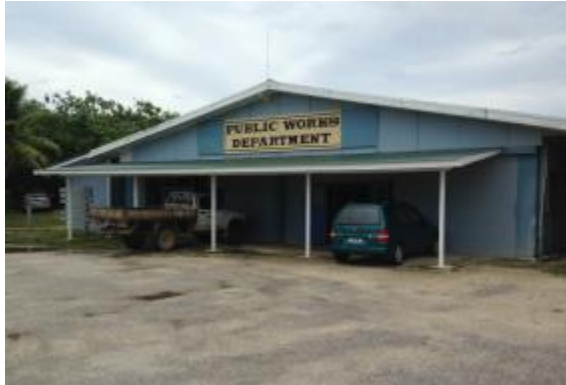
Photo 7: Public Works Department – Cladding Front and Sides

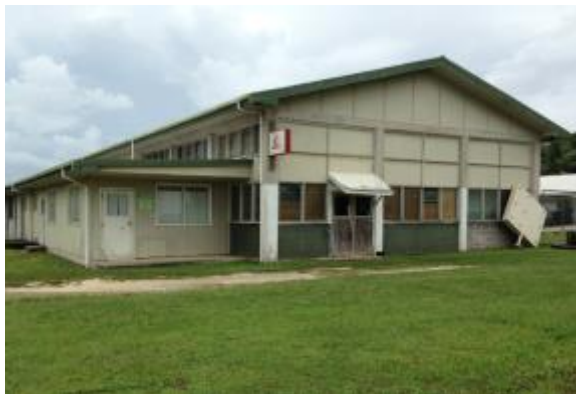
Photo 8: Vai Mamali/Rockbak Building Cladding

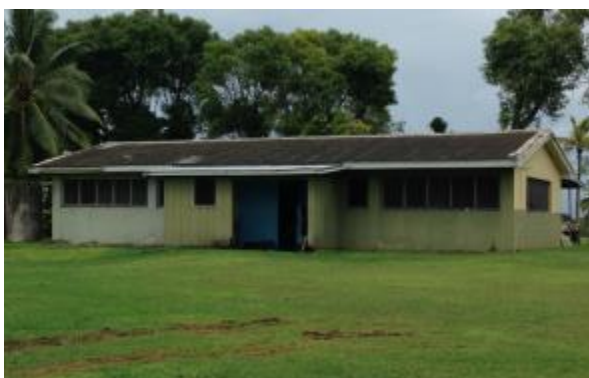
Apart from the houses there are three roofs that should be replaced, i.e. the abbatoir, the honey processing building and the Catholic Church as all are deteriorating. There may also be other non-residential roofs that were not spotted as part of this survey.

Photo 9: Honey Processing Building Roof

It should be noted that a wipe sample taken in the Honey Processing Building on the second visit produced a moderately high result for chrysotile of 71,000 Str/cm².

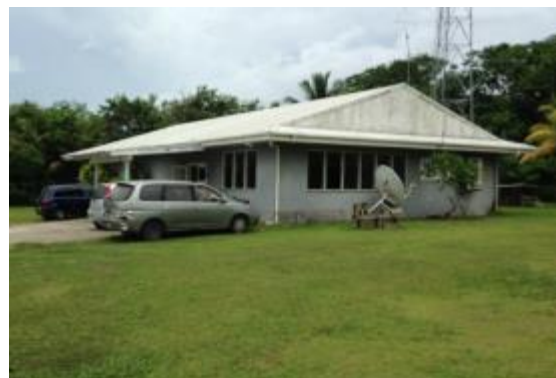
Photo 10: Niue Broadcasting Cladding/Soffits

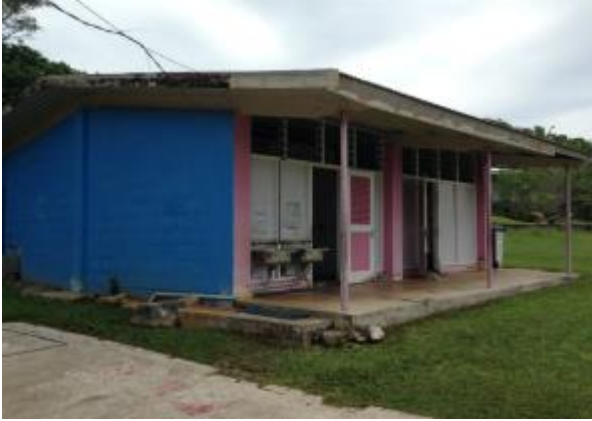
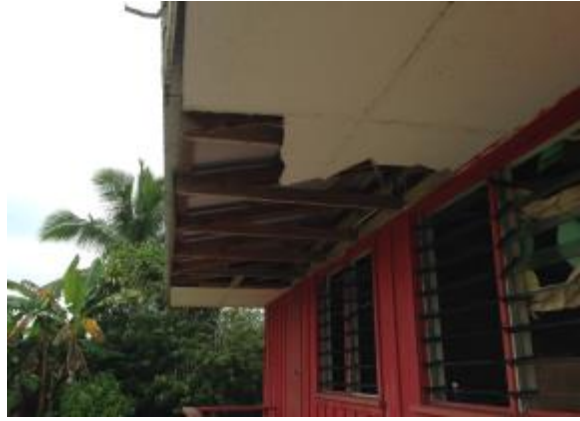
The Primary School has asbestos soffits and cladding in various places as indicated and it is more damaged than the cladding at the Secondary School. There is also some asbestos debris behind classrooms at the back of the school. It would be a simple matter to clean up this debris. It is understood that a new school is to be built soon so for now it would probably be sufficient to carefully repair the damaged asbestos and encapsulate the rest with a good paint system pending the construction of the new primary school.

Photos 11-12: Primary School – Cladding and Soffits

- h) Asbestos at both the primary and secondary schools should be rendered safe and preferably removed, although repair and encapsulation will probably be sufficient for now.

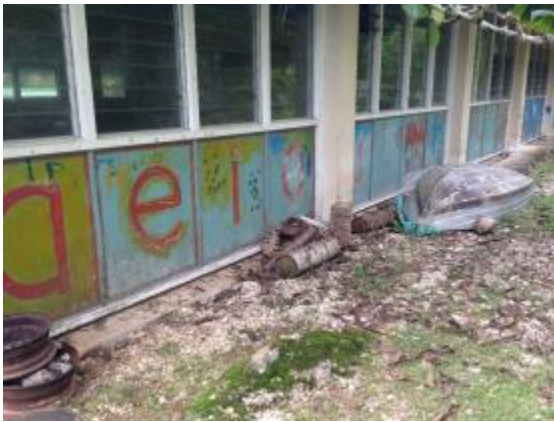
Photo 13: Asbestos Debris Behind Primary School

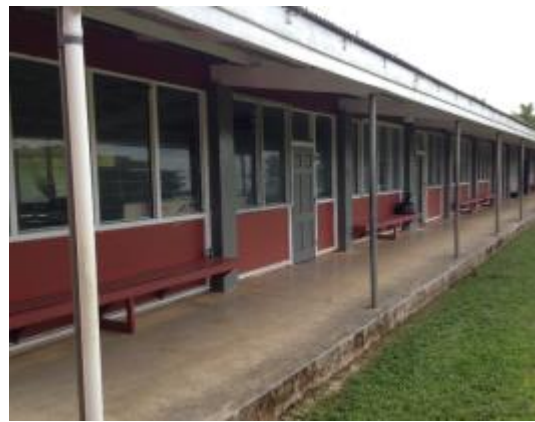
Another issue is the asbestos in the schools. The Secondary School has a large amount of asbestos cladding which is at present in good condition and well painted so it is presenting little risk. Seeing as children are at risk it may pay to program in the replacement of this cladding and in the meantime precautionary measures should be taken regarding maintenance and any damage sustained to the cladding.

Photo 14: Secondary School Cladding

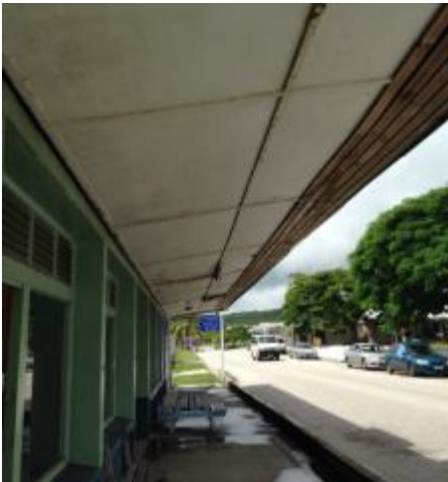
Photo 15: Alofi Bread Shop Soffits

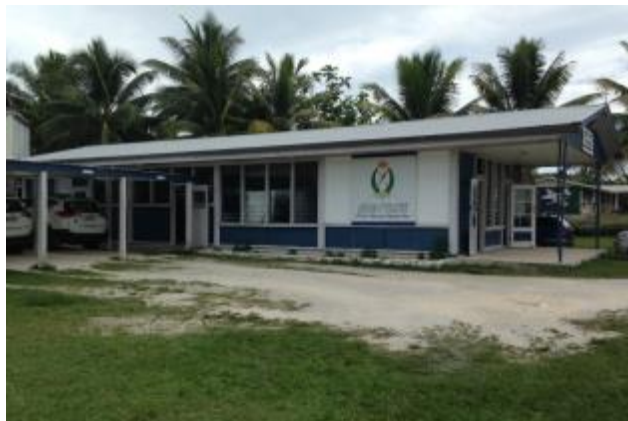
Photo 16: Police Station Cladding

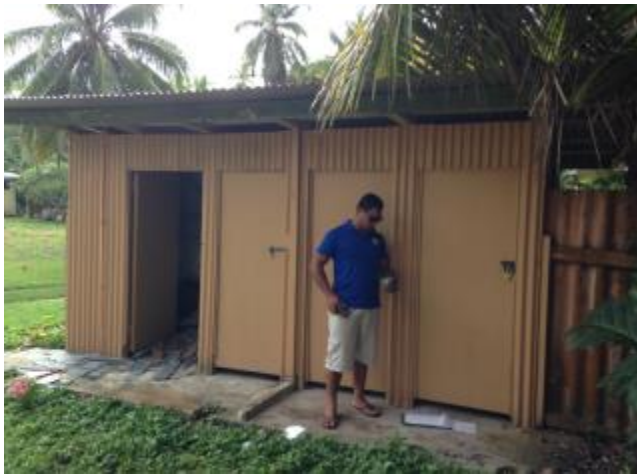
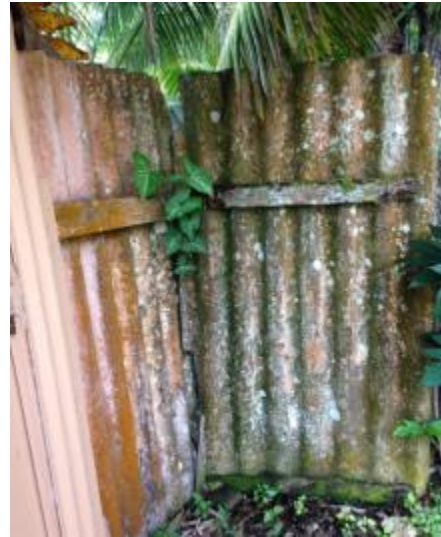
Photos 17-18: The Shed and Fence Behind Makini Handicrafts

The shed in Photo 17 tested negative but the fence shown in Photo 18 that is made out of asbestos roofing materials tested positive. An air sample was taken from this shed that proved to be negative. A wipe sample was also taken that demonstrated moderate surface chrysotile contamination.

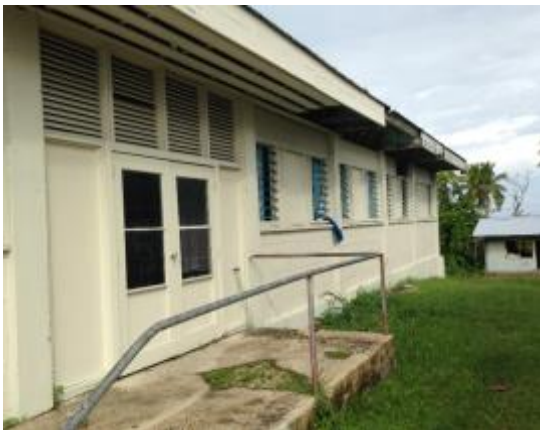
Photo 19: Alofi South Hall Cladding

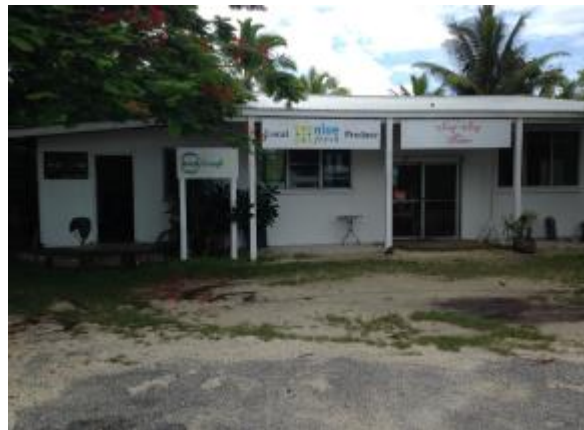
Photo 20: Sassy Fashions/Breakthrough Cladding

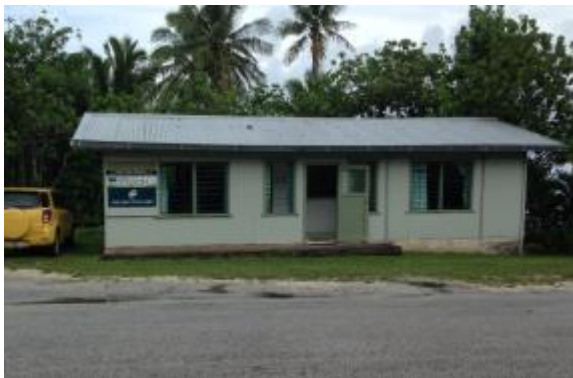
Photo 21: Peleni's Travel Cladding

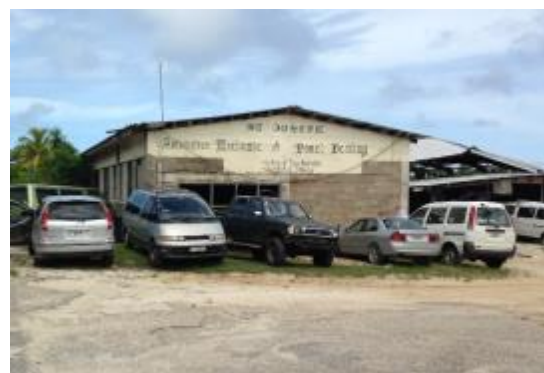
Photo 22: St Joseph's/Peta Paints Roof and Cladding

The old building housing the St Joseph's Automotive Repair Shop and the Peta Paints Retail Shop has a large amount of old asbestos roofing and cladding. An air sample was taken inside Peta Paints that proved to be negative. A wipe sample taken on the first visit produced a very high result of 910,000 Str/cm² for chrysotile and a moderately high result of 81,000 Str/cm² for amphibole (amosite and crocidolite). A second sample was taken on the second visit and chrysotile was still high at 350,000 Str/cm² and amphibole was still significant at 12,000 Str/cm².

This building needs to have the asbestos removed and the structure needs to be cleaned. It is an old high building and some significant safety issues need to be addressed, regarding the removal of the asbestos.

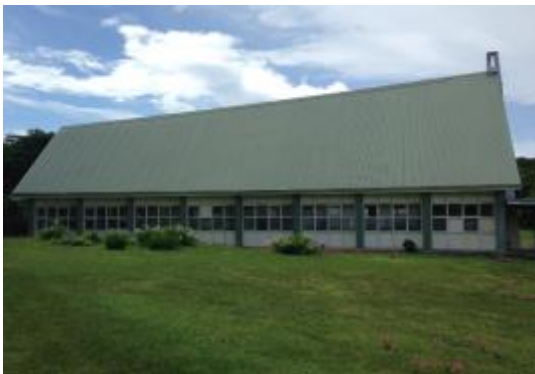
Photo 23: Avatele Church Panels

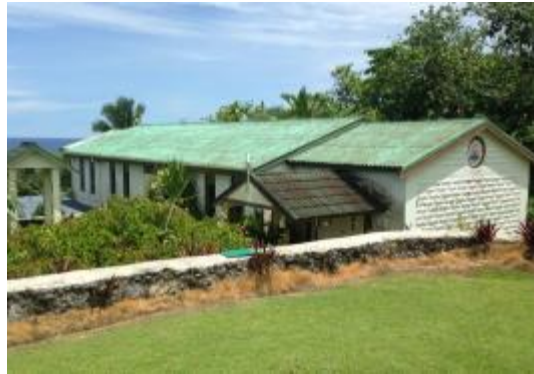
Photo 24: Catholic Church Roof

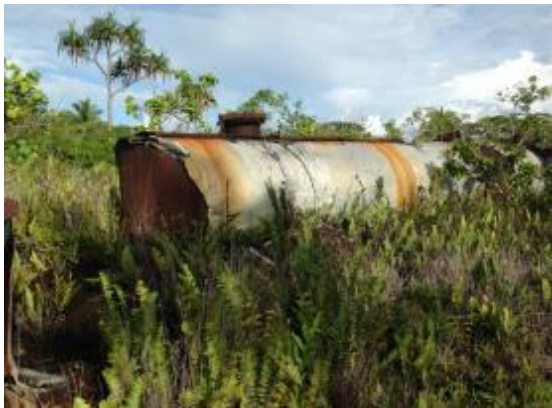
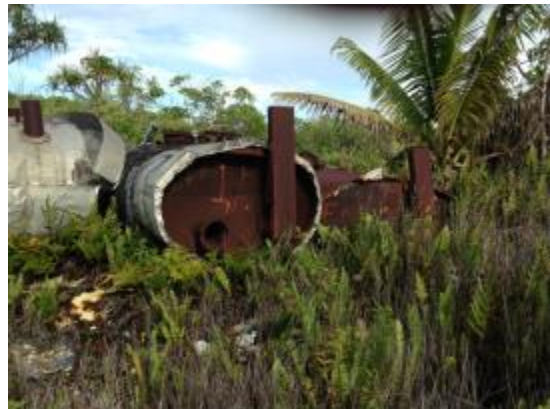
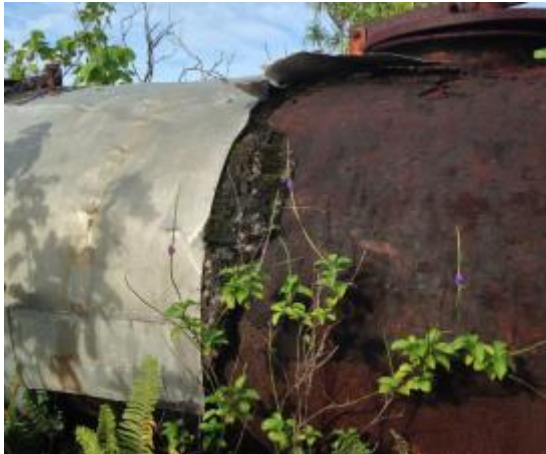
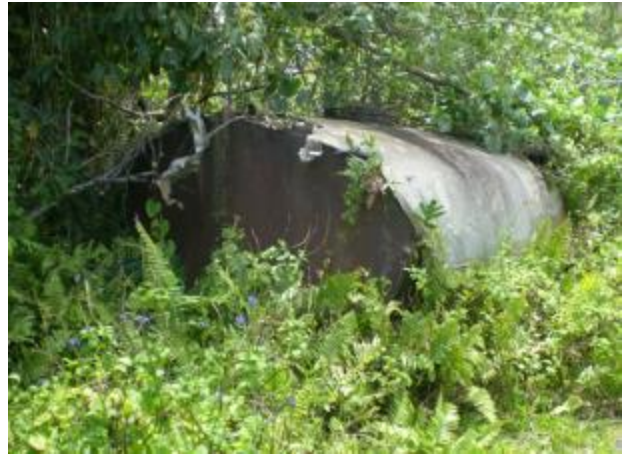
The other matter that needs to be focussed on urgently is the bitumen tankers at two locations. The asbestos is friable amosite (at least part of it is) and this is very serious. Ground contamination is also occurring. At least the sites are not very accessible which reduces the risk. Because of the serious nature of the contamination, however, and the fact that the tankers are deteriorating, this matter should be addressed urgently. The original New Zealand owners of the tankers should be approached, perhaps through the New Zealand High Commission, as the clean-up should be funded as a special project.

Photo 25: Reservoir Bitumen Tank A

Photo 26: Three Reservoir Bitumen Tanks

Photo 27: Close-up of Tank A Lagging

Photo 28: Bitumen Tank at Hui Hui

Photos 25-28 show the bitumen tanks abandoned by Fulton Hogan from an earlier roading project. There are three tanks in one location on the road to the hospital near a reservoir and at least one (and possibly more than one) near the entrance to the Hui Hui hazardous waste site. Based on the analyses done to date and reported in section 4.1 above, a large amount of the lagging in these tankers is amosite asbestos. Some of the lagging has tested negative but seeing as much of it has tested positive for amosite, probably all the lagging should be regarded as amosite or at least potentially amosite contaminated.

- g) The friable amosite asbestos associated with the abandoned Fulton Hogan bitumen tankers should be removed safely and the two locations where these tankers are located should be cleaned up. This is specialist work and is also urgent, given the hazardous nature of the asbestos. Until this remediation work can be carried out, fencing and danger signs should be erected.

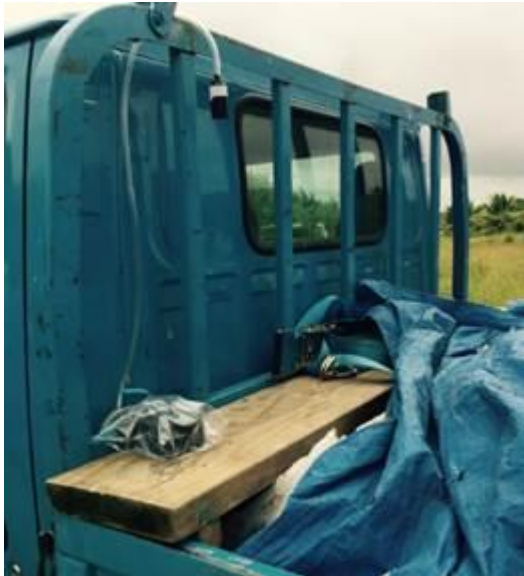
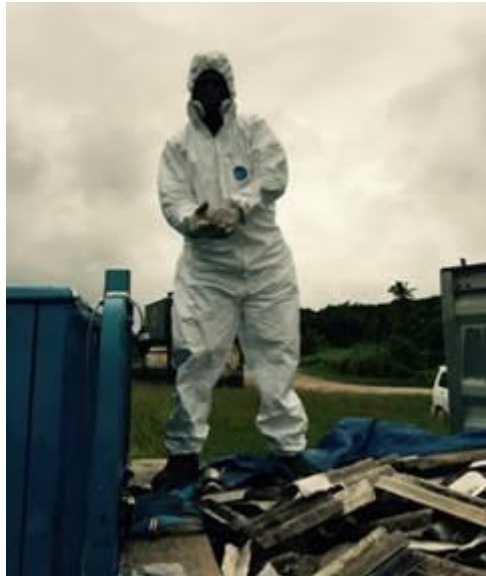
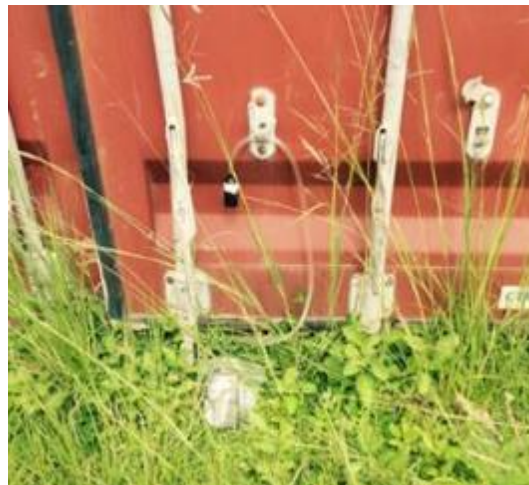
- Sample 1 was taken on the truck at Lakepa during loading of asbestos
- Sample 2 was taken on the truck just outside the container where the scraping was being done prior to shipment.
- Sample 3 was taken to one side of this container.

These sample locations are shown in Photos 29-31 below.

The analyses of these air samples demonstrated significant amounts of airborne asbestos around these operations. The PCM results may pick up other fibres besides asbestos but they were verified by further analyses using the Transmission Electron Microscope (TEM). These results are reported in Section 4.2 above. High results were reported from Sample Pumps 2 and 3 but Sample Pump 1 also registered a significant result.

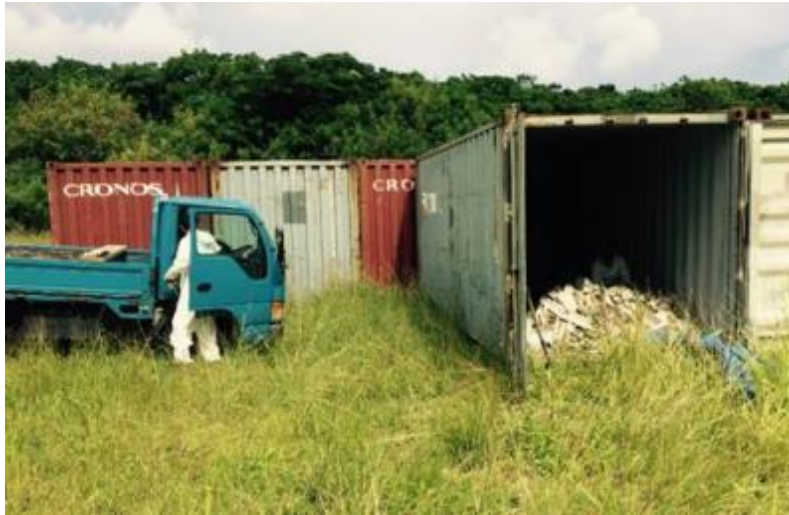
Photo 32: Asbestos Processing Operations

Photo 32 below shows the operations at the container area. The worker shown in the container is scraping the asbestos in preparation for export. Based on the air results, the conclusion can be drawn that these workers are at risk of asbestos exposure. The ground may also be in the process of becoming contaminated.
