Survey of the Regional Distribution and Status of Asbestos-Contaminated Construction Material and Best Practice Options for its Management in Pacific Island Countries

Report for the Independent State of Samoa

**Prepared for the Secretariat of the Pacific Regional
Environment Programme (SPREP)**

May 2015

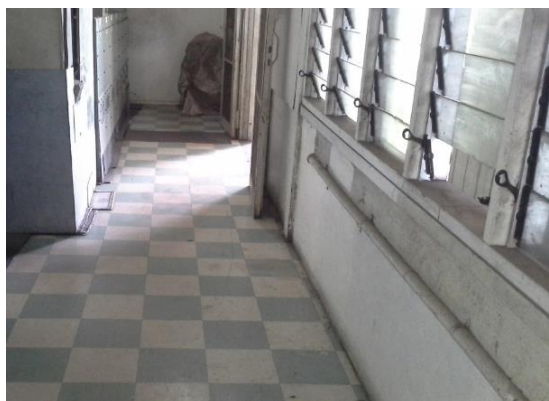
Photo 1 – Tuiala Power Station

Photo 1 below shows the vinyl tiles in the Tuiala Power Station which tested positive for a low level of chrysotile. Photo 2 below shows the ceiling panels at the Femei Matafa Office of Statistics which tested positive. There may be other ceiling tiles containing asbestos in this building.

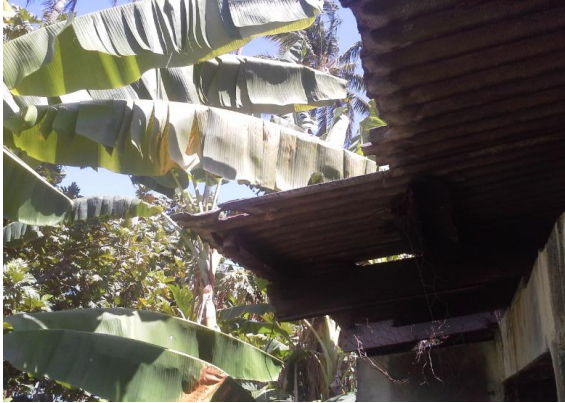
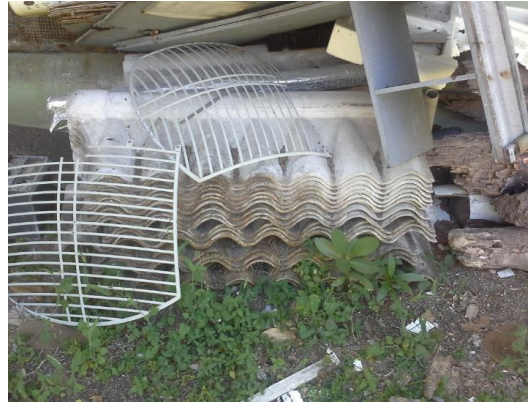
Photos 3 and 4 – Meteorological Station, Apia

Photos 3 and 4 below are of the Meteorological Station in Apia. Photo 3 shows the roof and Photo 4 shows a small stack of asbestos. There is more asbestos debris scattered around the site.

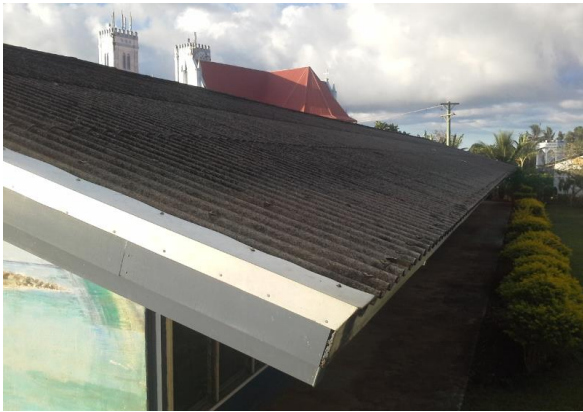
Photo 5 – Paul VI College

Photo 5 below shows the asbestos roof at Paul VI College and Photo 6 below shows loose AC sheeting at Fasitoo Tai Village.

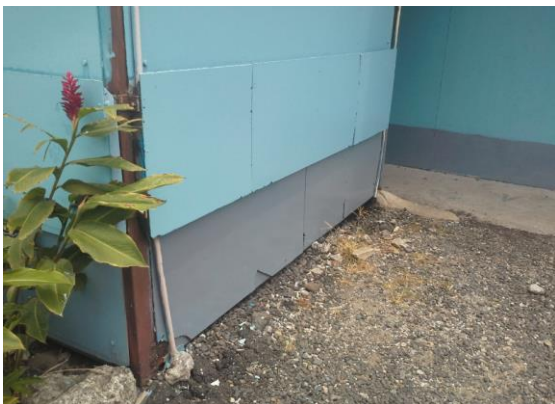
Photo 7 – Customs Building, Apia Port

Photo 7 below shows the exterior façade on the Customs Building at Apia Port and Photo 8 below shows the Toilet Block asbestos roof at USP Savai'i. There is also some asbestos debris from former roofing at USP Savai'i.

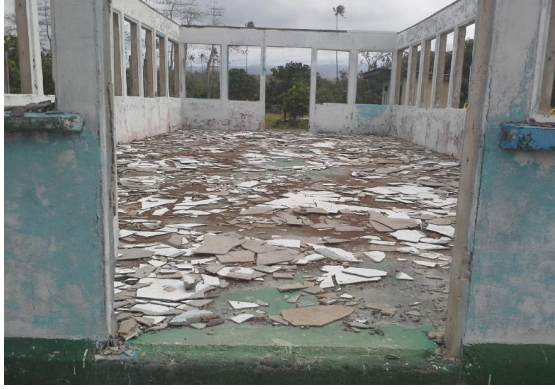
Photo 9 – Loose Debris, Fagamolo Village

Photo 9 below shows the a derelict building at Fagamolo Village with a large amount of loose asbestos cladding debris and Photo 10 below shows the sunshades at the WSLAC Building in Apia.

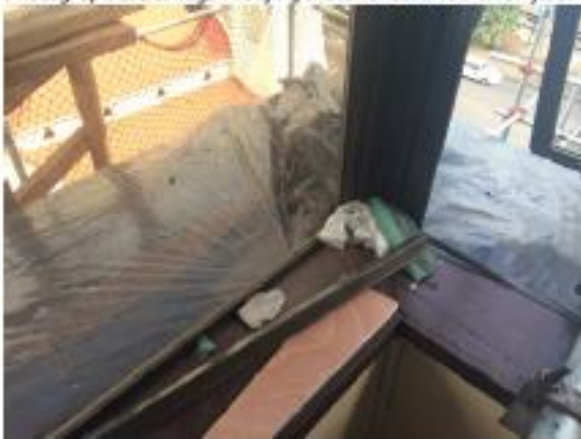
Photograph 2: Damaged roofing material observed on 6th floor of John Williams Building.

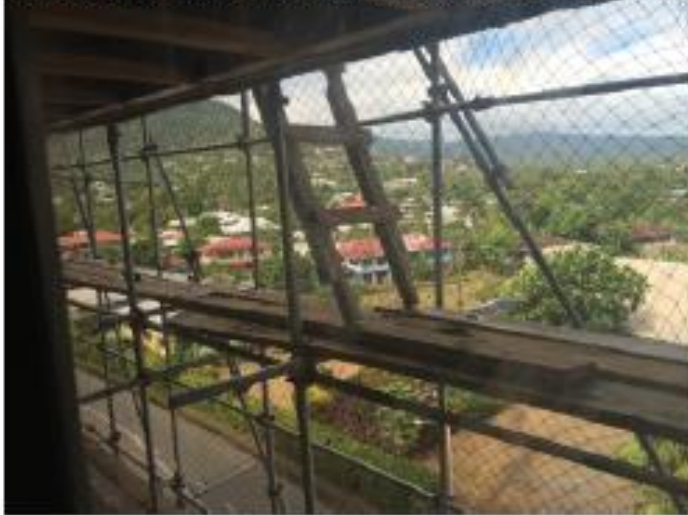
Photograph 3: View south west from sixth floor of damaged roofing material on scaffolding boards.

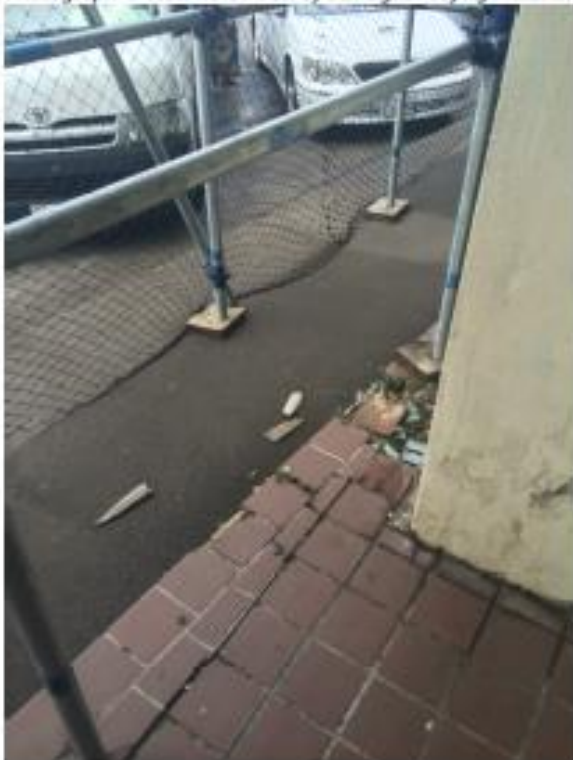
Photograph 4: View north west of damaged roofing material on footpath of Cross-Island Road;

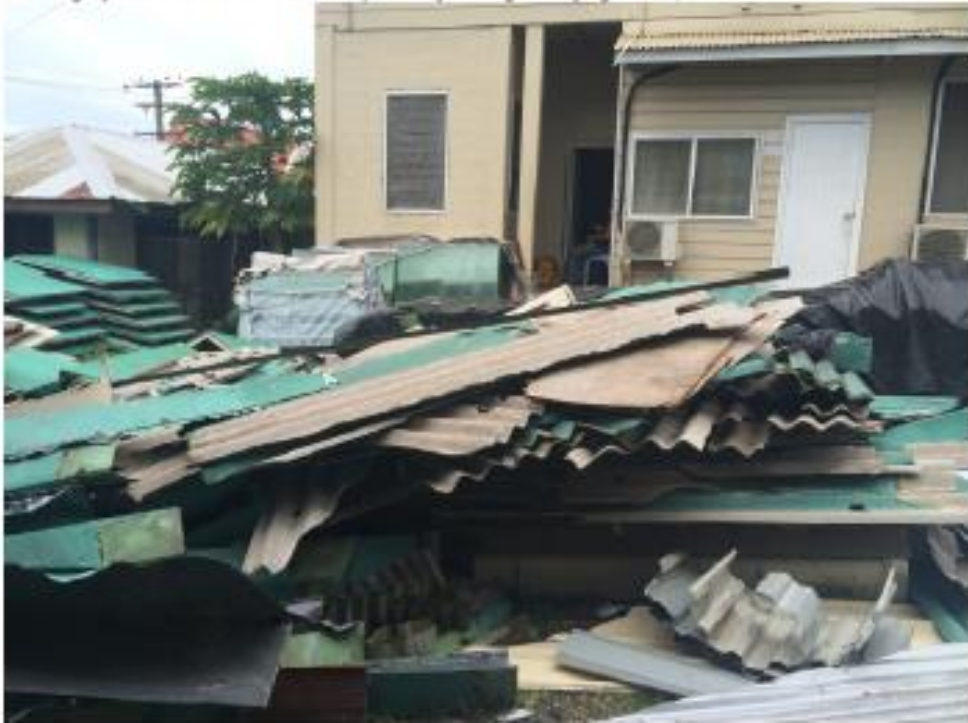
Photograph 6: View north in SPC compound of damaged roofing sheets;

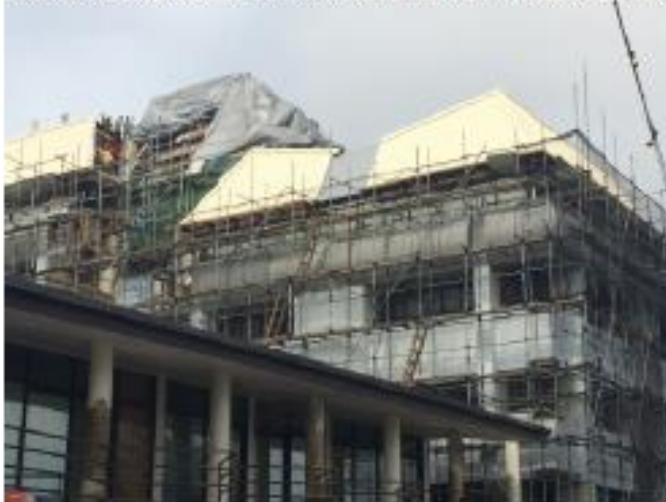
Photograph 7; View south west towards John Williams. Former roof (in green) being removed.
