# **Survey of the Regional Distribution and Status of Asbestos-Contaminated Construction and Waste Material and Best Practice Options for its Management in Pacific Island Countries**

## **Report for the Republic of Vanuatu**

**Prepared for the Secretariat of the Pacific Regional  
Environment Programme (SPREP)**

**May 2015**

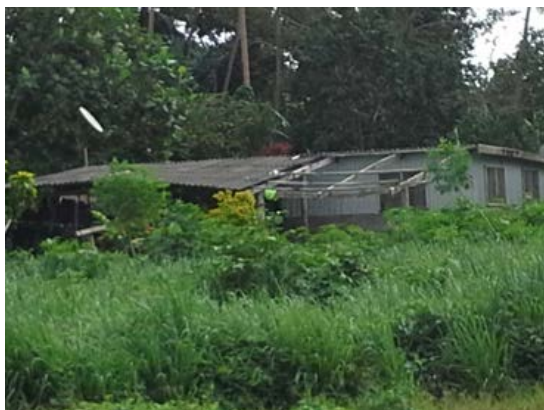
**Photo 1 - Pang Pang Residential**

Photo 1 below is of a residence in Pang Pang with an asbestos roof. The dwelling owner reported that the roofing material had been resourced from the nearby Forari Mine, which returned a positive sample.

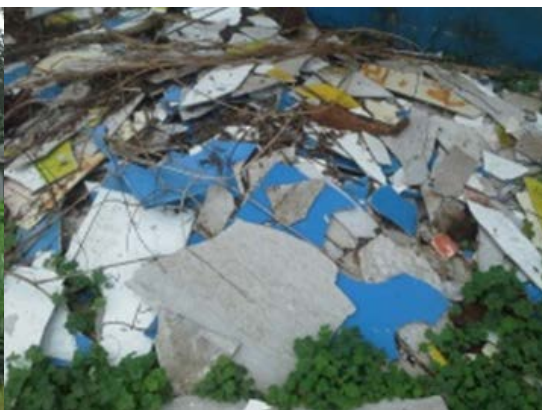
**Photo 2 – Residential Demo Site Rue de Wales**

Photo 2 below shows a residential demolition site in Rue de Wales where asbestos cement (AC) cladding was lying spread out on the ground. It was located in a residential area with a playground adjacent to the north and Port Vila’s main hospital to the east.

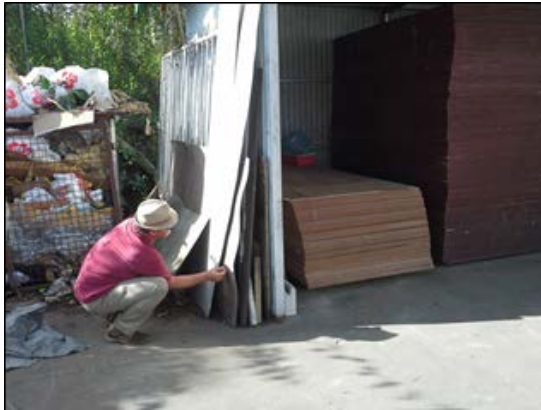
**Photo 3 – Hardware Store New Sheeting**

Photo 3 below shows an AC sheet at the entrance to a Chinese Hardware Store (MOK 3) in Elluk Rd. The shop manager had previously reported that he sometimes sells asbestos cement sheeting but that he did not have any in stock at the moment. The above panel was then found and sampled.

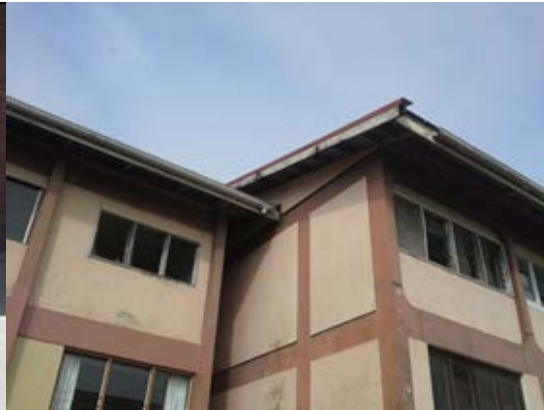
**Photo 4 – Ministry of Lands and Nat Resources**

Photo 4 shows AC cladding on the Ministry of Land and Natural Resources building at Port Vila. The AC sheeting was confined mostly to the outside gable and soffits, although limited quantities were also used as wall cladding.

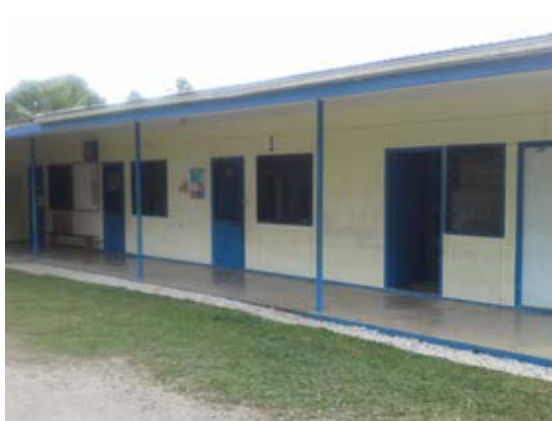
**Photo 5 – Paonangisu Health Centre**

Photo 5 below shows AC cladding on the Paonangisu Health Centre. The sample was collected at the reception area but ACM has presumably been used on all the five structures present at the site.

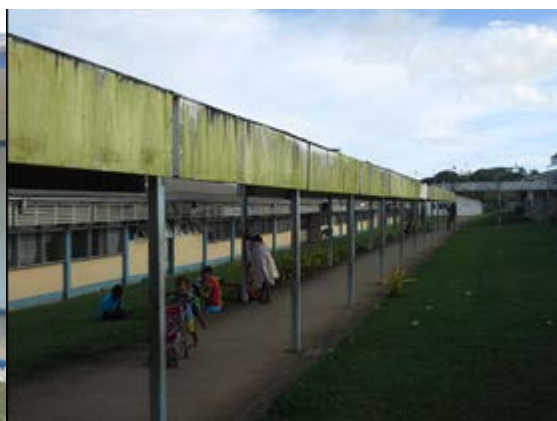
**Photo 6 – Port Vila Central Hospital**

Photos 6, 7 and 8 were all taken at the Port Vila Central Hospital. Photo 6 shows the covered walkways connecting the building. Photo 7 shows an example of the vinyl floor. Only one of the three sampled floors returned a positive result and this sample was collected from the theatre corridor. Photo 8 shows the services and heating pipes running the length of the covered walkways connecting the buildings. Some of these pipes are lagged with asbestos lagging, as confirmed by visual inspection.

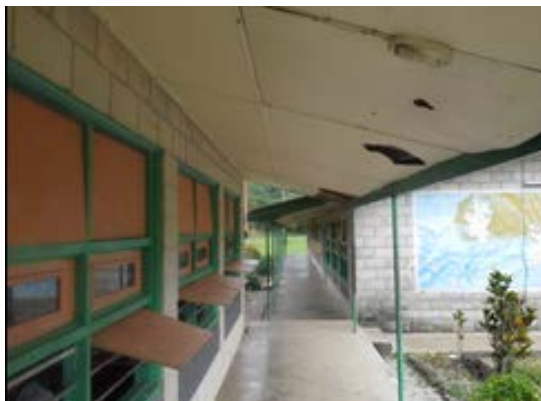
**Photo 9 – Presbyterian College**

Photo 9 shows the soffit material surrounding most of the classrooms at the Presbyterian College. Photos 10 and 11 are from the Malapoa College. Photo 10 shows AC cladding material which is applied to walls throughout the whole college. Photo 11 shows the roof with bitumen coating, which has been applied to roofs on all four buildings. Photo 12 has been taken at the abandoned manganese mine in Forari, and there is AC cladding and roofing on four remaining structures. The site is abandoned and in a rural area.

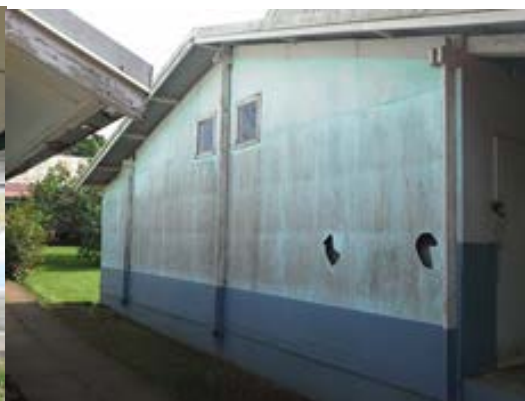
**Photo 10 - Malapoa College**

S6	Malapoa College	Cladding	Mixed - some badly damaged	500	10% Chrysotile and 10% Amosite
S7	Malapoa College	Cladding	Mixed - some badly damaged	500	15% Chrysotile and 5% Amosite
S8	Malapoa College	Bitumen Roof	Damaged	600	60% Chrysotile

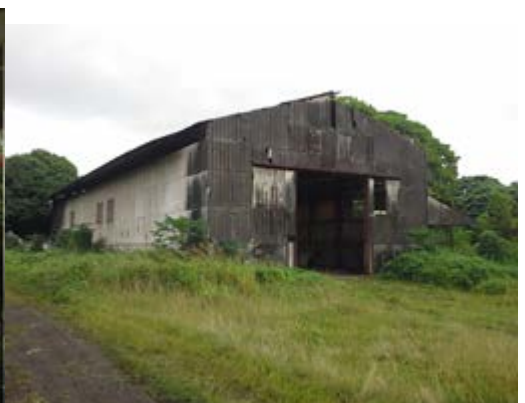
**Photo 12 – Manganese Mine Forari**

Sample No	Location	Type	Condition	Quantity (m2)	Result
S31	Old Manganese Mine	Roofing and Cladding - All Super 6, on four remaining structures	Badly Damaged	7000	20% Chrysotile
S39	Residence in Luganville with WW2 sourced asbestos	Cladding	Damaged	25	10% Chrysotile and 2% Amosite
S40	Residence in Luganville with WW2 sourced asbestos	Roofing	Damaged	50	20% Chrysotile and 2% Amosite
S49	Residential Centre, West Luganville - Shed next to Church	Cladding	Damaged	40	20% Chrysotile
S37	Western Part of Hospital Grounds	Cement Piping - mostly underground and not visible	Unknown	Unknown length	20% Chrysotile
S47	Residence in Luganville	Cladding	Badly Damaged	100	15% Chrysotile and 2% Amosite

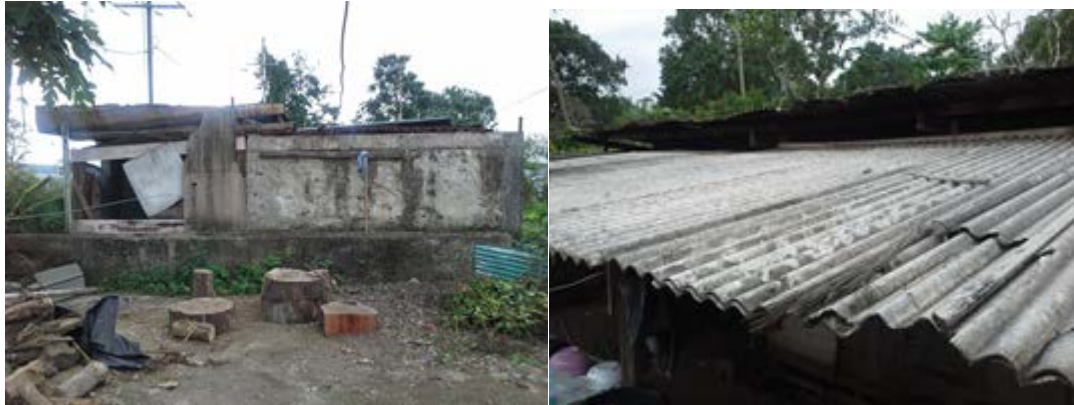
**Photos 13 and 14 – Residence in Luganville**

Photos 13 -16 were all taken in Luganville. Photo 13 shows AC cladding on a residence and Photo 14 shows the asbestos roofing on the same dwelling. The house was made of concrete, except for the

roof and several sheets. The owner reported that he sourced these asbestos materials from other WWII structures in the neighbourhood. He stated that he had also built a shelter out of these materials. It was unclear where this shelter was located. A family member pointed out that most of the houses in the surrounding area (approximately 100 dwellings) originally had similar roofing but that most of them had been replaced over the years. He was not sure where the asbestos had been deposited. Approximately 25 structures in the immediate surrounding area were inspected but no other PACMs were encountered.
