Tree Stocktaking Assessment Report

**Tree Stocktaking, Replacement, Maintenance and
Monitoring of Tagabe River Catchment, Vanuatu.**

November 2024

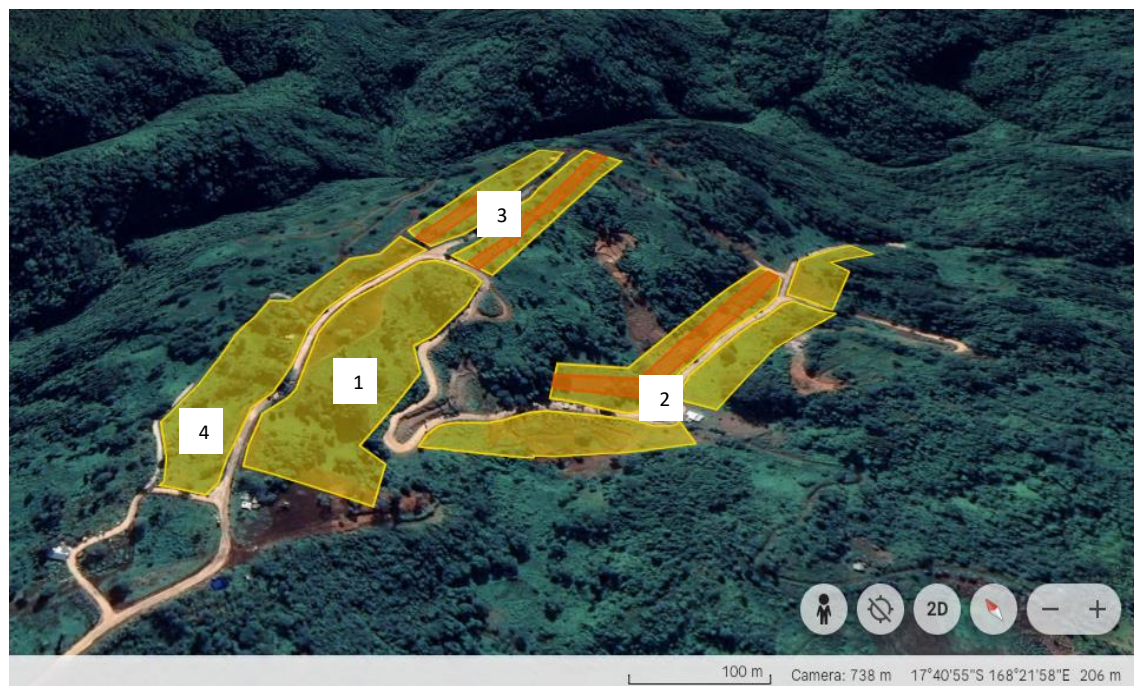
Figure 2. Image of Aku Farm with four areas for assessment: 1. South Ridge, 2. East Valley, 3. North Ridge, 4. West Hillside. Note: The areas shaded yellow (9.54ha) will be maintained monthly, while areas shaded red (0.94ha) are marked for replacement planting. This was identified during the tree stocktaking (6 November).

We have identified 0.94 ha that require replacement planting in two locations, Area 2 (East Valley) and Area 3 (North Ridge). We estimate that approximately 300 seedlings would be sufficient to cover the replanted area with a preference for fast-growing seedlings like mahogany and whitewood. The East Valley planting area also appears to be a waterlogged area and has a high concentration of weedy grass and shrubs.

- Coordinate with the Department of Forestry nursery to allocate 300 seedlings for the replacement planting activity (seedlings will be available mid-December).
- Develop a replacement planting plan.
- Once replacement planting is complete, conduct fortnightly maintenance of replanting areas and monthly maintenance of the rest of the planting areas (details to be provided in a replacement planting plan).
- Continue to engage youth in the communities with replacement planting and maintenance activities.
