Groyne Assessment Report

Kingdom of Tonga, 2019

By
Coastal Resources Section,
Natural Resources Division

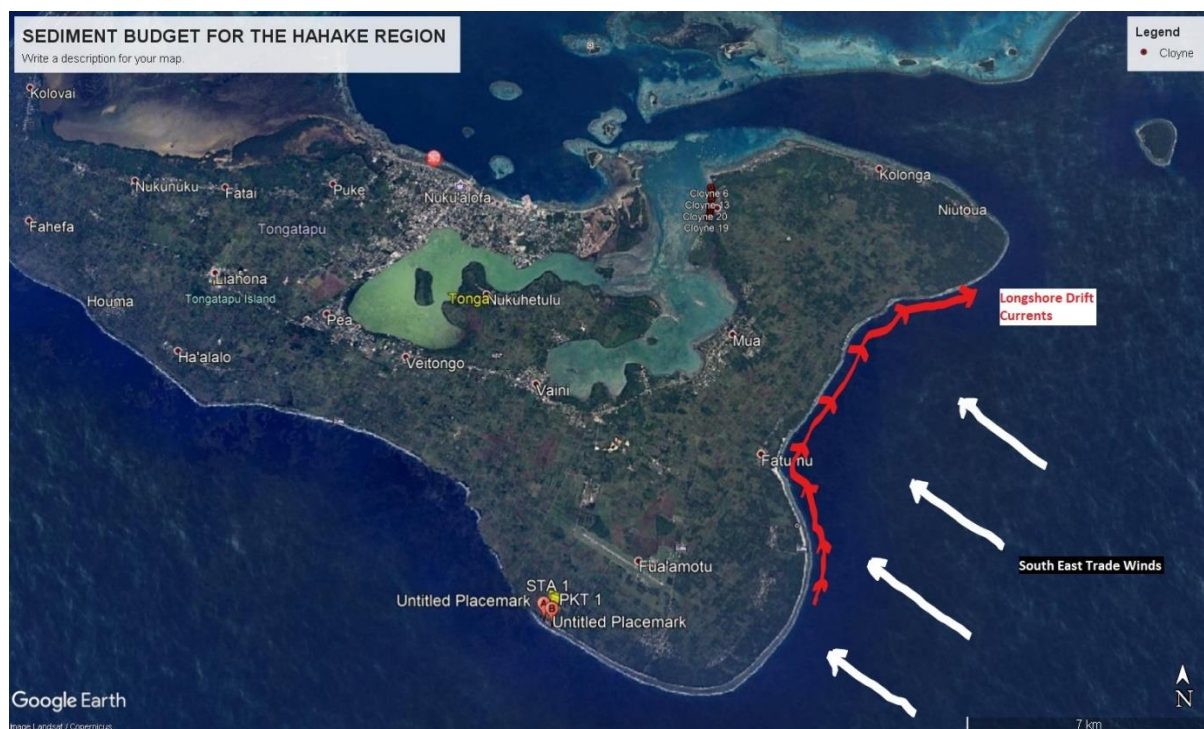
Sediment Budget at the Hahake Region

The source of sediment at this zone is from the eastern side of Tongatapu. The south east trade winds impact on the eastern side to generate a very high wave energy environment. The effect of strong waves on the coastal brought more offshore sand into the beaches and more effectively at the time of cyclone. The strong longshore drift current transported sands from the beaches at the eastern side and deposit along the other beaches further to the north and western part of Hahake region.

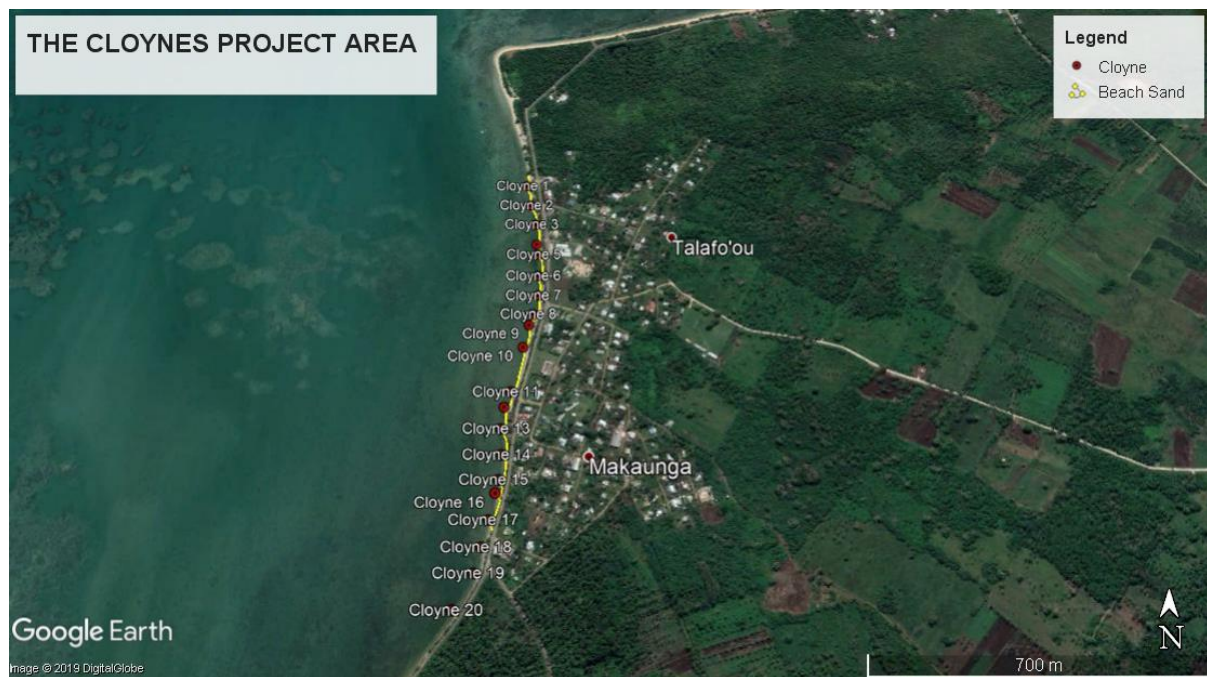
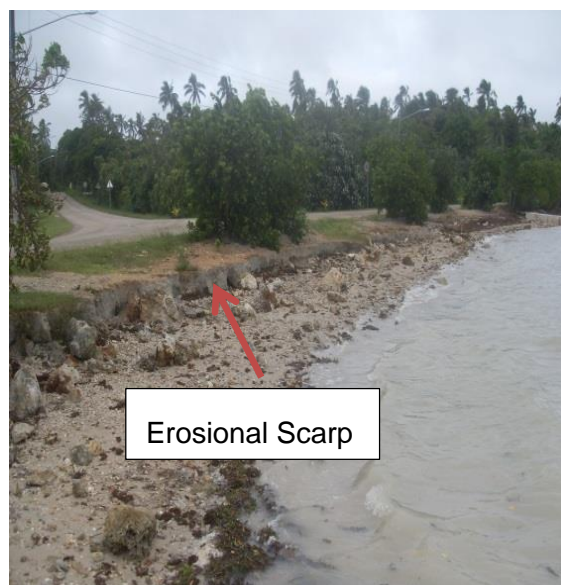
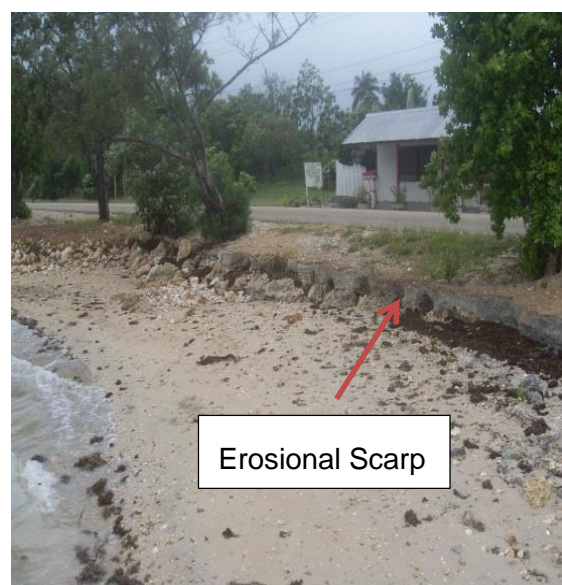
Project Area: Makaunga and Talafo'ou Beach

This is a very low elevation coastline experienced with frequent erosions. Erosional scarp noticed along the beach berm close to the edge of the Hahake road parallel to the shoreline. The height above High Water Mark (HWM) to the top edge of the erosional scarp approximately below 2 meters in average therefore, it is highly vulnerable to extreme erosions and flooding specifically at the event of natural

disasters.

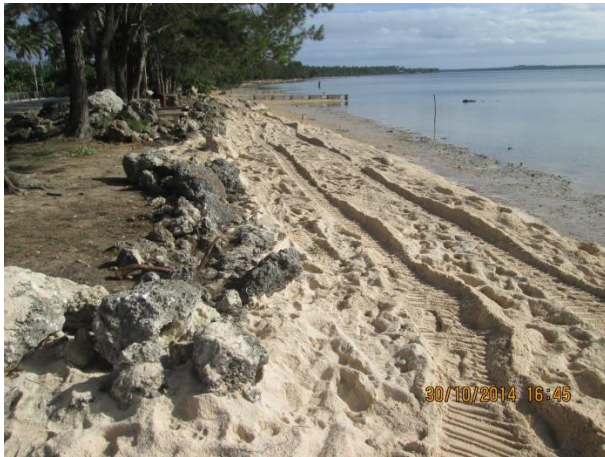
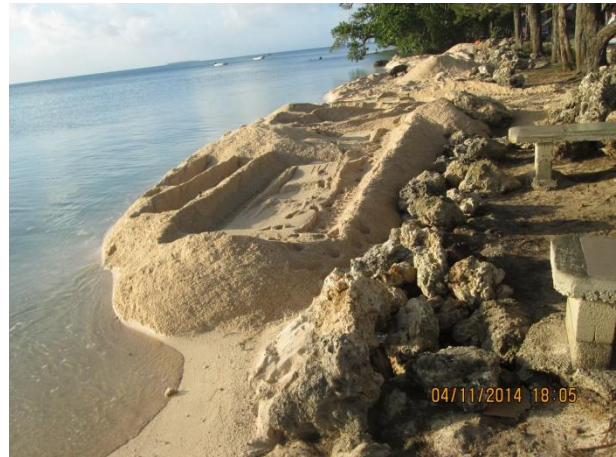
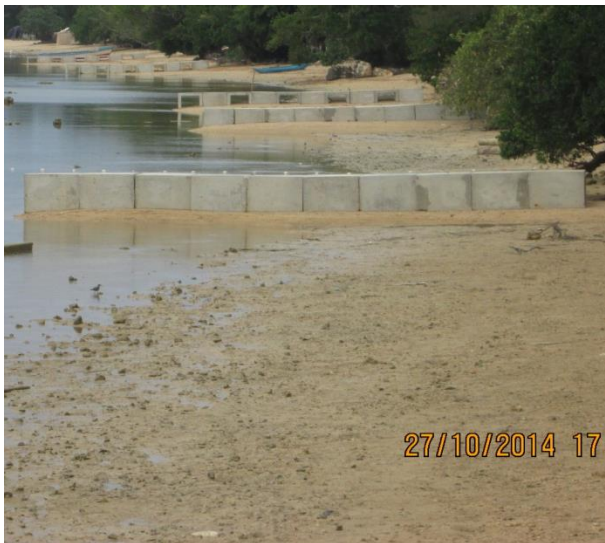
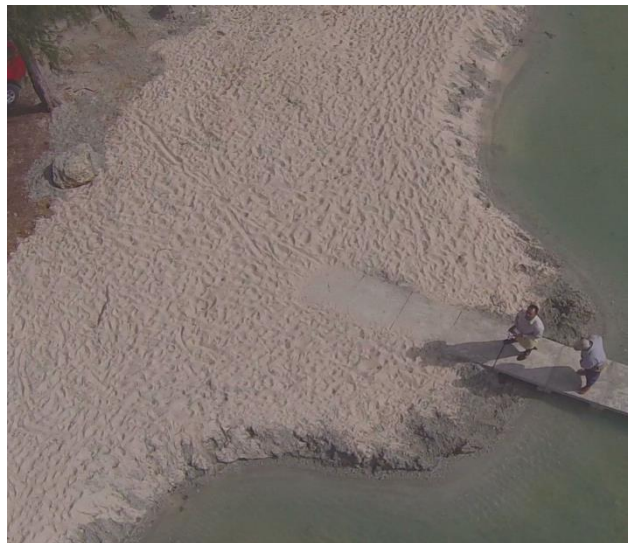
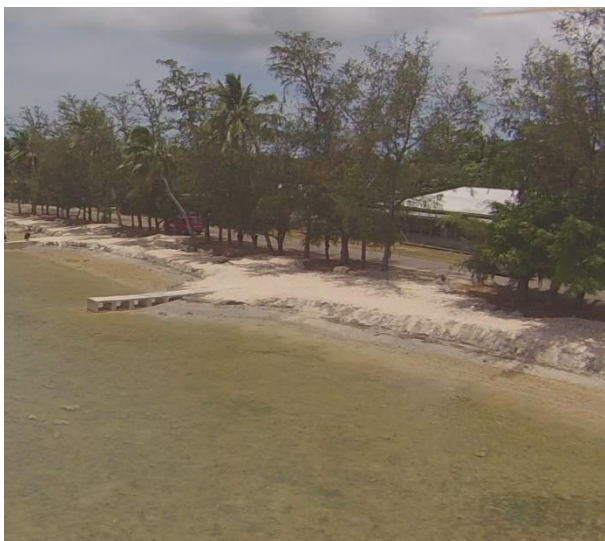
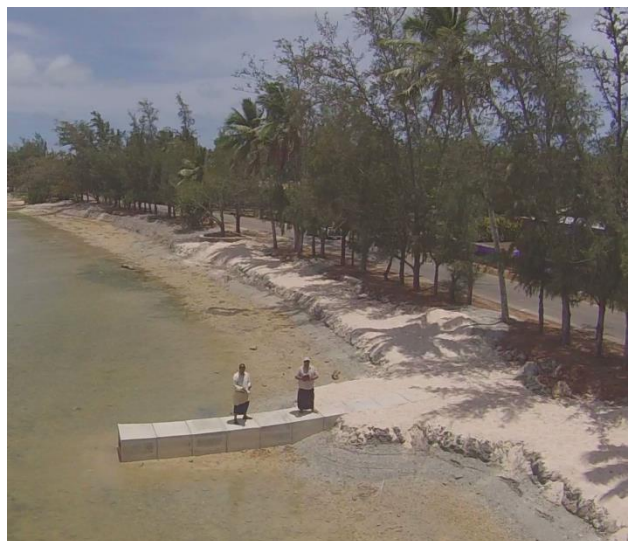
The area was filled up with abundance of sand from the 'Emeline and Niutao beach and levelled up to the highest ground elevation.

It is noticed that huge amount of sand has eroded from the beach until at its normal stable state now. Sands are only deposit symmetrically on both sides of the 17 groynes from the northern side of Talafo'ou beach and the other 3 groynes to the southern end have few to no sands at all. More sands discovered at the groynes with closed distance apart than the far distance one. It is also notified that sands among groynes have been eroded. Quantity of beach sands decreases as going further on the southward trend.

The groyne's structure, positioning and layout are considered to readjust. Inward Groynes' end should have been placed affirm the undisturbed area beyond the erosional scarp edge. This is to prevent the skipping of sand due to strong wind weather condition that may encourage huge amount being washed offshore.

1. To discard the initial project activity and implement a 1.5 meter high rock revetment rehabilitated with geotextile mat immediately for Makaunga and Talafo'ou foreshore.
2. To establish a committee, each member from the relative government stake holders who's responsible to all activity interacts with the coastline and to make sure that the committee's main obligation involve examine and indicate the best practices to implement in each coastline development, to avoid the wasting of fund.
3. All individuals responsible for EIA to every development practices interfere the natural process, should hold a minimum of Bachelor Degree in earth science or geology from a recognized University. This is to prevent the false activity suggested and inaccurate interpretation.

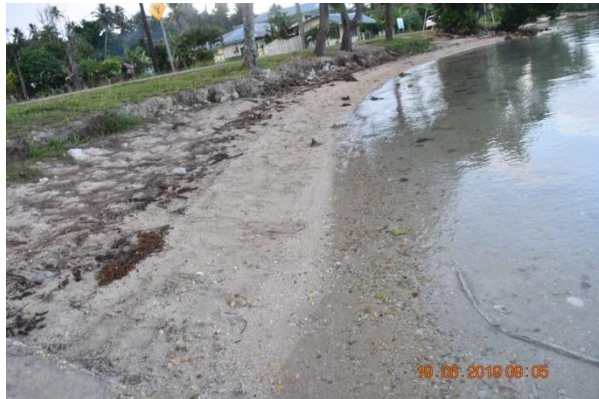
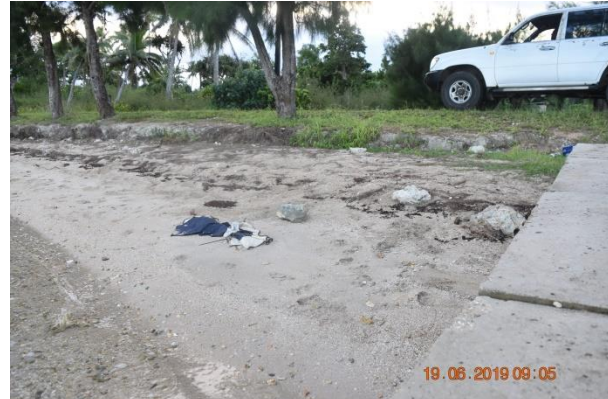
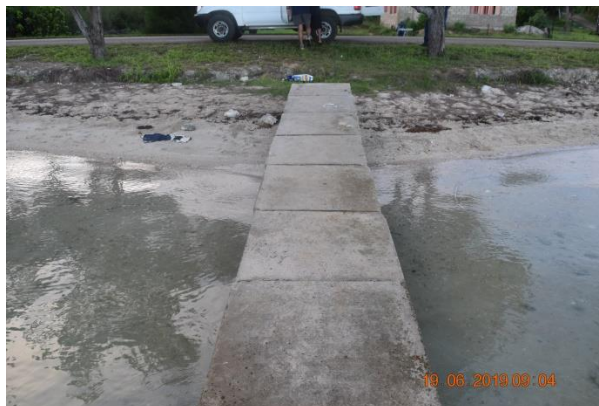
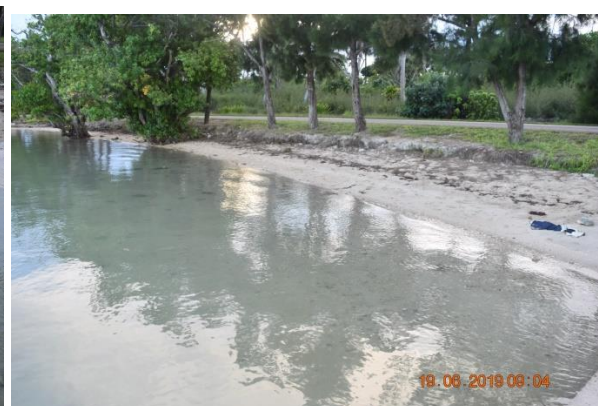
Sands at distance between groynes were consumed by the process; they were removed and deposited along each groyne axis and the rest being washed away offshore as results of the overall net force originate from the two currents' collision.

This is a part of a channel and the tidal current can be growing stronger at the narrow section in the beginning of Makaunga Village (groynes 17-20). The disruption of the crashing of the longshore and tidal current at this specific area generates strong offshore back wash of sand.
