Situation Report Palau

Impact assessment of past climate change adaptation actions

05/11/21

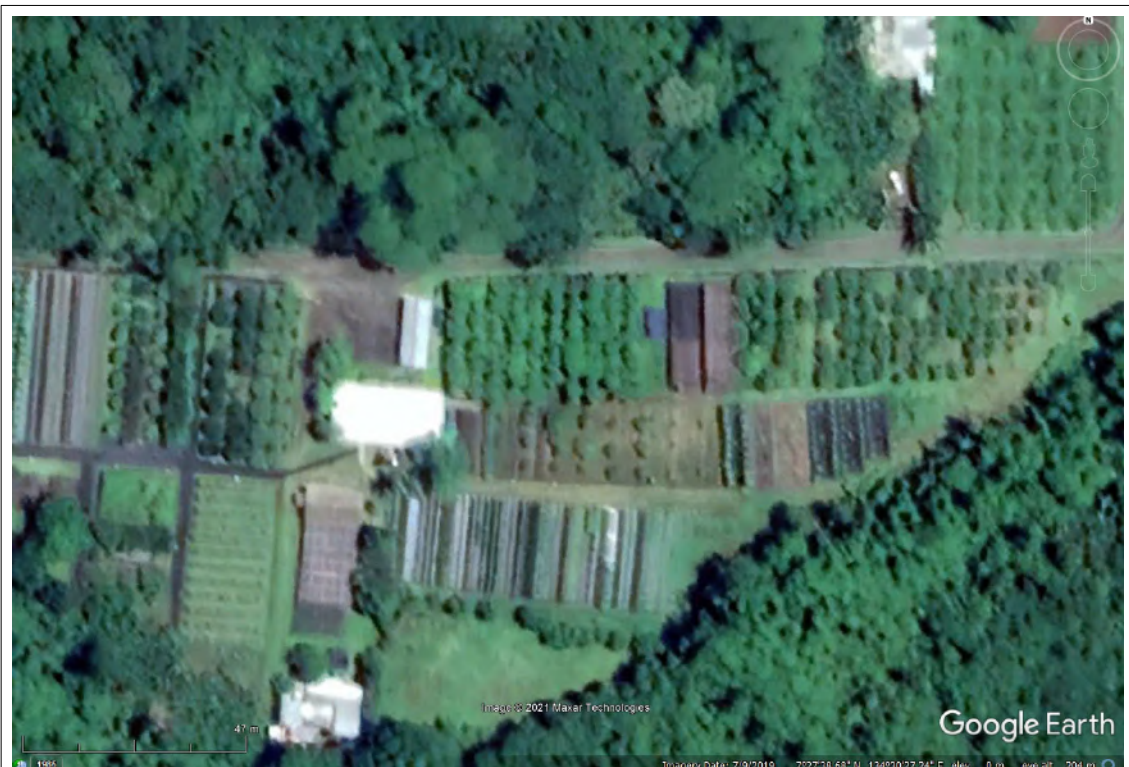
Figure 4.1.1-03: A further zooming in allows to recognise agricultural crops

Recent image data is available with a spatial resolution allowing to see agricultural crops as shown in figure 4.1.1-03. Currently the information is missing:

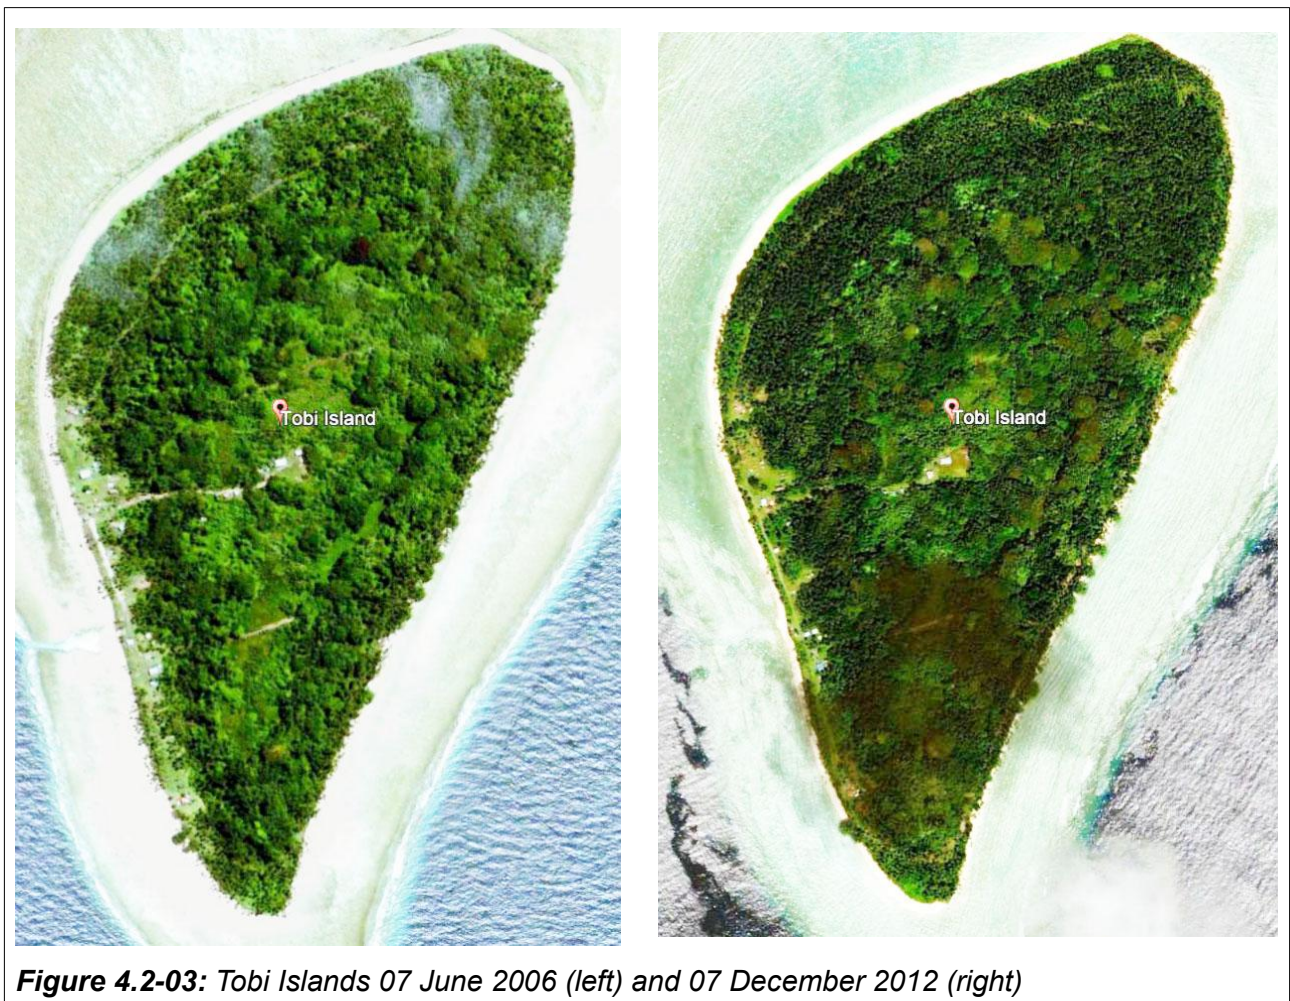
Figure 4.2-03: Tobi Islands 07 June 2006 (left) and 07 December 2012 (right)

the centre of the map below the phosphate mine. However, the image data do not show a significant difference.

In addition, the PACC project had a time period from 2009 to 2014⁸ and the image data was captured 2012. It is possible that a cropland extension was made after 2012.

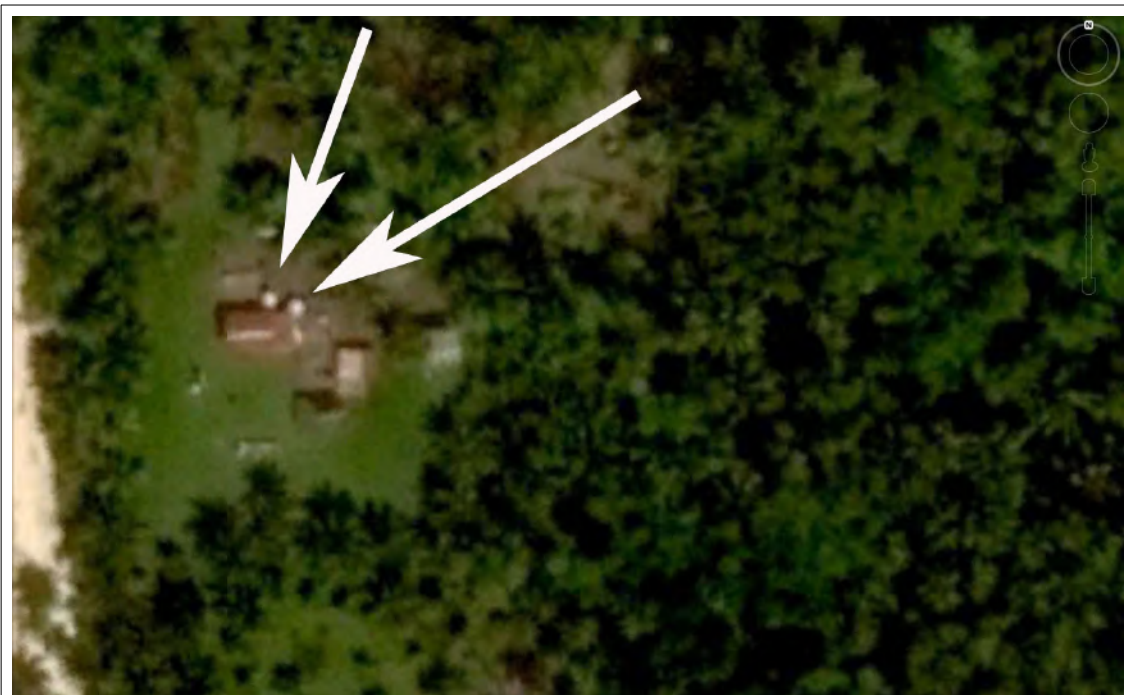
Figure 5.1.2-01: Zooming in allows to recognise infrastructure which could be concrete rain water tanks.

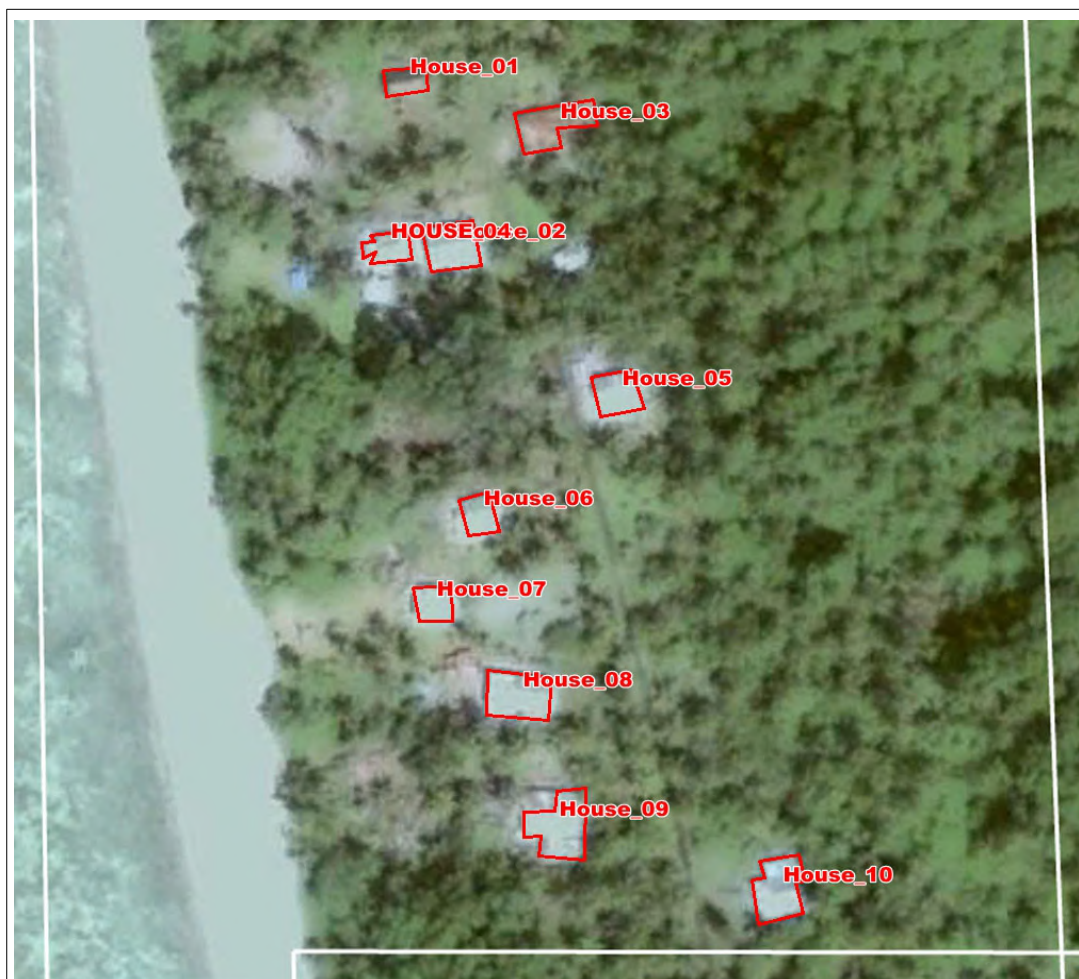
Figure 5.2.4-01: Digitised roofs in the northern part of village Dongosaro

The Google Earth image display was captured as screen dump together with a polygon drawn on top of the image. The polygons were exported as KML files and imported to GIS environment. As a next step the screen dumps were registered using the KML polygon corner points as reference points.

The resulting GIS layer was used to digitise the roof area.

If the images shown in figures 5.2.4-01 and 5.2.4-01 are printed and send the village the survey just concentrates on:

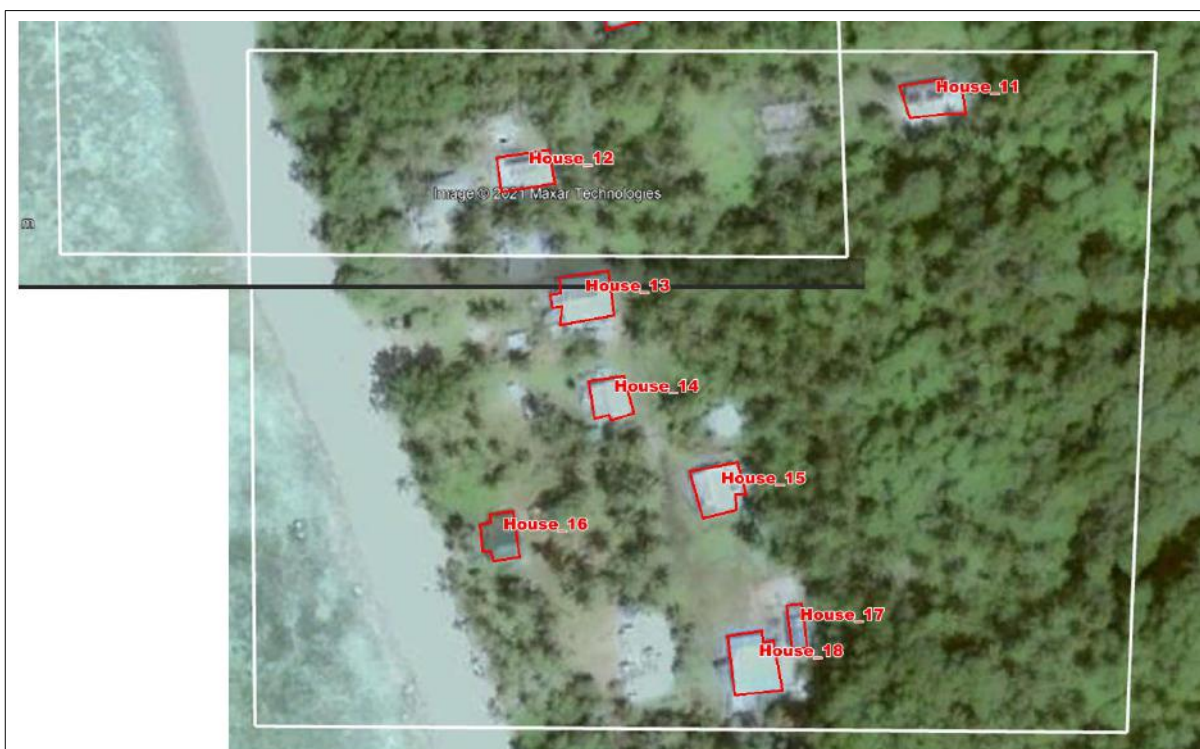
Figure 5.2.4-02: Digitised roofs in the southern part of village Dongosaro

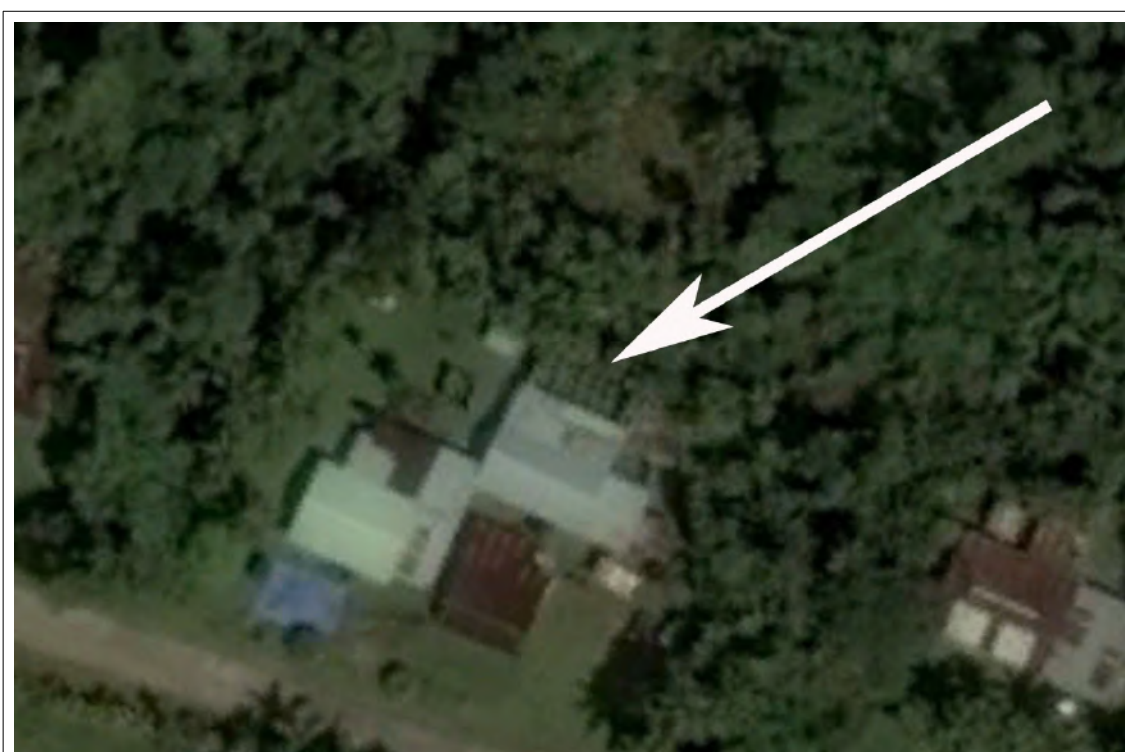
Figure 5.3.3-01: Backyard of a house with apparently agricultural products. These could be an indicator for a functioning water supply during try periods.

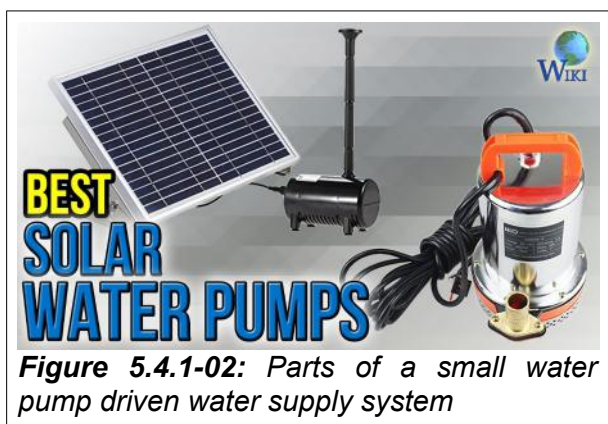
Figure 5.4.1-02: Parts of a small water pump driven water supply system

There are several companies on the market producing solar pumps. There are two types to distinguish (i) bigger systems pumping water from the ground to a reservoir from where gravity feeding supplies the consumers, (ii) small units producing pressure in yachts or single households to get e.g. a shower working with water supply from a tank close by. These individual systems can also be used to pump water out of an own well.
