Situation Report Tonga

Impact assessment of past climate change adaptation actions

Situation Report

Tonga

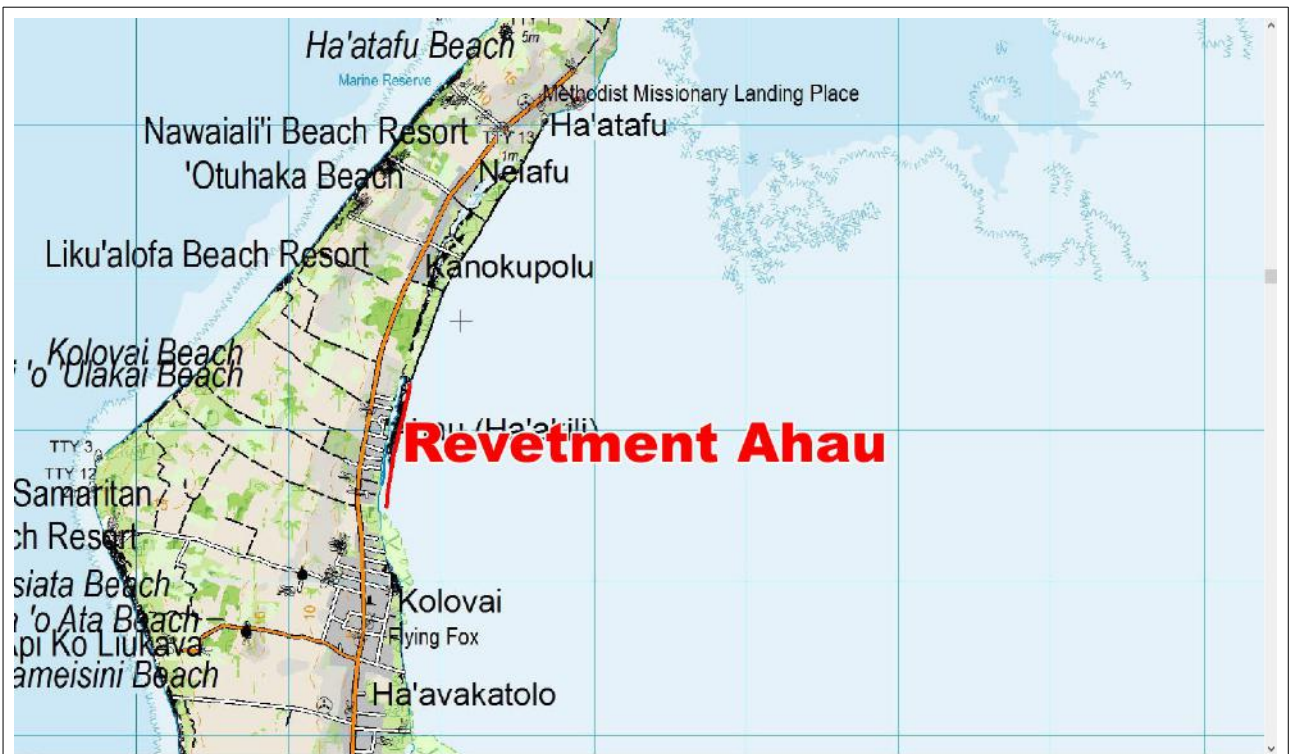
Figure 3.4-04: After digitising the revetment of Ahau on Google Earth display the line element was imported to GIS. The GIS elements allow labels (Revetment Ahau) and the calculation of the length (806 metres).

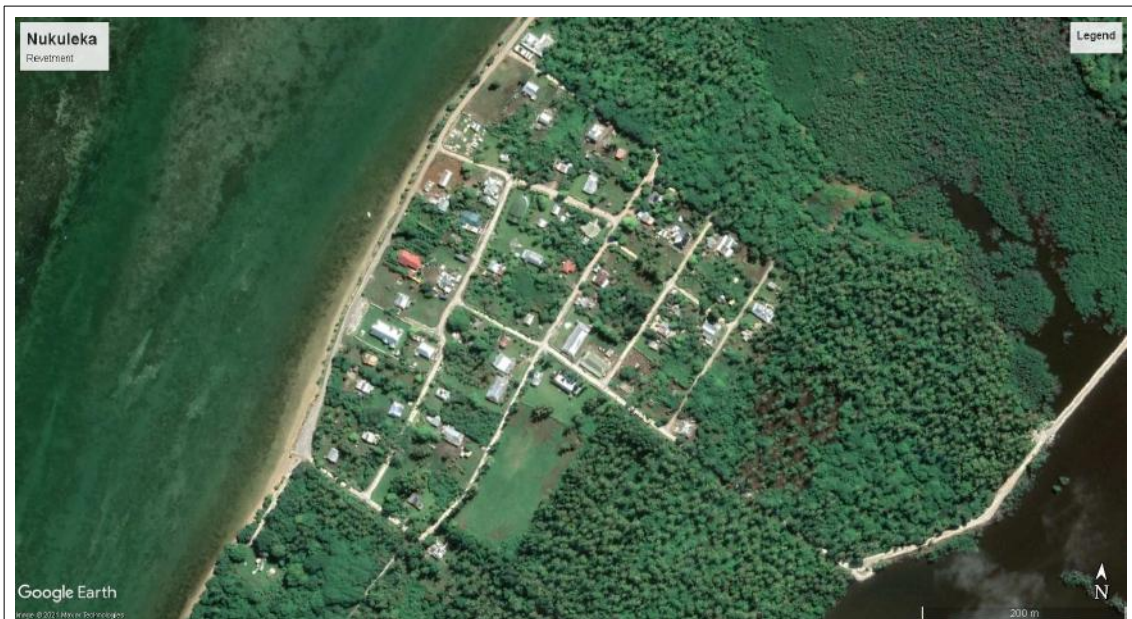
Figure 3.5-01: Nukuleka recorded July 2021. A revetment is currently not visible with very high resolution image data.

For the coastline in front of the villages Kolonga, Navutoka and Nukuleka image data are available recorded in 2021. This is just two years after finishing the construction. There is the possibility that the revetments are already covered with vegetation as fast vegetation overgrow is also visible with the Ahau revetment see figure 3.4-05.

As a next step these three revetments should be surveyed with GNSS equipment suitable for 1:10,000 scale mapping³. This can be performed in half a day and will provide exact location in GIS

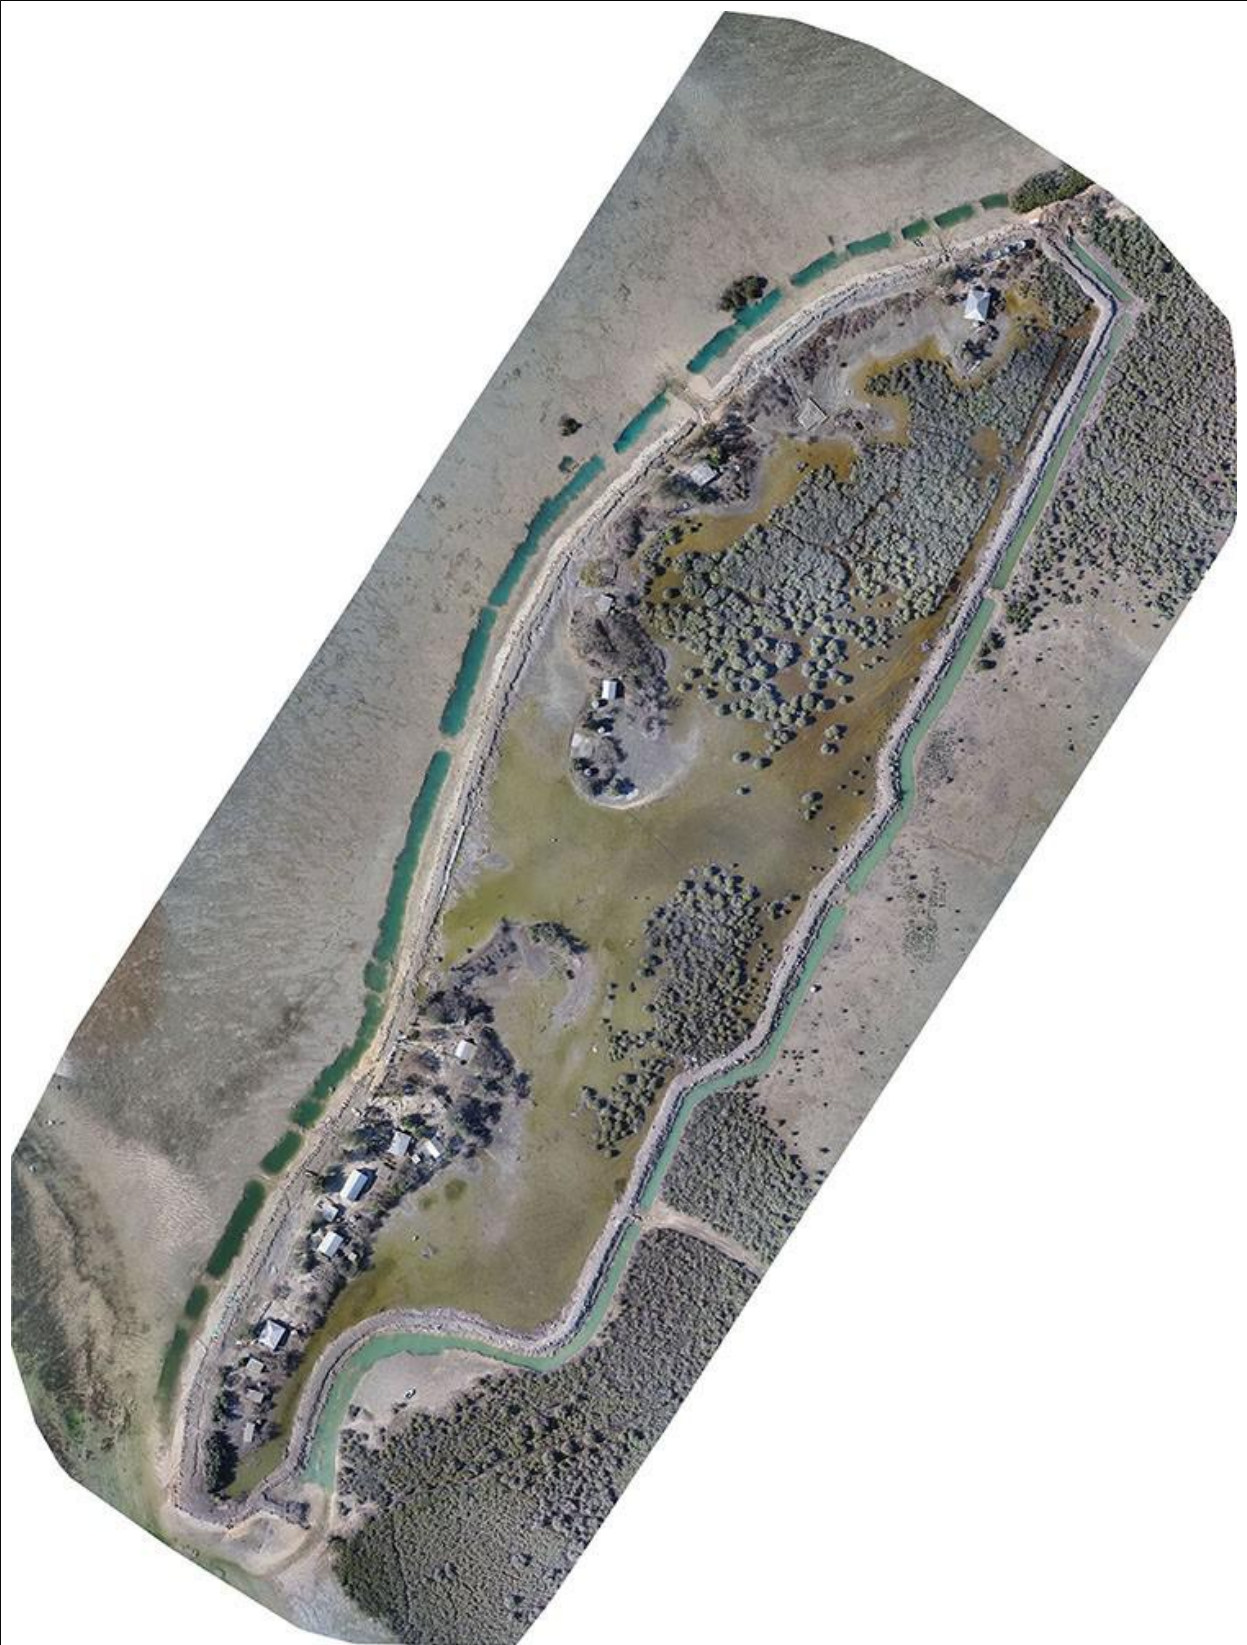
Figure 3.9-11: UAV borne image data of revetments and channels. Image of Lands Department Tonga

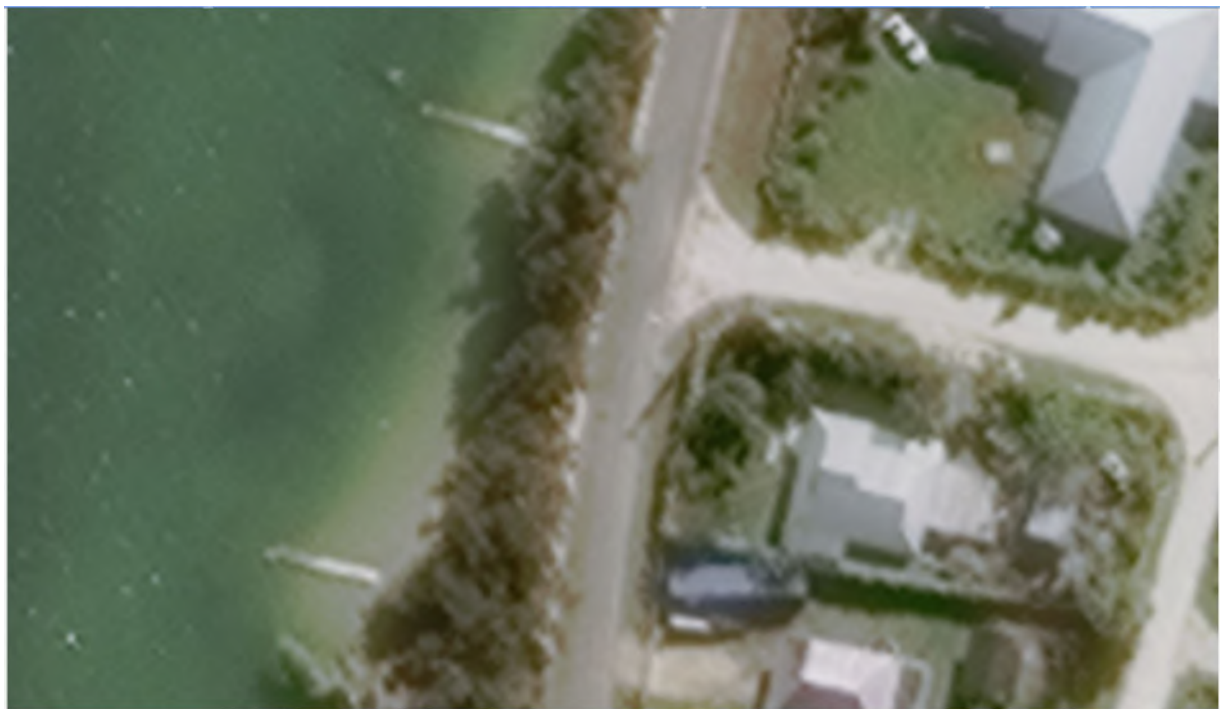
Figure 4.3.1-01: Satellite image data of 15 cm spatial resolution allow the identification of the groyne established during the last years.

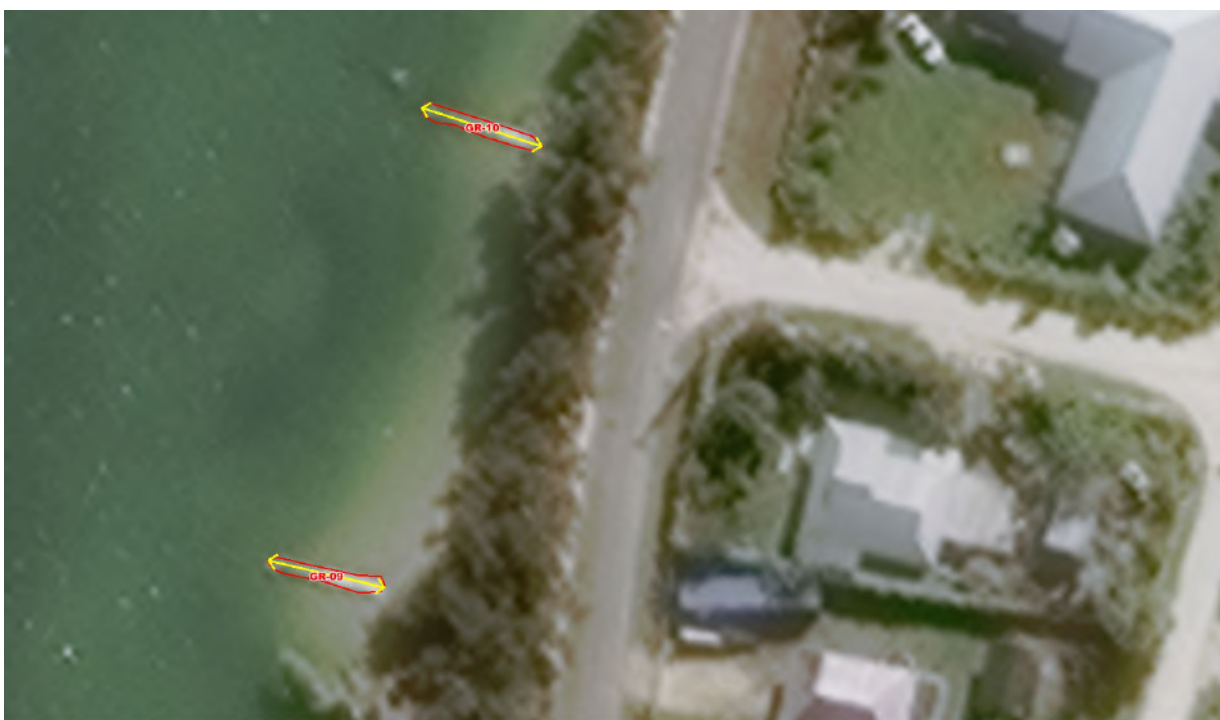
Figure 4.3.1-02: A GIS based estimation of length and area is possible.

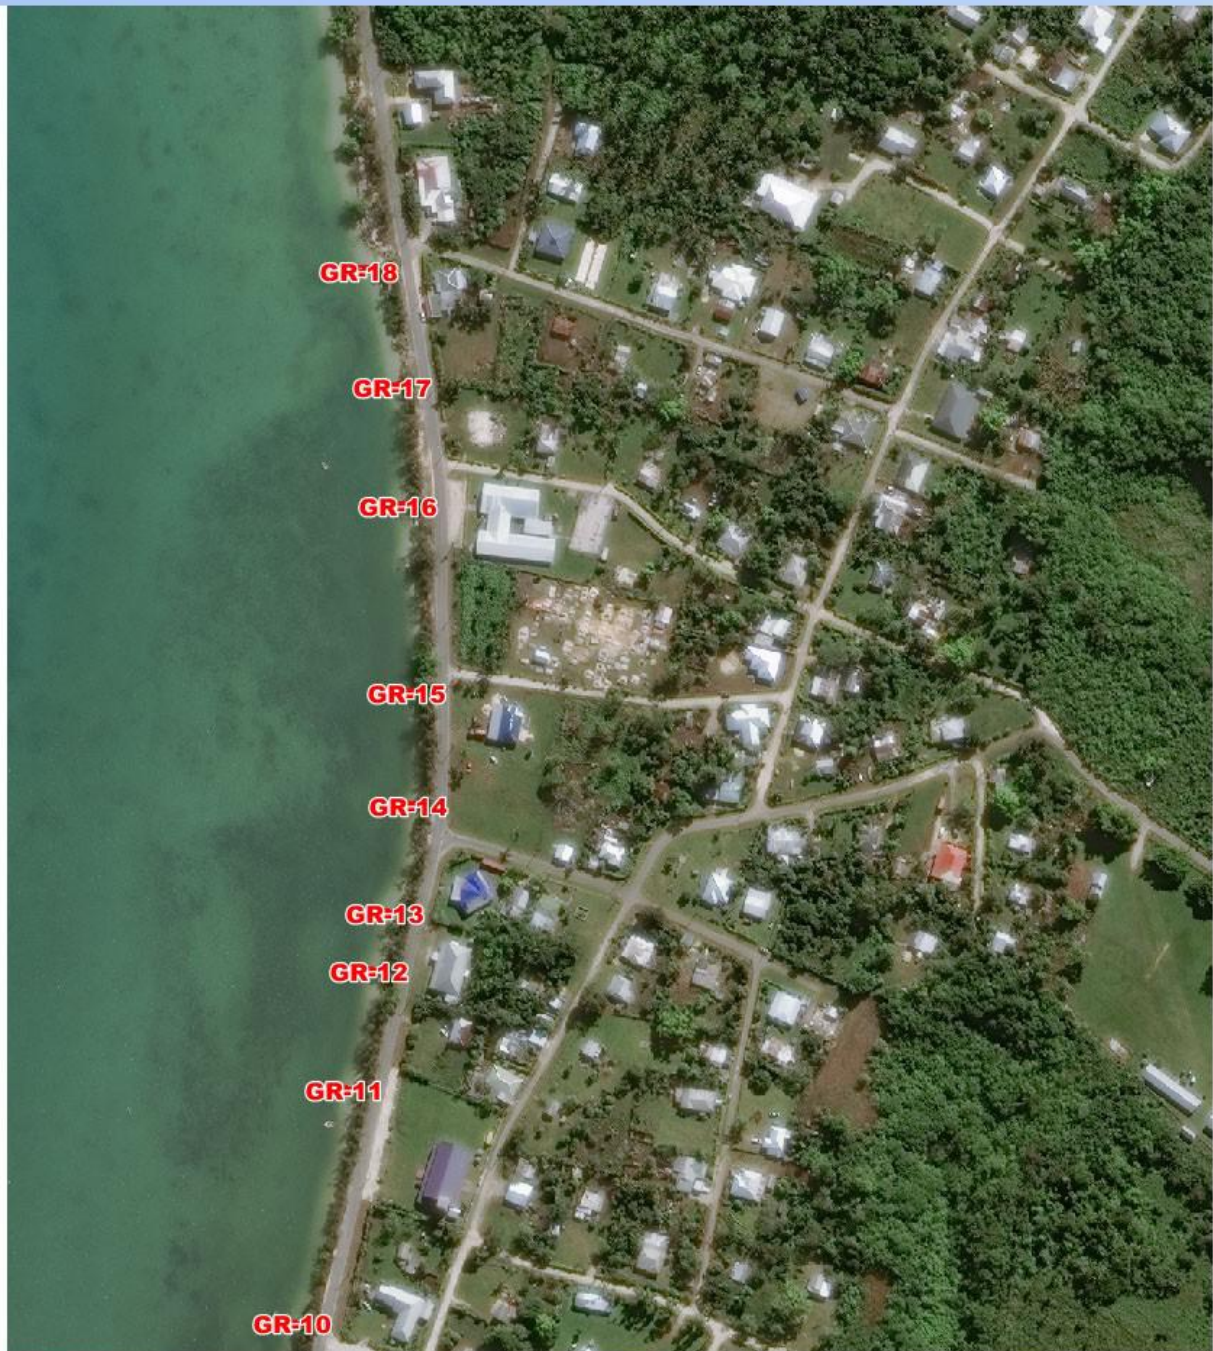
Figure 4.3.1-03: Display of groyne of image subset 02. Every groyne has a unique ID. The corresponding GIS layers allow a zoom in, see figures 4.3.1-01

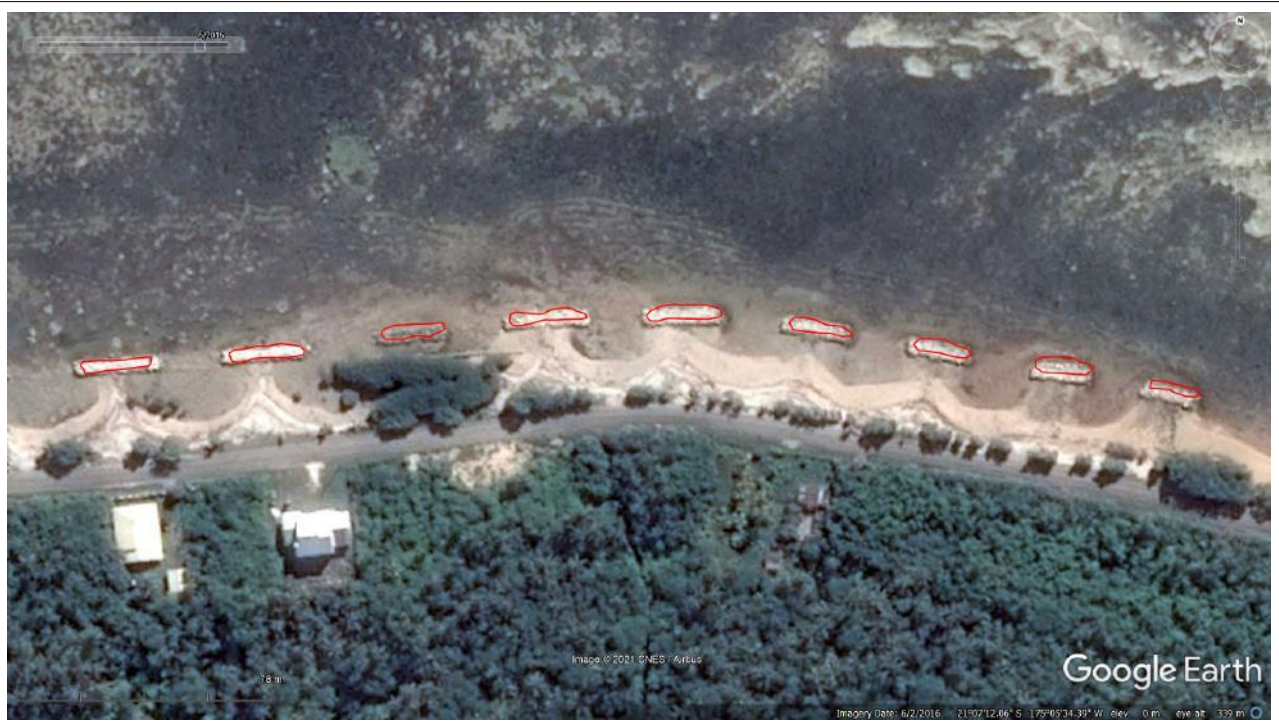
Figure 4.3-03: Location of breakwater polygons on space borne image data recorded on 02 June 2016. The breakwaters were constructed and started to change the shoreline.

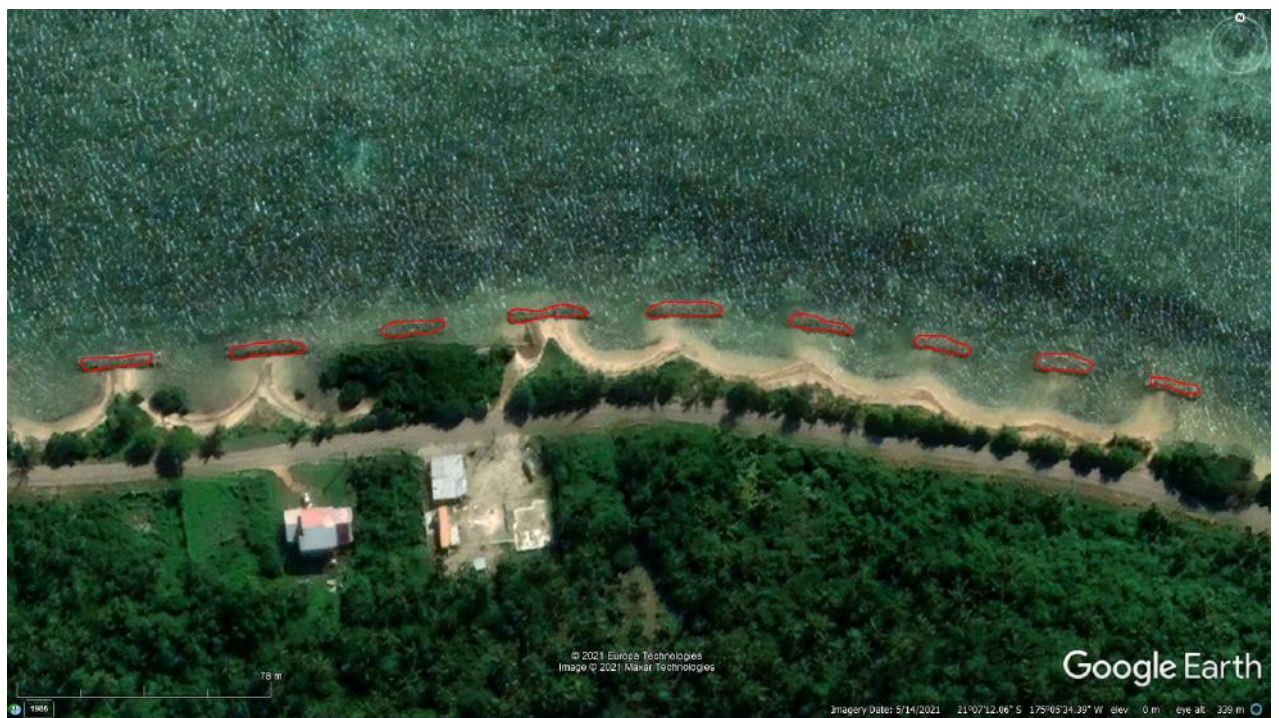
Figure 4.3-04: Location of breakwater polygons on space borne image data recorded on 14 May 2021. Vegetation is visible on the accumulated sand.

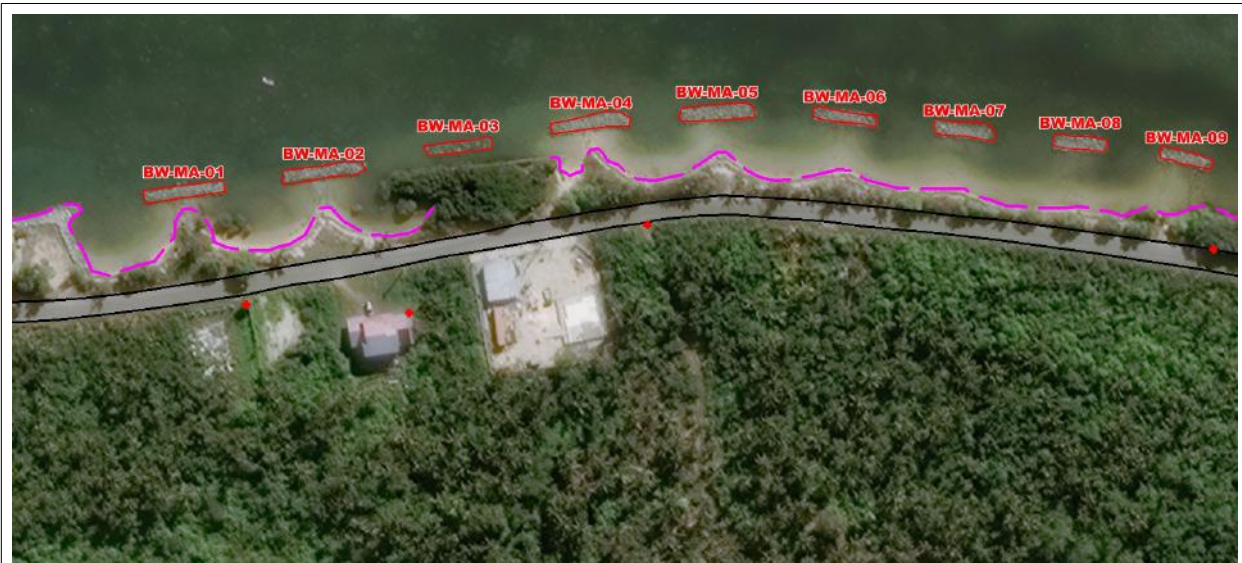
Figure 5.3.1-01: The breakwaters were digitised again as the image had a better geo accuracy compared to Google Earth copies. The coastline was digitised and the coastal road as reference.

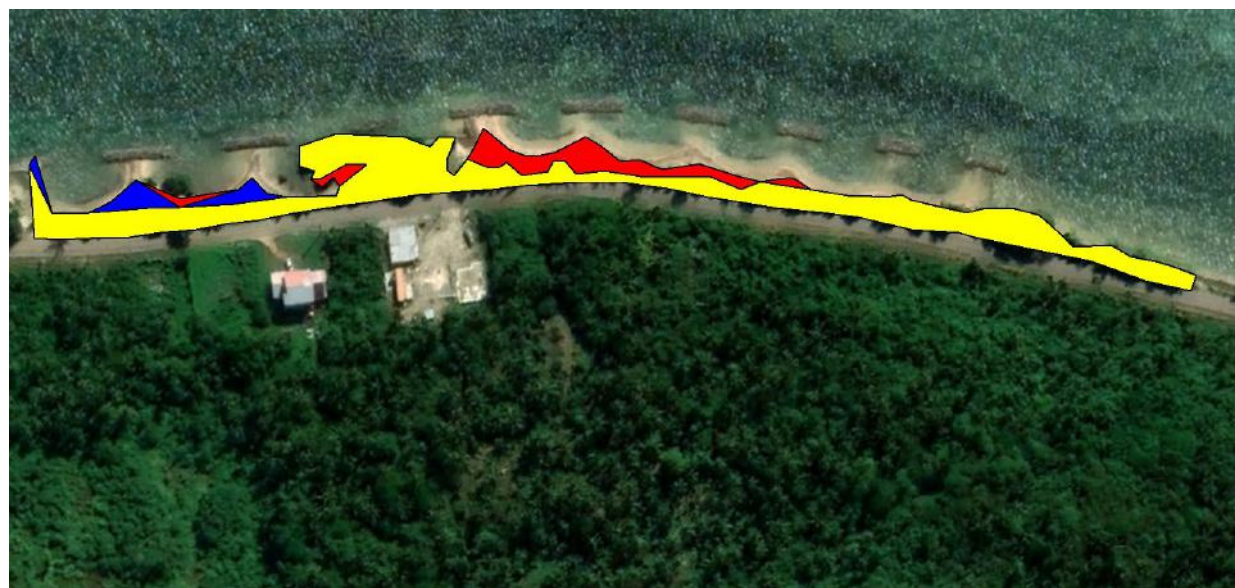
Figure 5.4-01: Change of beach after breakwater establishment. Yellow = original beach in 2014, blue = beach area 2016 and red = beach area 2021.

The established breakwaters in Manuka definitely changed the beach. The beach line was mapped with data from 2014 before the breakwater establishment and then mapping with data recorded

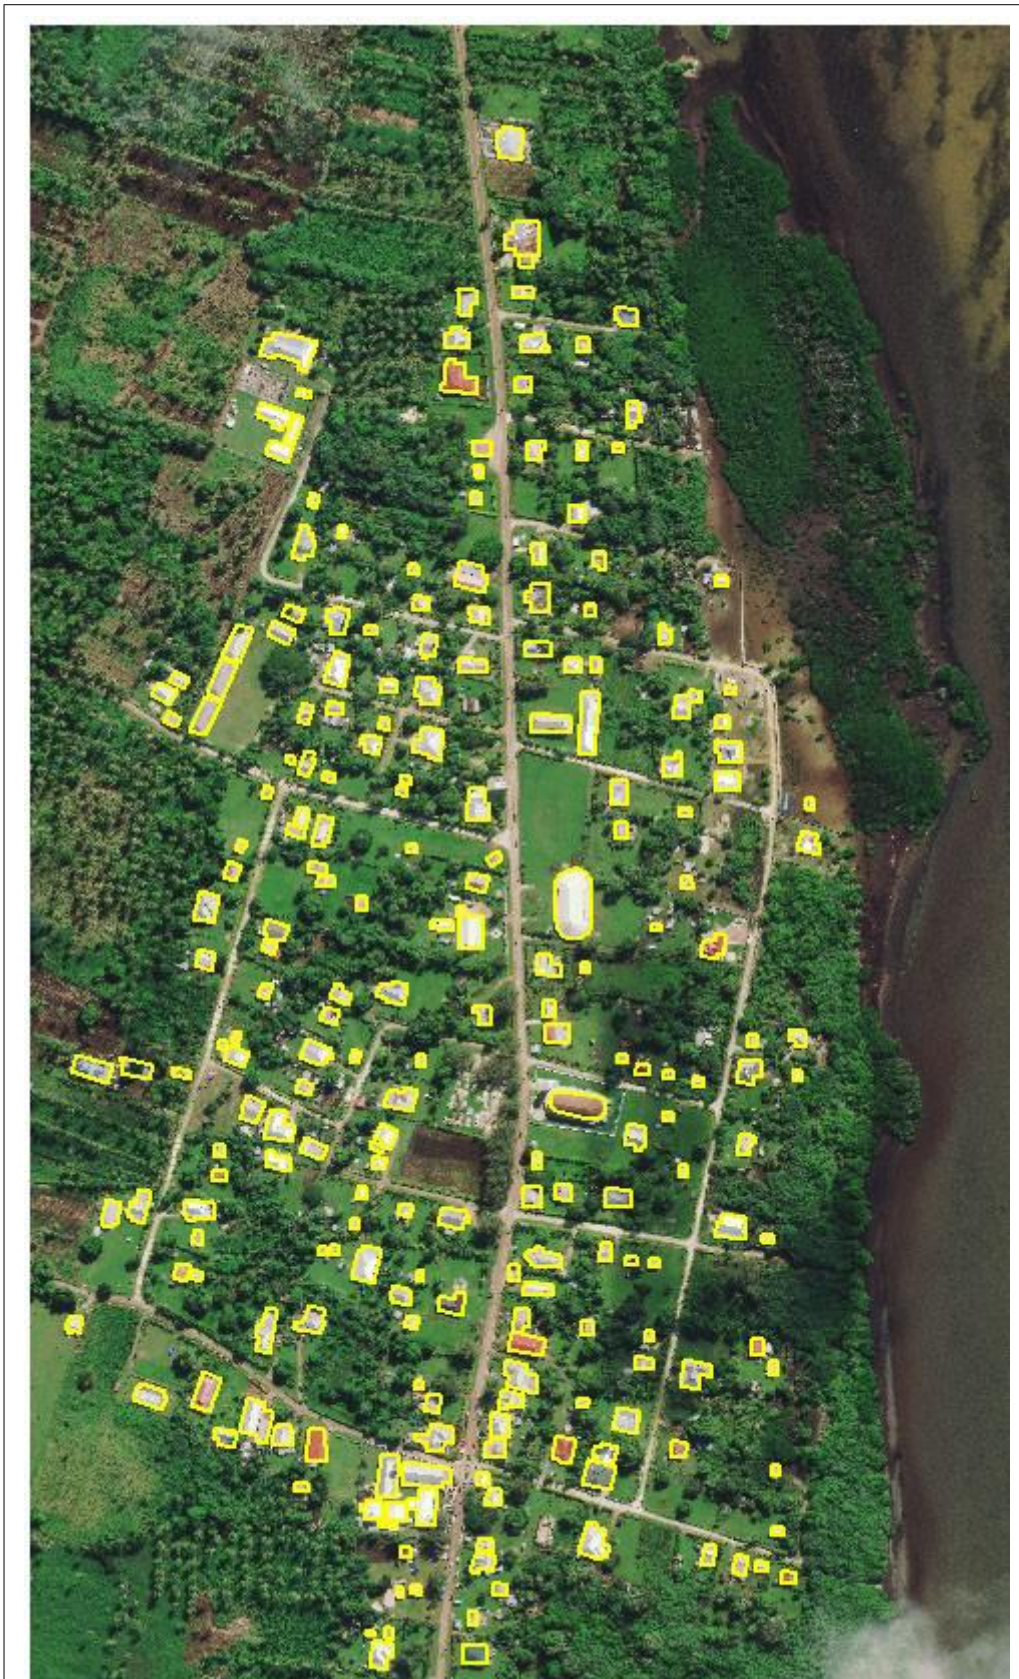
Figure 7.1.2-01: Digitised roofs of Kolovai. The image tile covers the complete village. So far 231 roofs were digitised.
