Case study

Asbestos - Banaba

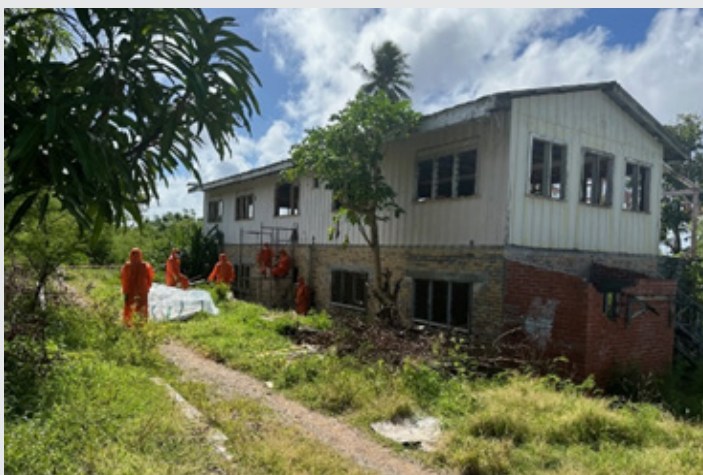
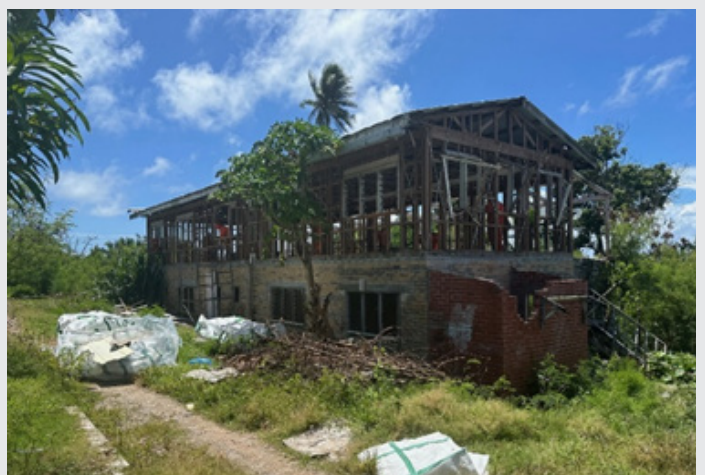
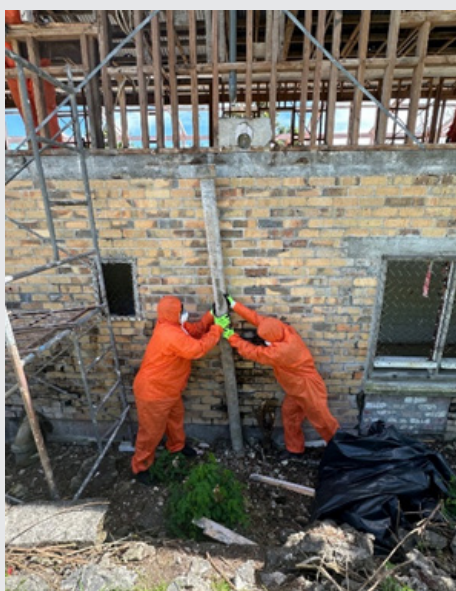
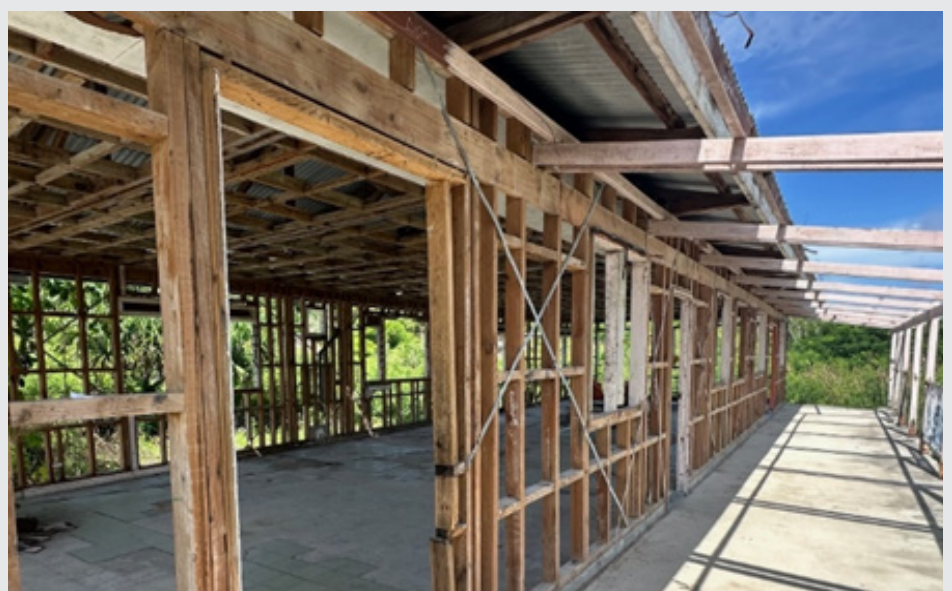
Removal of Asbestos from the Schools

Work begins after the morning safety brief with the de-nail/unscrewing of the existing roof sheets and cladding to allow access for removal. Once that is done removal and disposal of the exterior corrugated fibre cement roof sheets and cladding occurred. All asbestos waste removed on-site was placed in Hazibags and placed in an allocated waste disposal area.

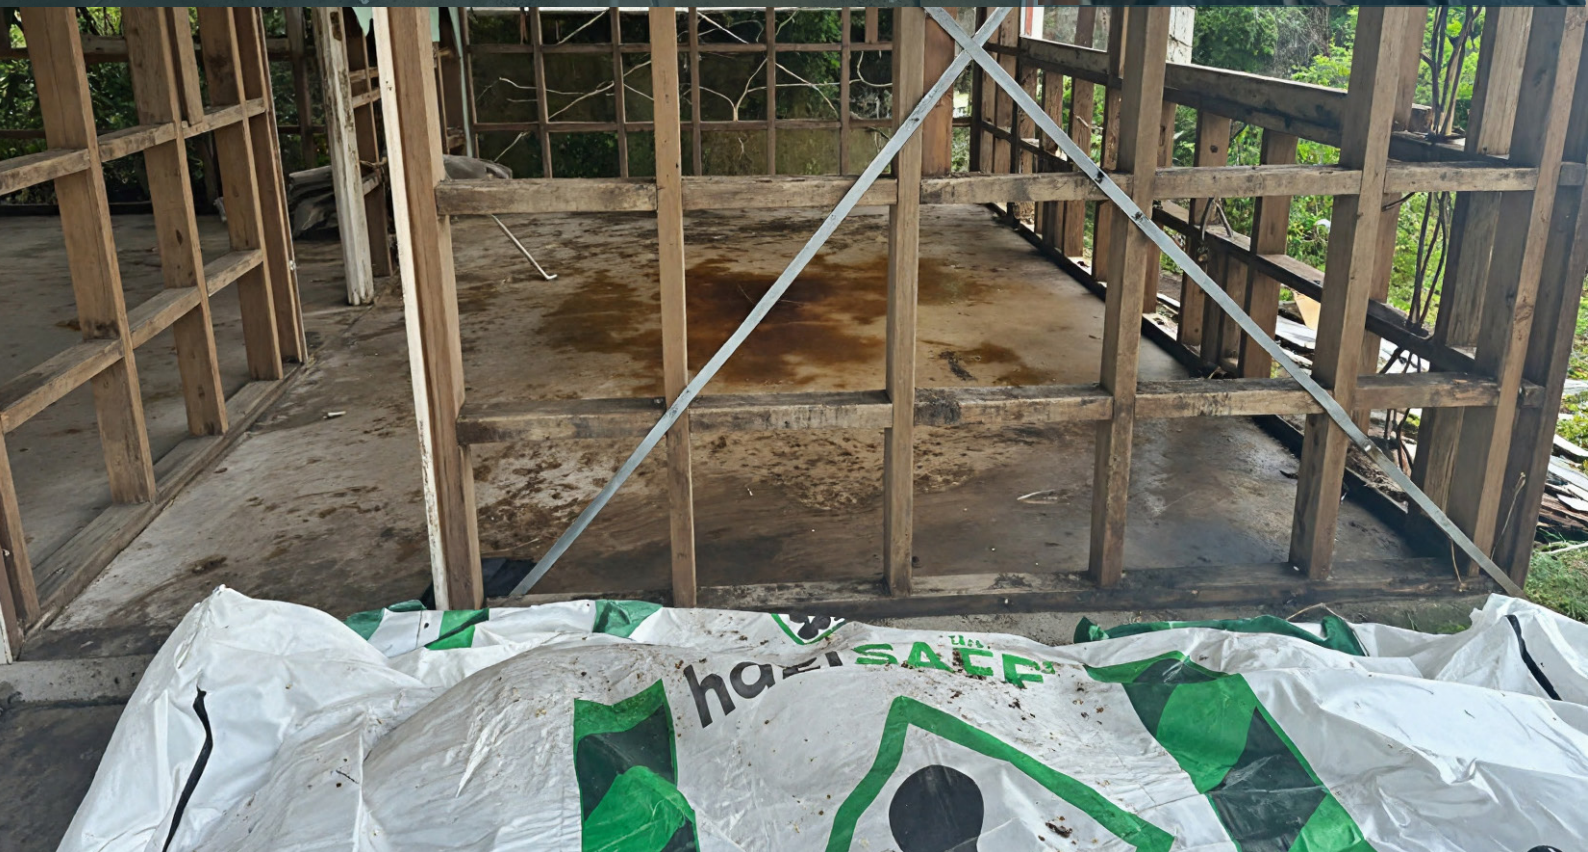
Removal of Asbestos from Hospital Interior

Utilising standard construction tools (drills, etc.), asbestos containing materials were removed from the building structure in-tact and taken to the waste staging area for safe management.

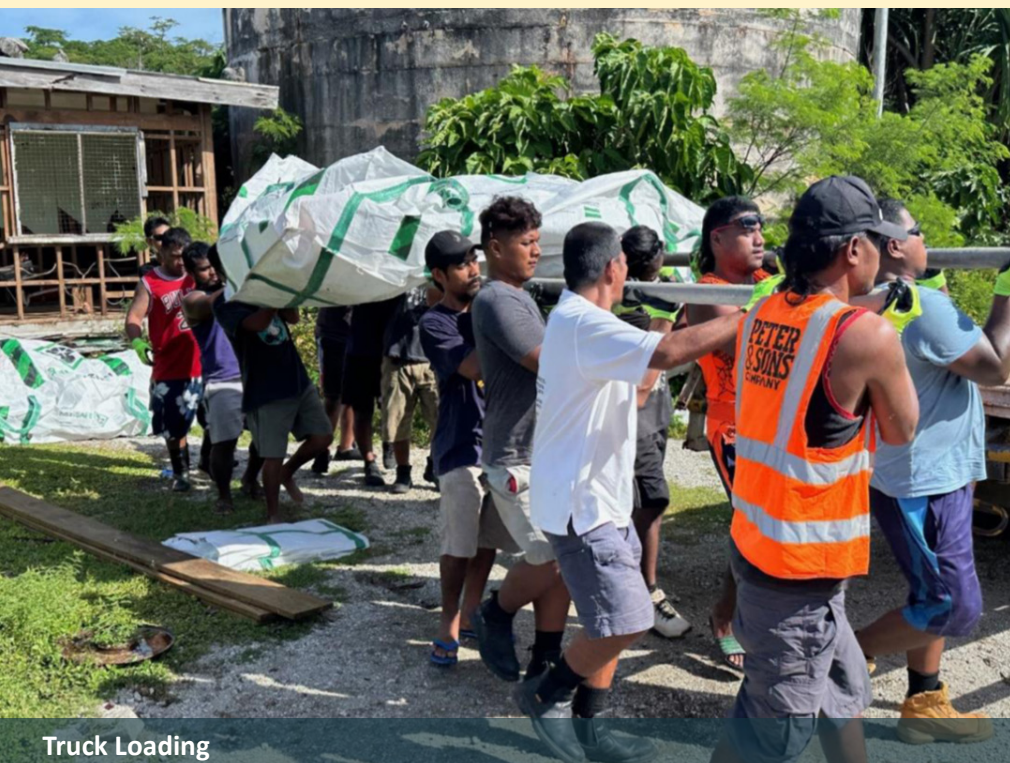
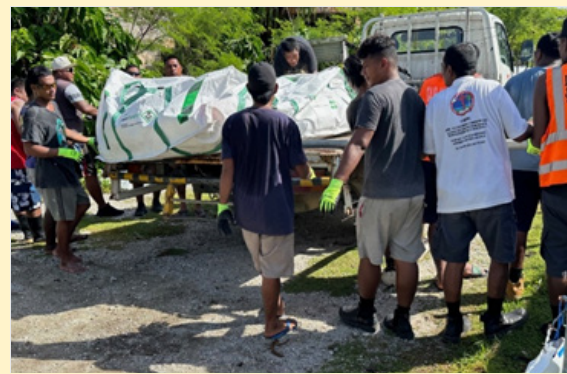
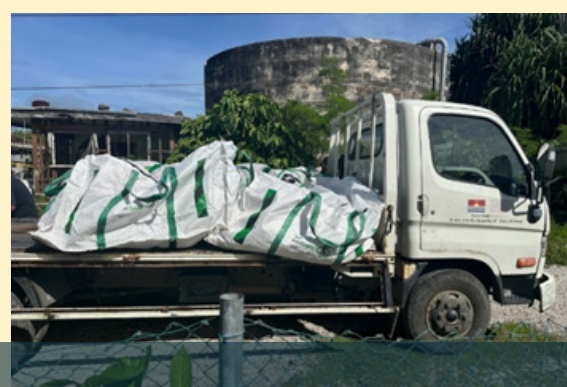
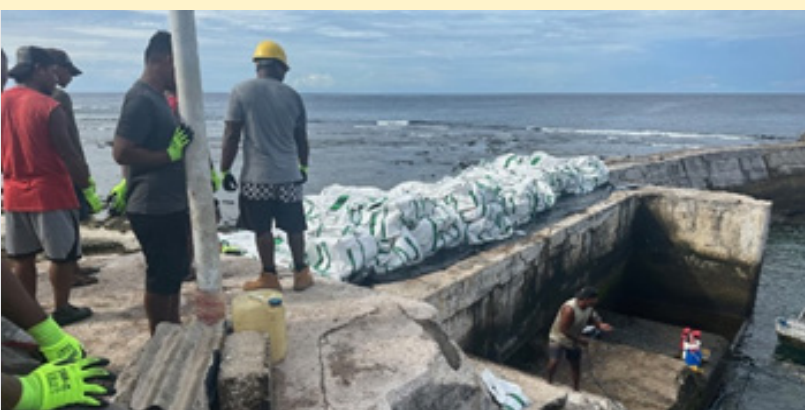
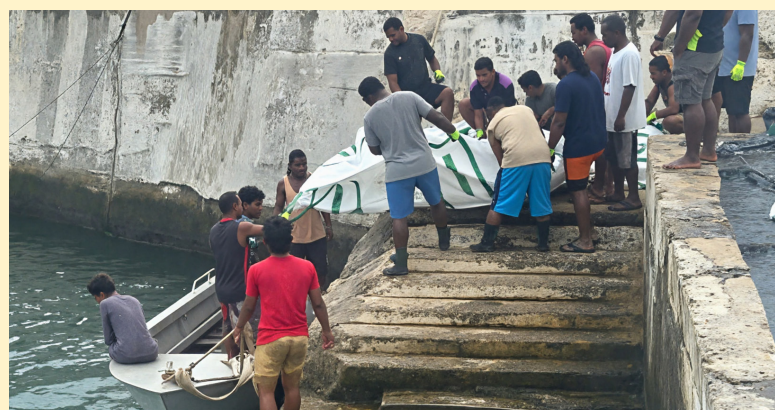
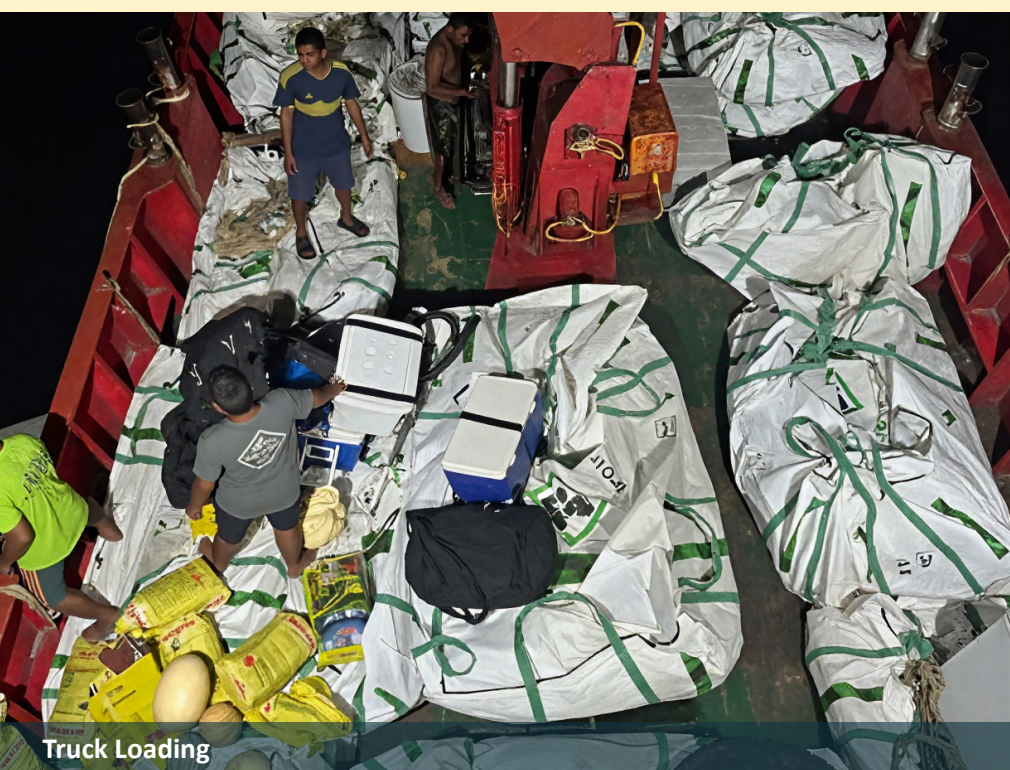
Truck Loading

A local truck was utilised to transport the wrapped waste asbestos to the port. The seating was removed to allow hazmat bags to be transported to port. All loading and unloading was undertaken manually. Due to the mooring situation (1km from shore) it took one day to load all the asbestos waste.

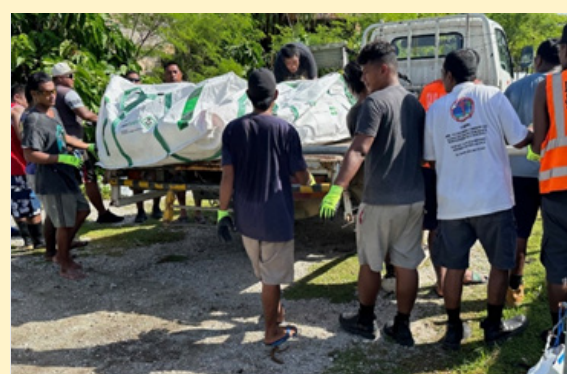
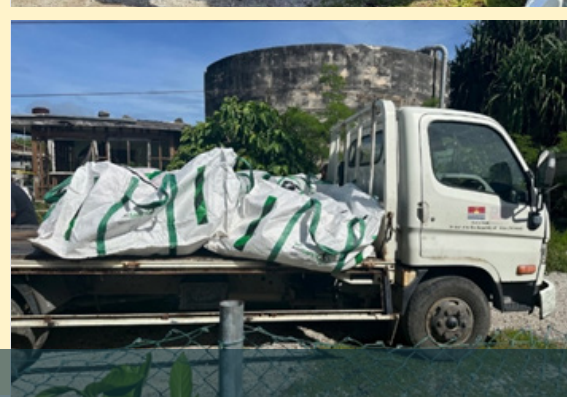
Truck Loading

- » A 12-person team involved in unloading the hazibags from the truck, stacking them at the Banaba Port.
- » Hazibags were lifted using manpower and a suitable lifting rig, onto a tray of a small truck for transport down to the wharf storage area. They were lifted by hand onto the shore-to-ship vessel for transport out to the ship where they are to be lifted by the ships crane into the hold.

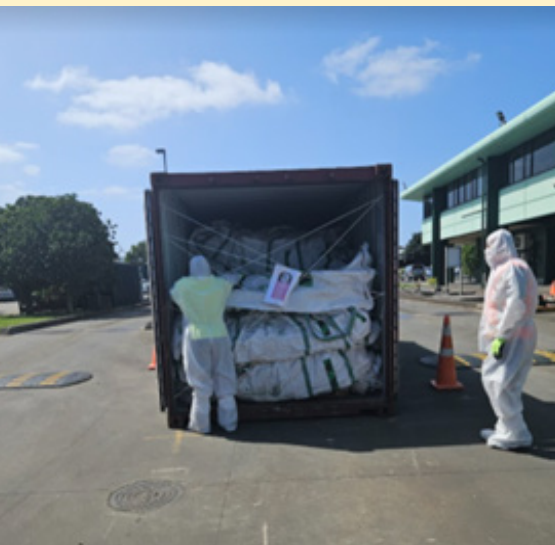
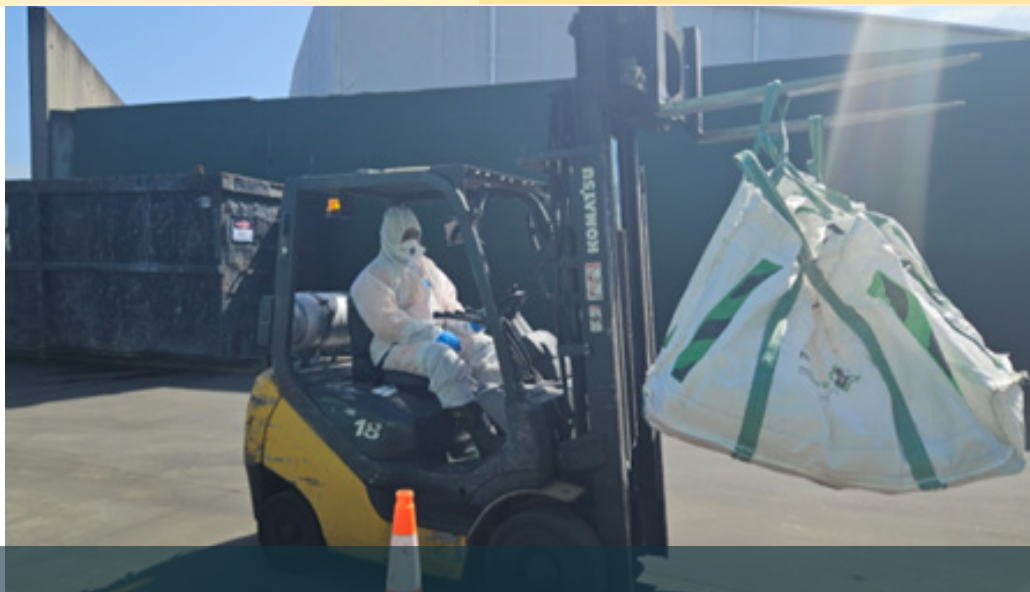
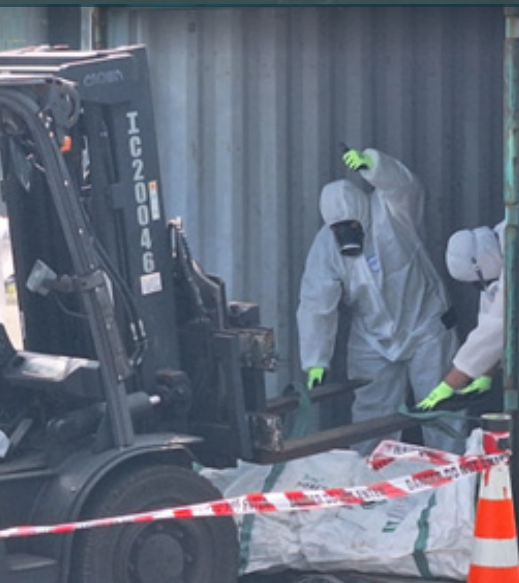
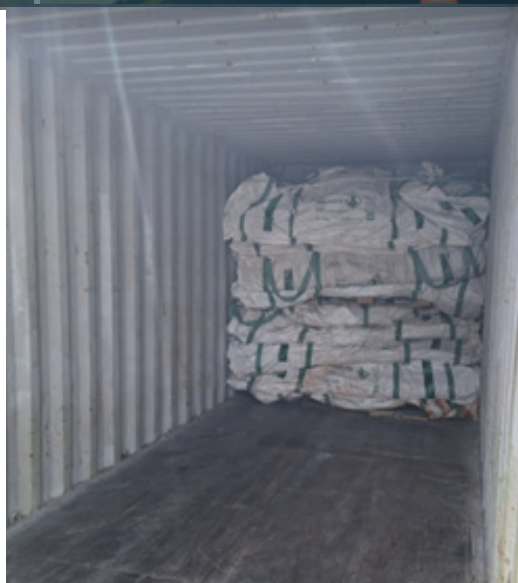
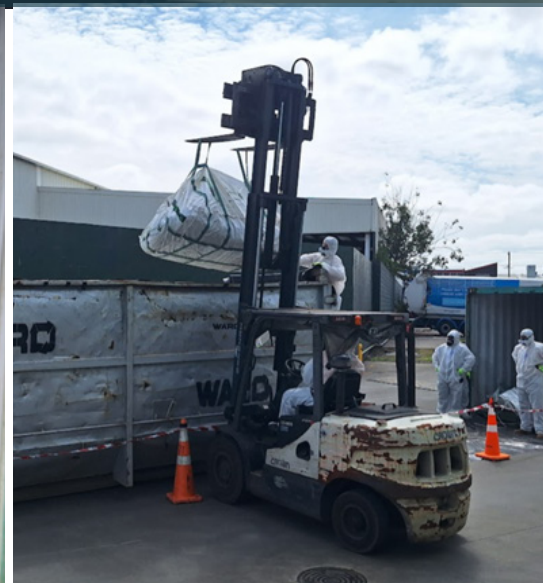
Waste unloading exercise

The waste asbestos was removed, the packaging was checked for integrity, and the removed waste was stockpiled for disposal to the EnviroNZ landfill at Hampton Downs.
