**SPREP**  
Secretariat of the Pacific Regional  
Environment Programme

# Case study Asbestos - Nauru

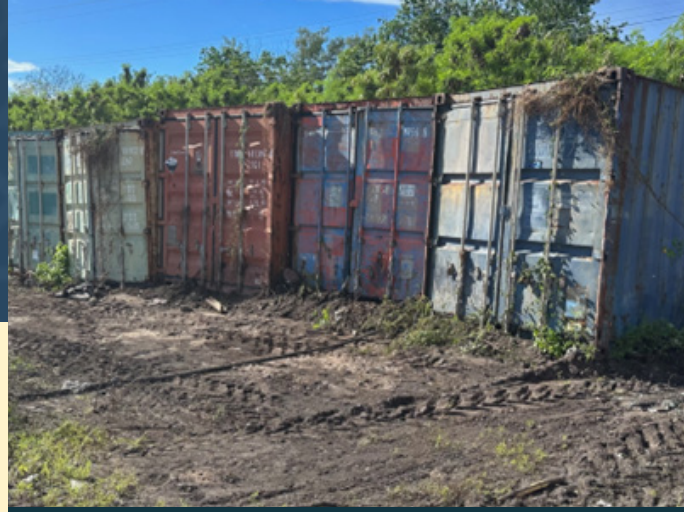
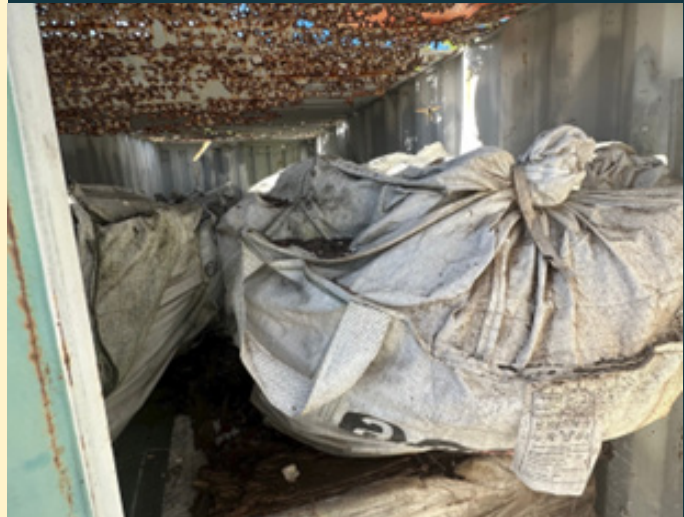
- » Contractors arrived in Nauru on 27 November 2023 and deployed to the NRC Landfill to inspect the containers. One was not accessible, but the others were full of packaged ACM. It was noted the packaging was deteriorated and needed to be replaced.

State of old containers

- » The old containers were then cleaned with High Efficiency Particulate Air (HEPA) equipment, vacuumed out where possible (most were badly rusted.)
- » On 18 December 2023 the containers were moved to the Nauru Port.

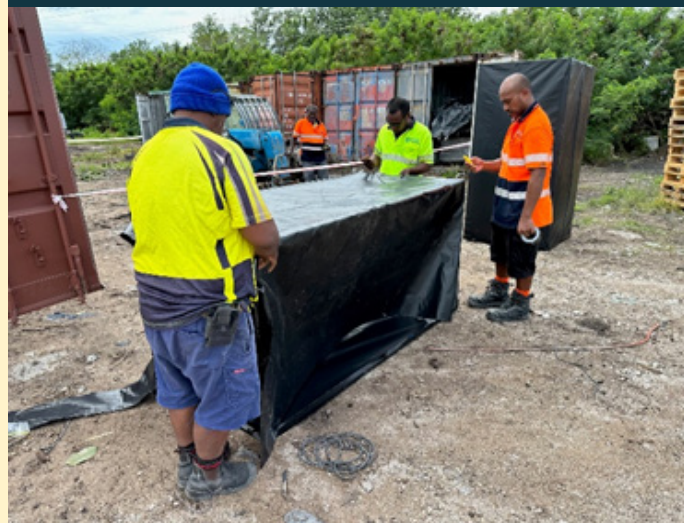
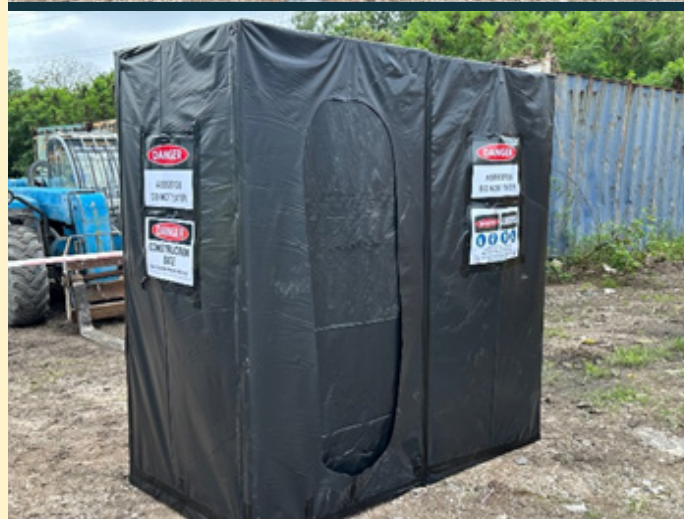
Building the Decontamination Unit

- » Replacement containers for the shipping were delivered over several days from 30 November through until 5 December.
- » Abatement activities commenced on 6 December 2023, with the construction of the decontamination unit and installation of air monitors prior to any unloading, repackaging, and loading of the new containers.

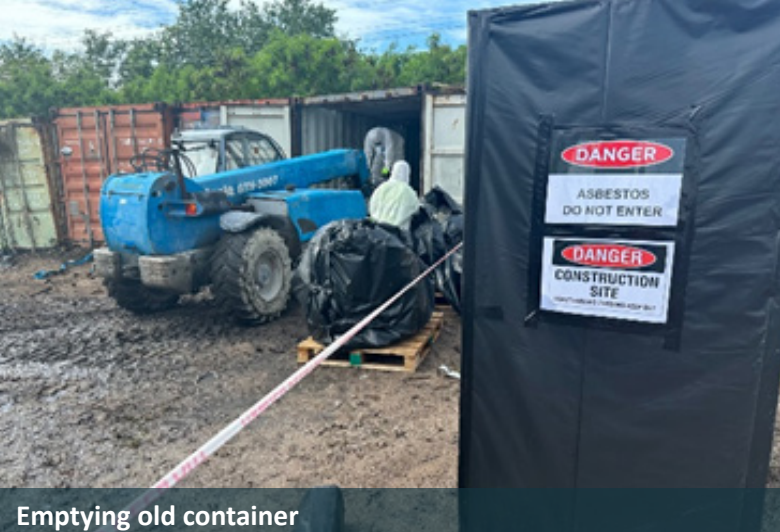
Emptying old container

- » A four-man team was used to remove Hazmat Bags from old containers and place them in the new containers. If any bags were damaged, then the contents were re-bagged.

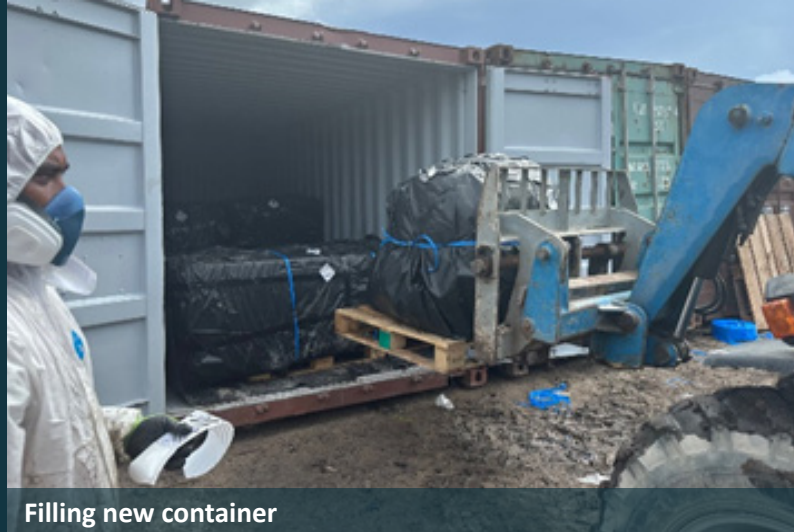
Filling new container

- » Once each container was full (approximately fourteen bags at one tonne) the container was closed.
- » Decanting of containers was done one at a time with a crew of six men.

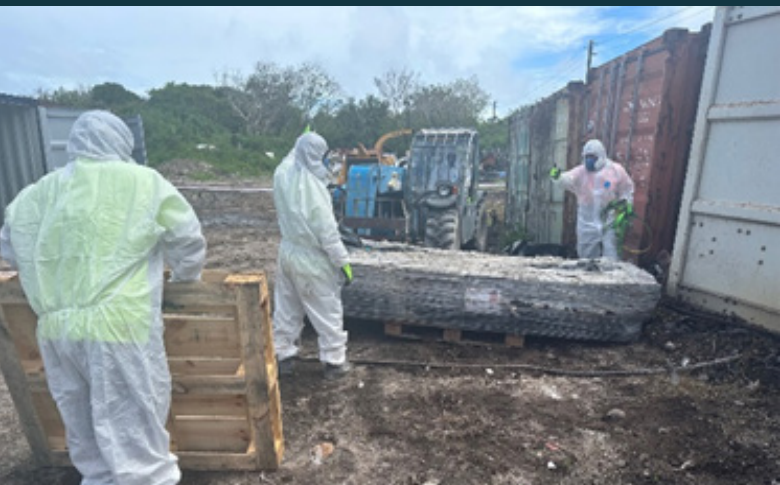
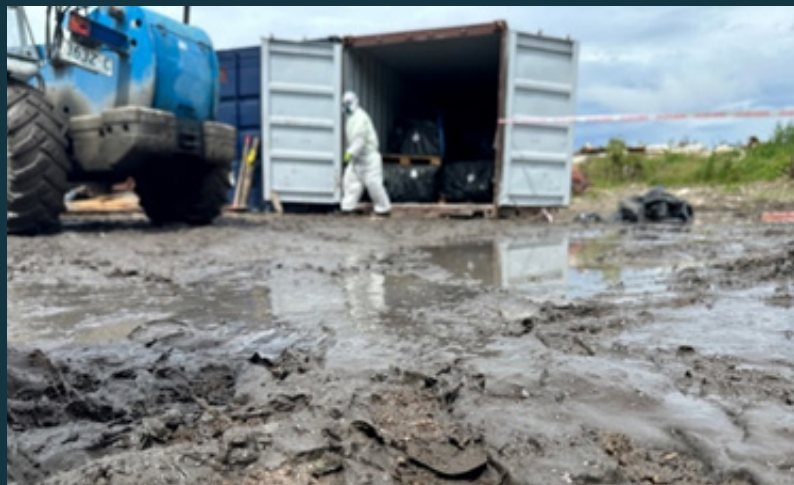
Wrapping loads and working in the mud

- » Rain caused significant difficulties with managing the resulting mud. The final container was filled on 15 December 2023.
- » All containers were confirmed to be appropriately loaded, with the materials firmly strapped down to ensure no movement during transportation, the containers were then wiped down to remove mud and debris to ensure the containers compliant with biohazard controls on international shipping.

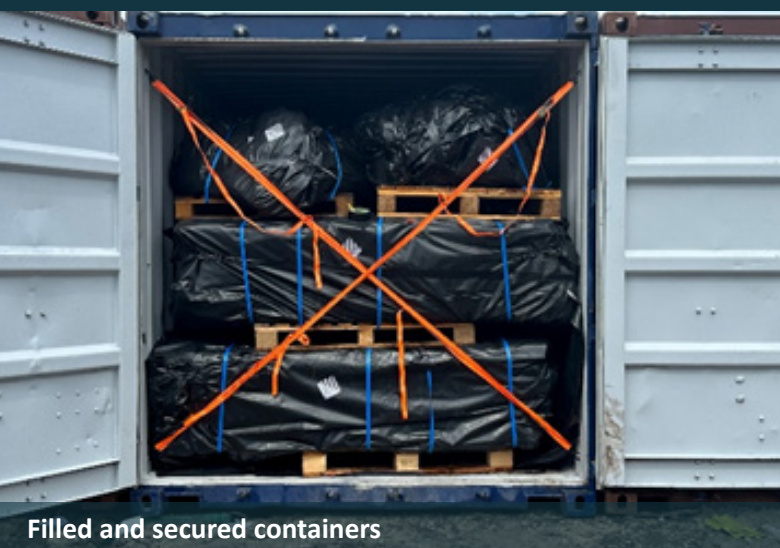
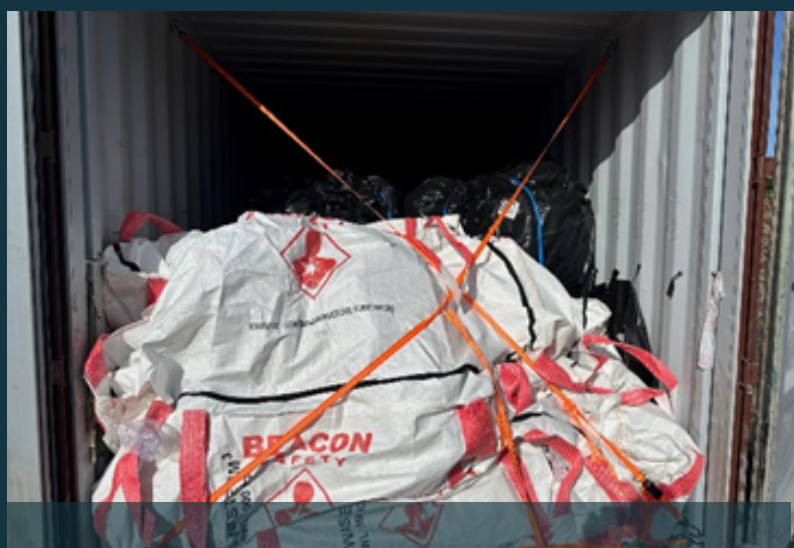
Filled and secured containers

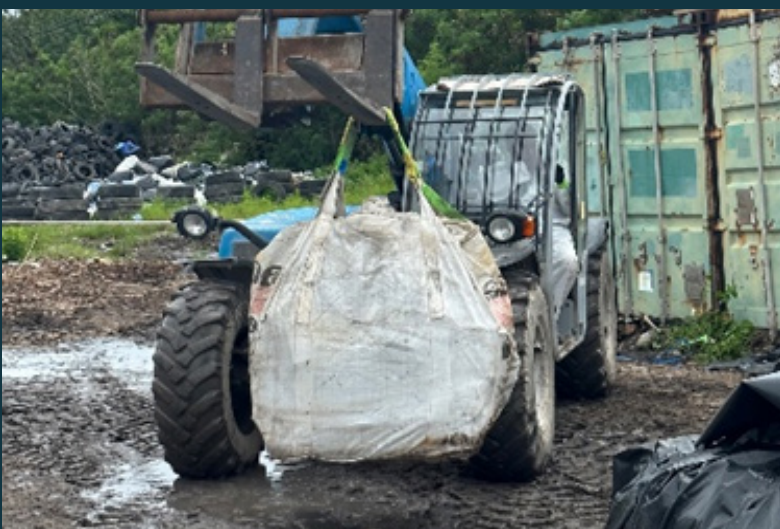
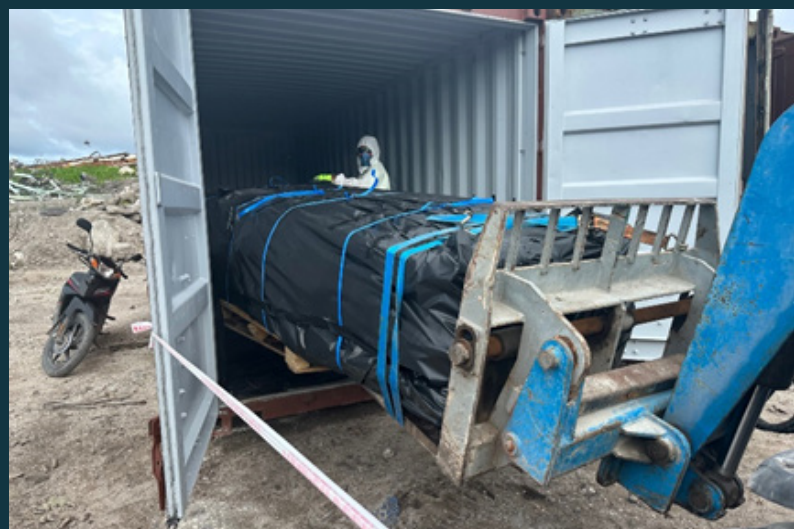
Container unloading and loading

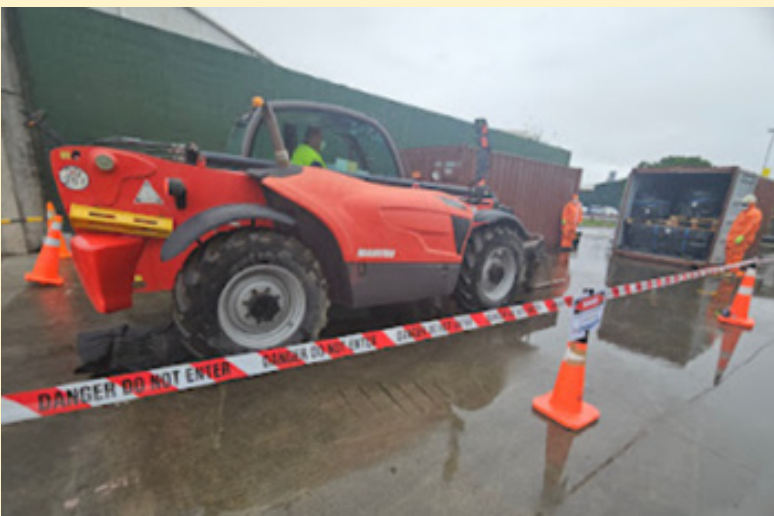
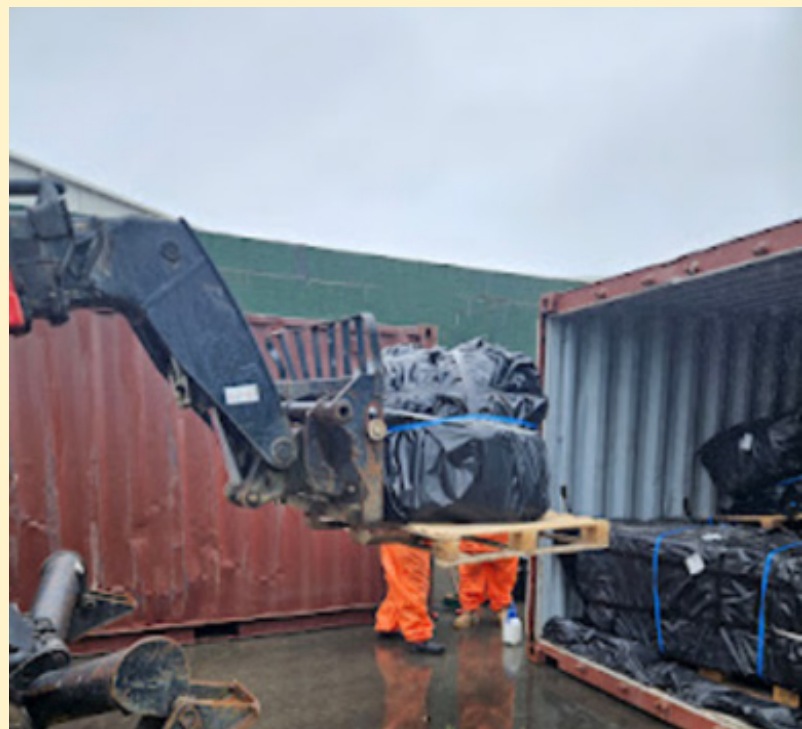
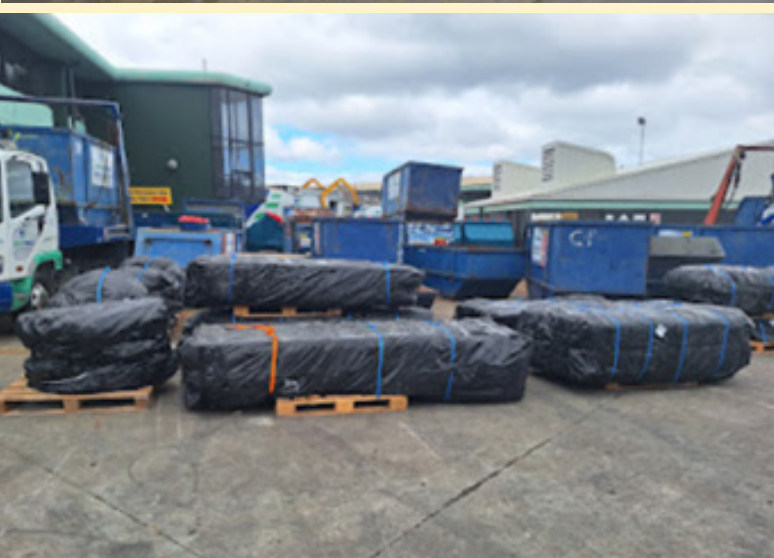
Removing loads from containers. loads removed and ready for disposal

The material arrived at the Port in New Zealand on 7 March 2024, and were granted biosecurity clearance on 10 March 2024. The cleared containers were transported to EnviroNZ (landfill) on 11 March 2024, and final asbestos materials removed from the containers and transferred to the care and control of the landfill operators on 14 March 2024. Final landfilling occurred on 18 March 2024.
