Disaster Risk and Climate Change Impact Survey in the Republic of Palau, Phase I

Executive Summary

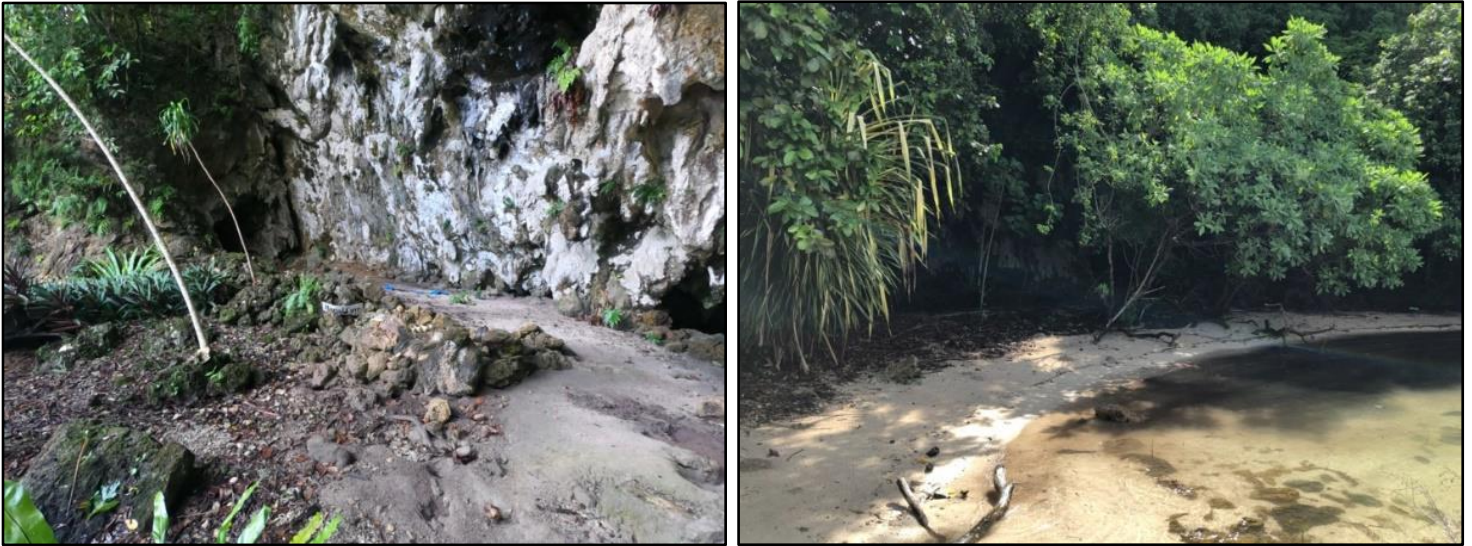
Figure 4. (Left) Area of Chelechol er a Orrak where archaeological excavations have taken place (photo by Matthew F. Napolitano). (Right) Beach leading up to Chelechol er a Orrak. From this photo, you can see that sea level is just slightly below the current surface and would be level with subsurface deposits (photo by Jessica Stone).

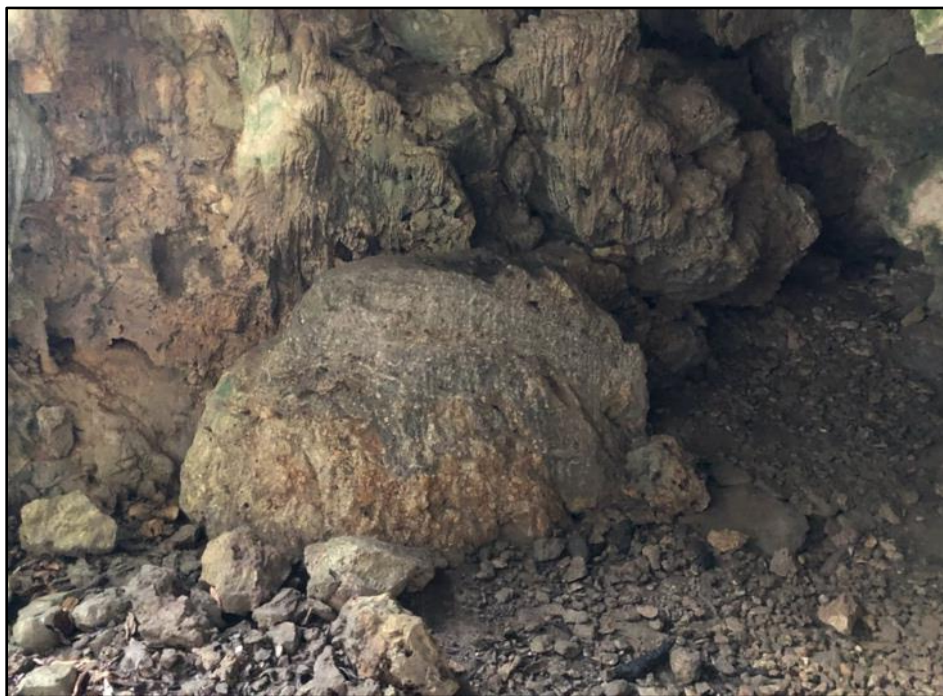
Aspects of the original and natural landscape have been maintained, but over the course of site use, quarrying of limestone for stone money would have modified the flowstone deposits. During World War II, people from Airai used Orrak as a refuge, and about 10 years ago, a modern dock was built on the beach to the west of the site, and modern structures (*Figure 6*), including a summer house and benches, are located along the beach. The site is also listed on Palau's Register of Historic Places.

Figure 5. *Unfinished stone money (photo by Jessica Stone).*

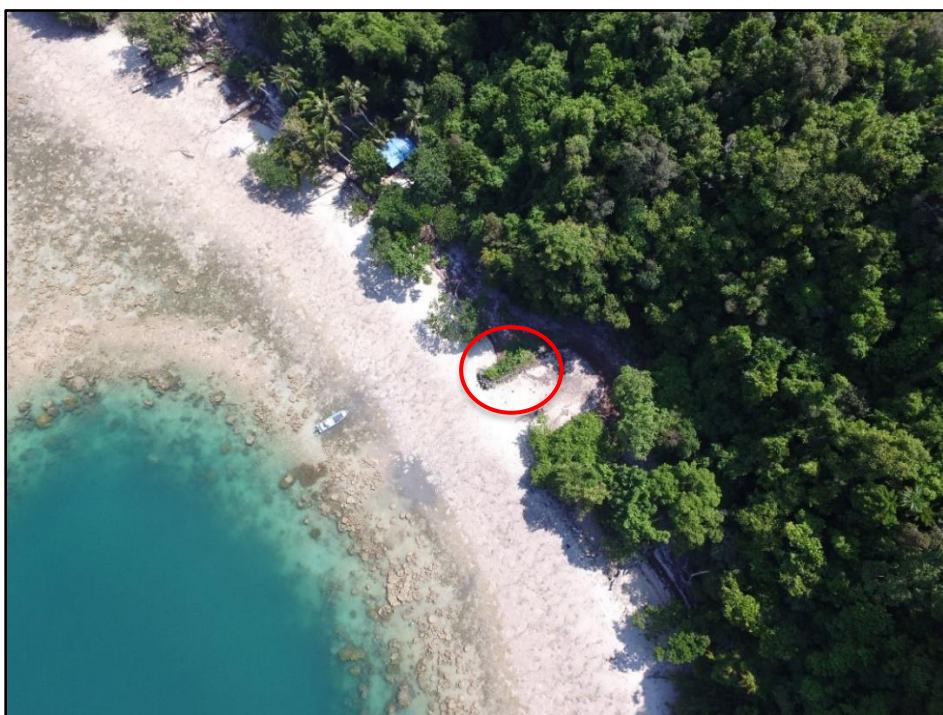
Figure 6. *Aerial photo of Chelechol ra Orrak. Notice recently constructed dock extending from access beach and boat to left for scale (photo by Scott M. Fitzpatrick).*

Overall, the site has good integrity with intact unfinished stone money and archaeological subsurface deposits, with the exception of those that have been excavated as a part of ongoing research. There are moderate impacts to the condition and integrity of the site due to sea level rise and construction of the modern dock ~10 years ago. The dock runs perpendicular to the existing beach and has increased sediment load and affected wave action, resulting in impacts to the beach and surrounding shallow marine habitats, including the adjacent seagrass beds (*Figure 6*). At high tide, archaeological deposits at the deepest areas of the site are already inundated, which will continue to be affected. The effects of sea level rise on the deepest archaeological deposits are particularly alarming, and during archaeological excavations in 2015, burials in the lowest portions of the site were already underwater during the highest high tides, which compromised preservation of bone and proper recovery.

Based on observations of current impacts affecting Chelechol er a Orrak, it is recommended that the modern dock be removed, which would restore natural wave action and beach formation processes. Currently, the dock creates a sediment sink that negatively impacts offshore seagrass beds that aid in coastline stabilization and reduce storm surge and tidal impacts. Restoration, maintenance, and protection of these ecosystems will lend further protection to the onshore cultural resources.

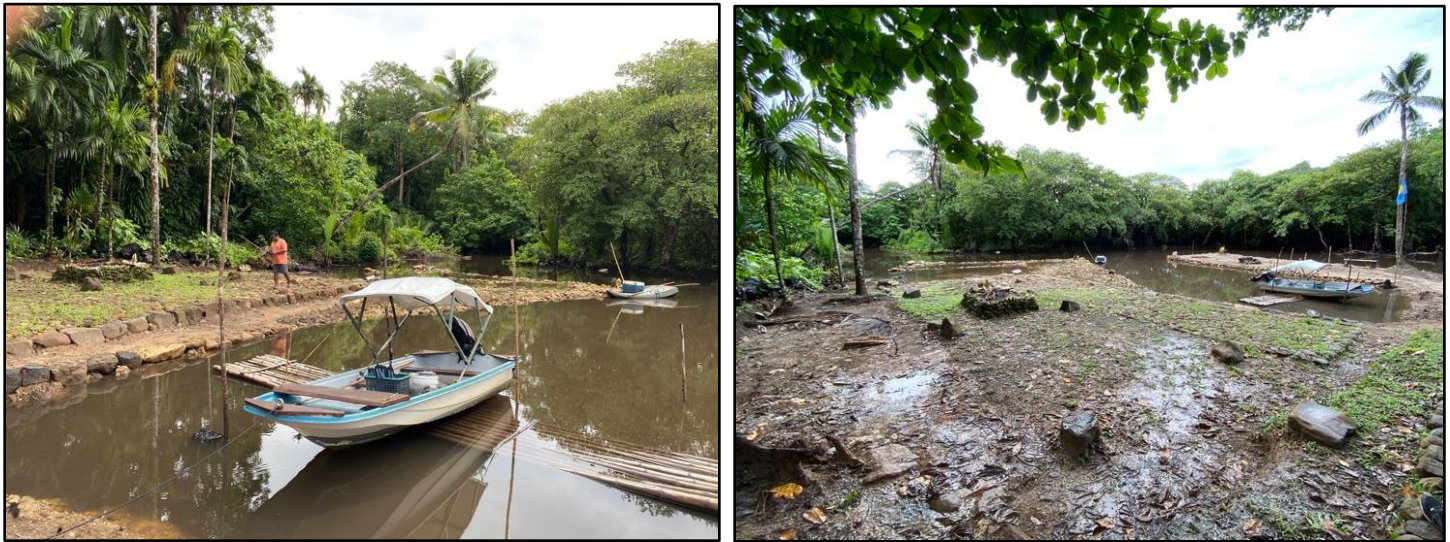
Figure 8. Images of Feature 12 and the surrounding mangrove channel (photos by Jessica Stone).

The site was recently restored and listed on the Palau Register of Historic Places on May 31, 2007, along with features 11 (stone pathway) (Figure 9) and 12 (stone platforms). It is still actively maintained; additions have been made to extend the existing dock feature for continued use of the site, and the dock has also been built up with sediment and rock.

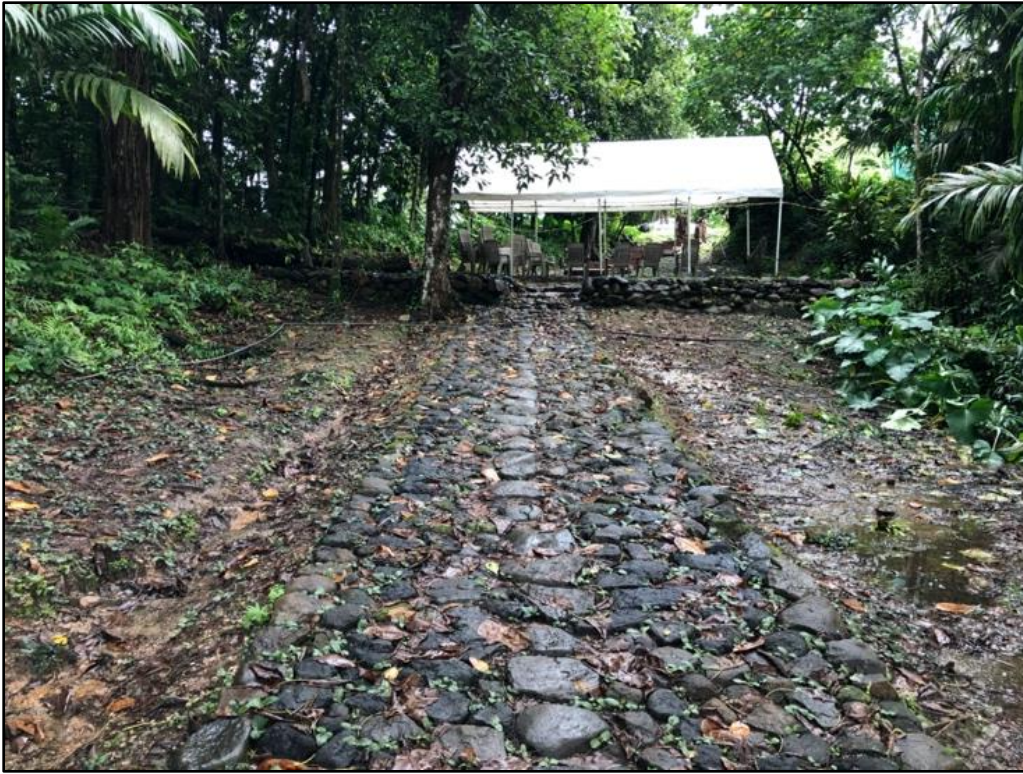
Figure 9. *Btelulachang er a Kermurrull (Feature 11), the stone pathway looking uphill (Photo by Matthew F. Napolitano).*

Overall, the site has good integrity. The dock, platforms, and pathway were recently restored and have been well-maintained. Some modern changes have been made; for example, the modern road cuts off the stone pathway at the top of the hill away from other village features, and the dock has been built higher for continued use. There is a high potential for future impacts to this site due to sea level rise and destabilization from drainage located uphill from the site. Currently, the presence of the modern road that cuts through the stone pathway combined with the downhill slope are resulting in water drainage that deposits water directly on to the platforms. The lack of a deeper drainage system also results in erosion of the soil on either side of the path and keeps moisture on the path itself, decreasing stabilization. Higher tides already inundate the lowest portions of the platforms and dock and with higher sea levels, will impact a broader area of the site (*Figure 9*). This is further compounded by the abovementioned drainage issues.

Based on the high potential for future impacts to the site, it is recommended that measures be taken to offset stress to the site by improving resilience and resistance to exposure, and to manage the already changing exposure. This can be achieved by improving the drainage system that moves water from the modern road towards the site. Deeper culverts or pipes that redirect water away from the stone path and platforms would allow for continued drainage from the modern road and improved stabilization of the site.

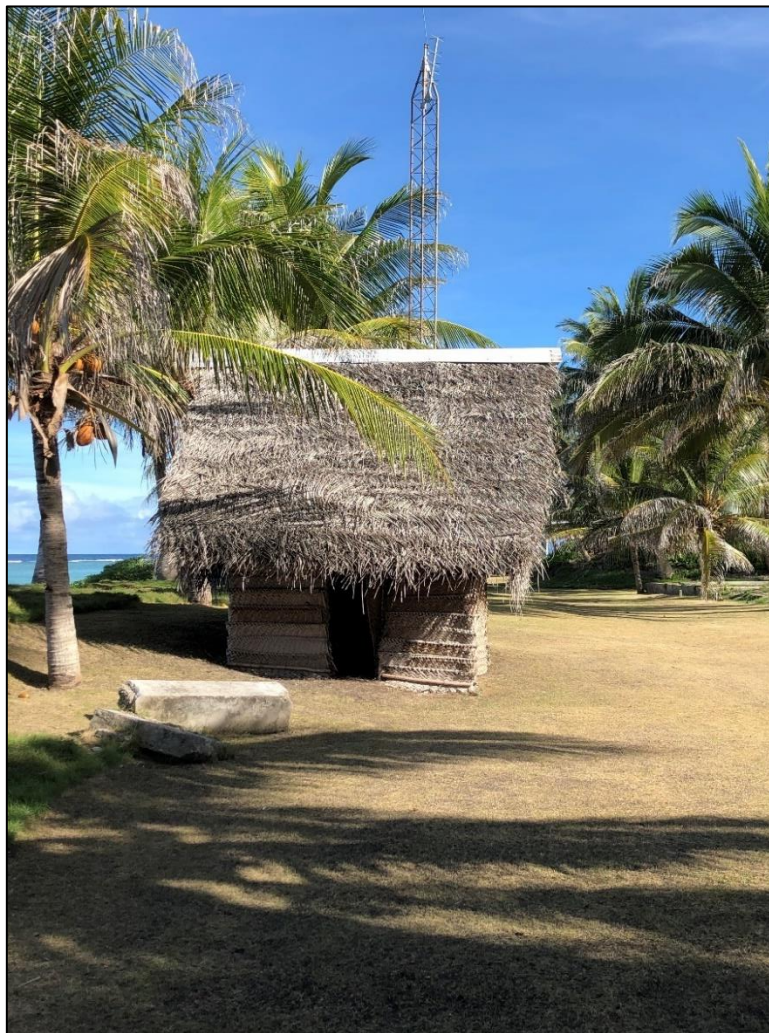
Figure 10. *Reconstructed menstruation house on Tobi Island (Photo by Matthew F. Napolitano).*

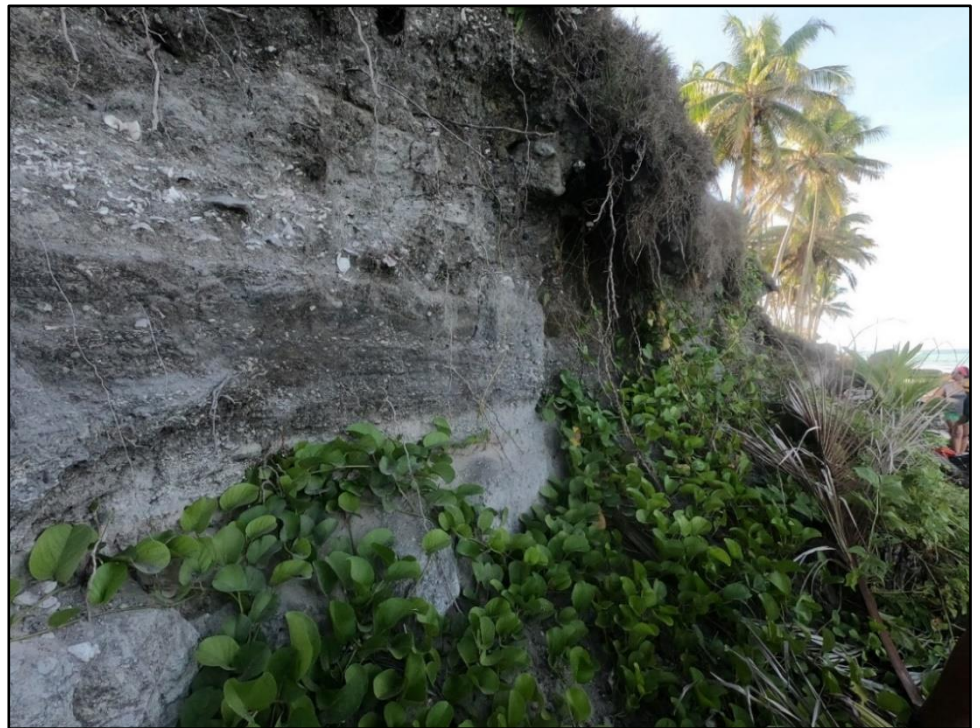
Erosion of the site has clearly been taking place at the site for decades. In addition to local sea-level rise, king tides, and catastrophic storm activity, Japanese phosphate mining activity in the early 20th century amplified the erosion. These activities also involved blasting through the coral reef that acted as a buffer to erosion and storm activity in order to build a shipping channel, resulting in strong lateral currents that have eroded the shoreline where Iporu is located (Hunter-Anderson 2000; see van Woesik and Cacciapaglia 2018).

Figure 12. *Coastal profile at Iporu.*

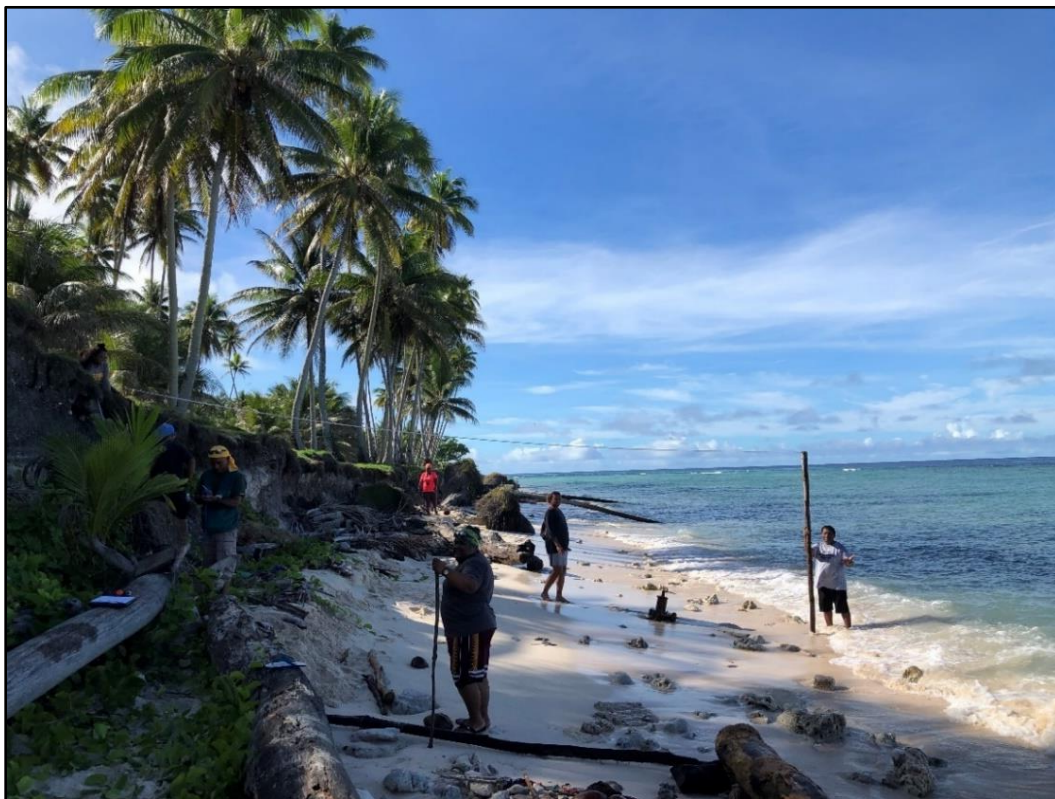
This site is a mound with multiple layers of deposition (*Figure 11*). There are no individual features at Iporu as the site is considered one intact cluster. The remaining portion of the site appears to be stratigraphically intact, but significant portions of the site have been lost (*Figure 12*). An estimated 34 ft (10.3 m), or approximately 75% of the site, has eroded and human remains were observed falling out of the exposed profile. Large trees can also be seen falling off of the bank's edge and root systems continue to pull down large chunks of the site. The landscape has been and is currently maintained by the local community, and there is a reconstructed menstruation house at the site that is in good condition. When encountered, human remains are collected after they erode from the bank. The exposed profile was mapped on March 9, 2020 to facilitate future monitoring and adverse effects (*Figure 13*).

Figure 13. *BCHP staff measures how much of the Iporu site has been lost to erosion (Photo by Matthew F. Napolitano).*

Tobi is one of the two intervention sites in the survey given its high level of vulnerability. For this intervention, the house made for housing eroded remains—originally located south of *Ferhuheh*—will be reconstructed. Based on our field assessments, we recommend the following additional actions to manage the changing exposure of the site and improve the resilience/resistance to the exposure:

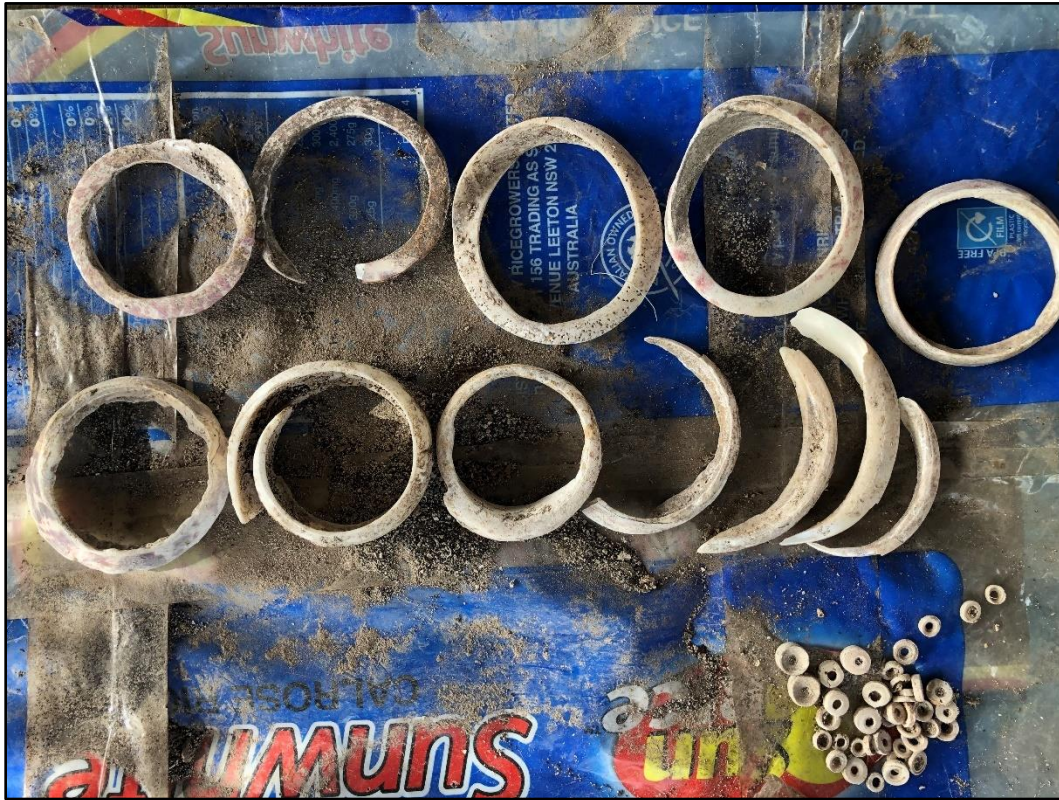
During a site visit in March 2020, we met with residents who showed us recently eroded bone and associated burial items. The objects appear to be consistent with what was reported by Hunter-Anderson (2000). Shell beads, bracelets or arm bands, and fishing lures were recently recovered with bone (*Figures 14 and 15*). A large coral pestle was also recovered.

Figure 14. *Shells beads and bracelets or arm bands.*

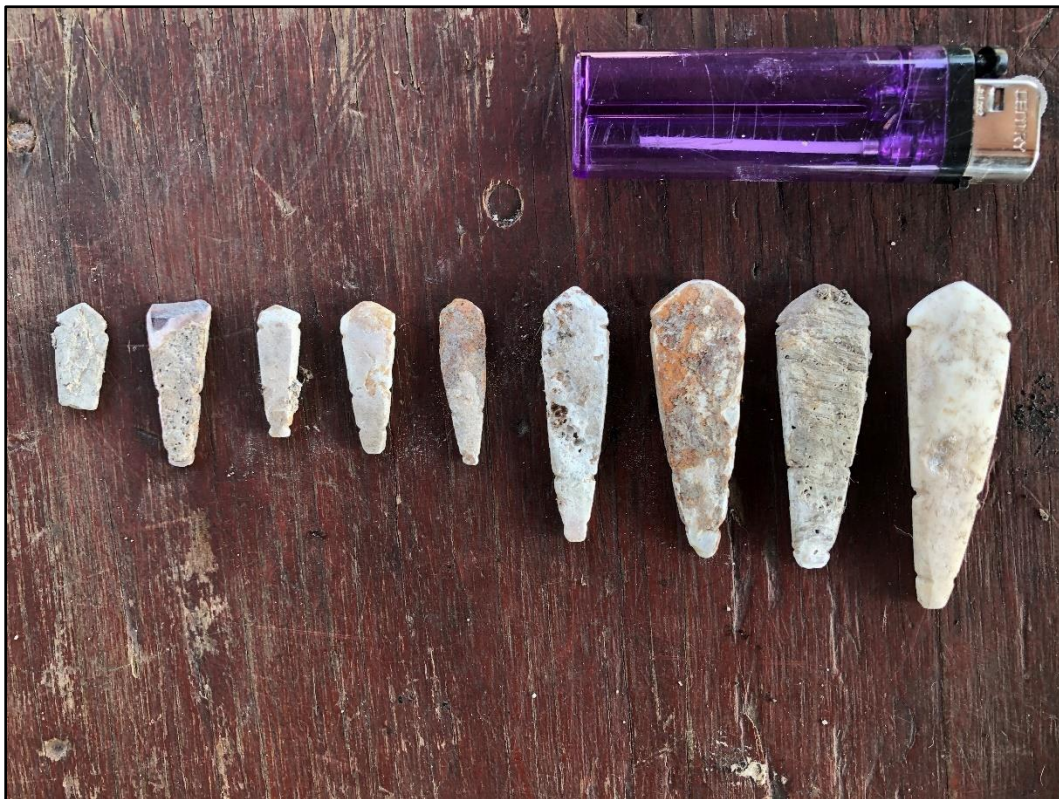
Figure 15. *Shell fishing lures from Tobi (Photos by Matthew F. Napolitano).*

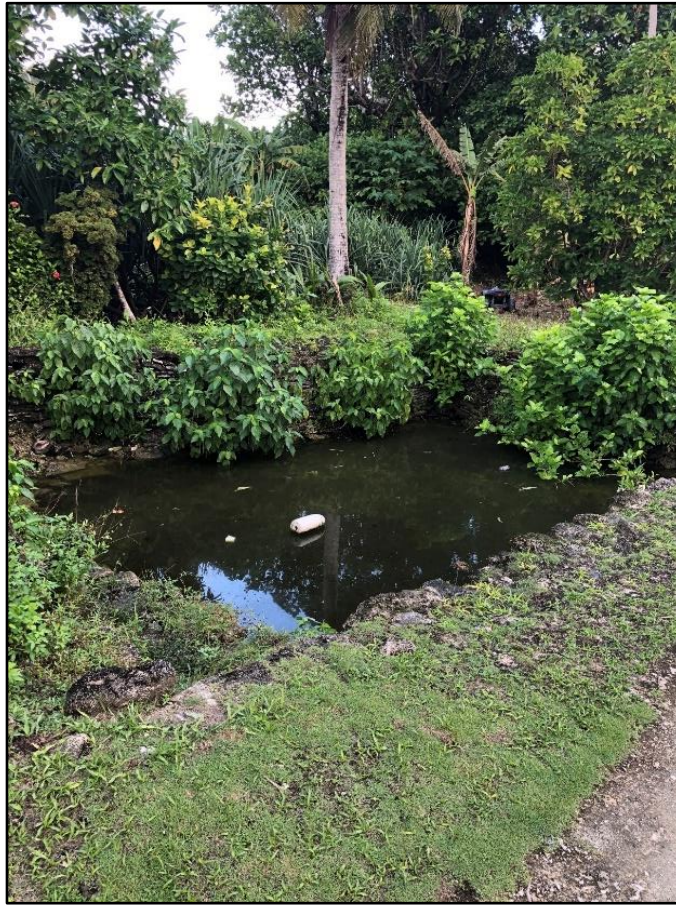
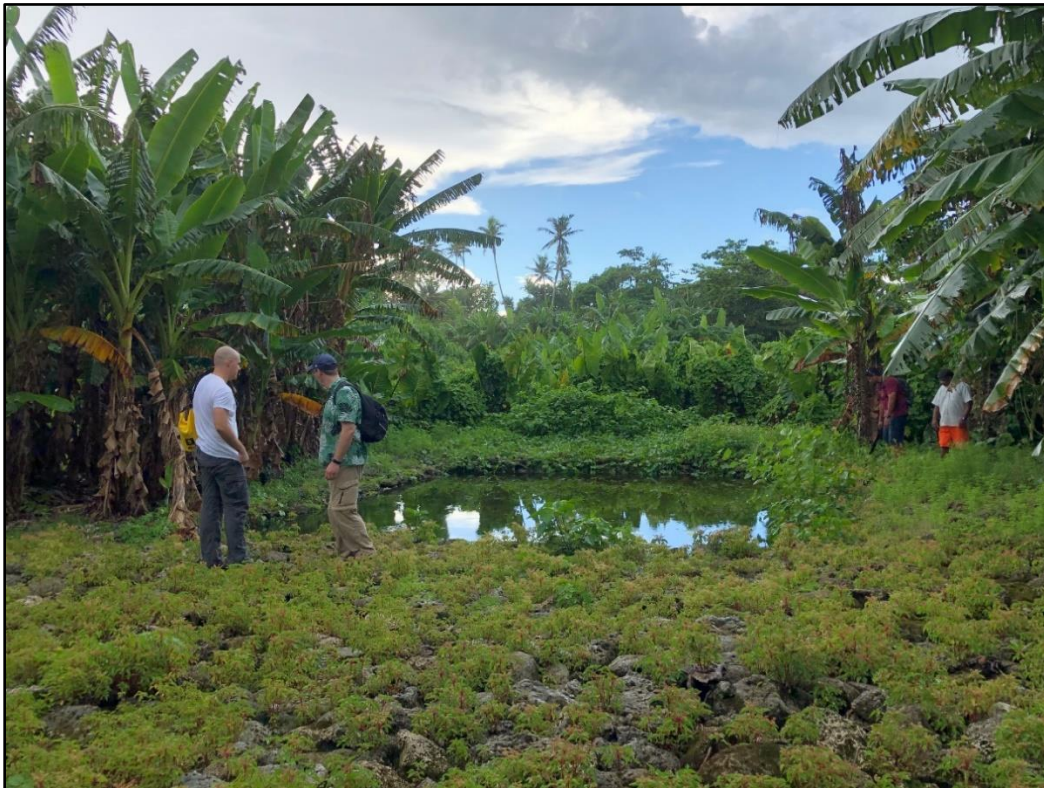
There are four (4) bathing pools (*Figures 16 and 17*) within the village are listed on the Palau Register of Historic Places and were recently restored through funding assistance from the U.S. National Park Service. As can be seen, many areas and features associated with these sites are also still being used (public cemetery, some platforms) (*Figure 18*). Over the years, vehicles driving on pathways has led to parts being damaged and some features have been altered or impacted from the purposeful or accidental removal of stones for reuse or from storm activity such as Typhoon Mike in 1990. Because these sites (and the island itself) are situated only a few meters above sea level at their highest point, inundation from sea water is an increasing concern, not only for structures, but for taro patches that are sensitive to salinity. For example, giant taro fields on Kayangel are still visible, but no longer used at present, probably due to saltwater inundation after Super Typhoon Bopha in 2012 (*Figure 19*). While the presence of the Ghyben-Herzberg (freshwater) lens has been a critical resource for peoples living on atolls around the world, rising sea levels will not only increase the salinity of this freshwater source but also prevent proper drainage of rainwater that can lead to more frequent periods of standing water, flooding, and other issues.

Figure 16. *Bathing area at B: NH-1:1 (Feature 7) (Photo by Scott M. Fitzpatrick).*

Figure 17. *Bathing area (Photo by Scott M. Fitzpatrick).*

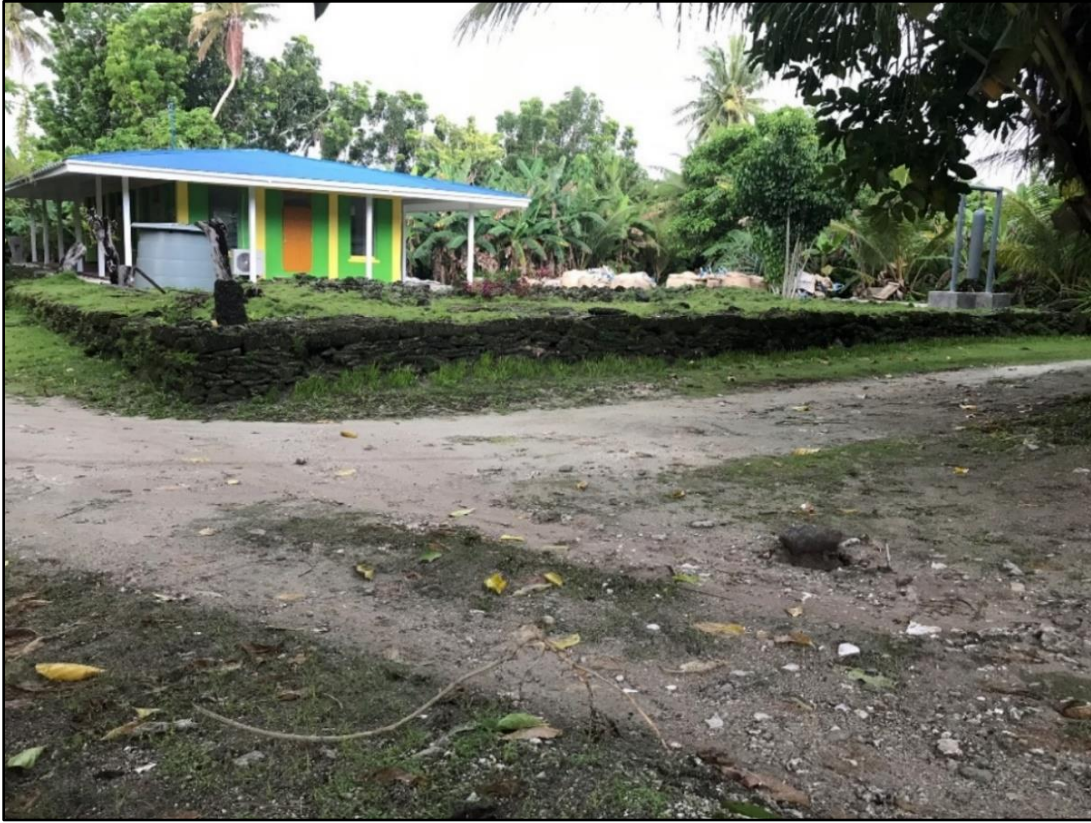
Figure 18. *Stone house platform and intersecting pathways at B:NH-1:1 (Photo by Scott M. Fitzpatrick).*

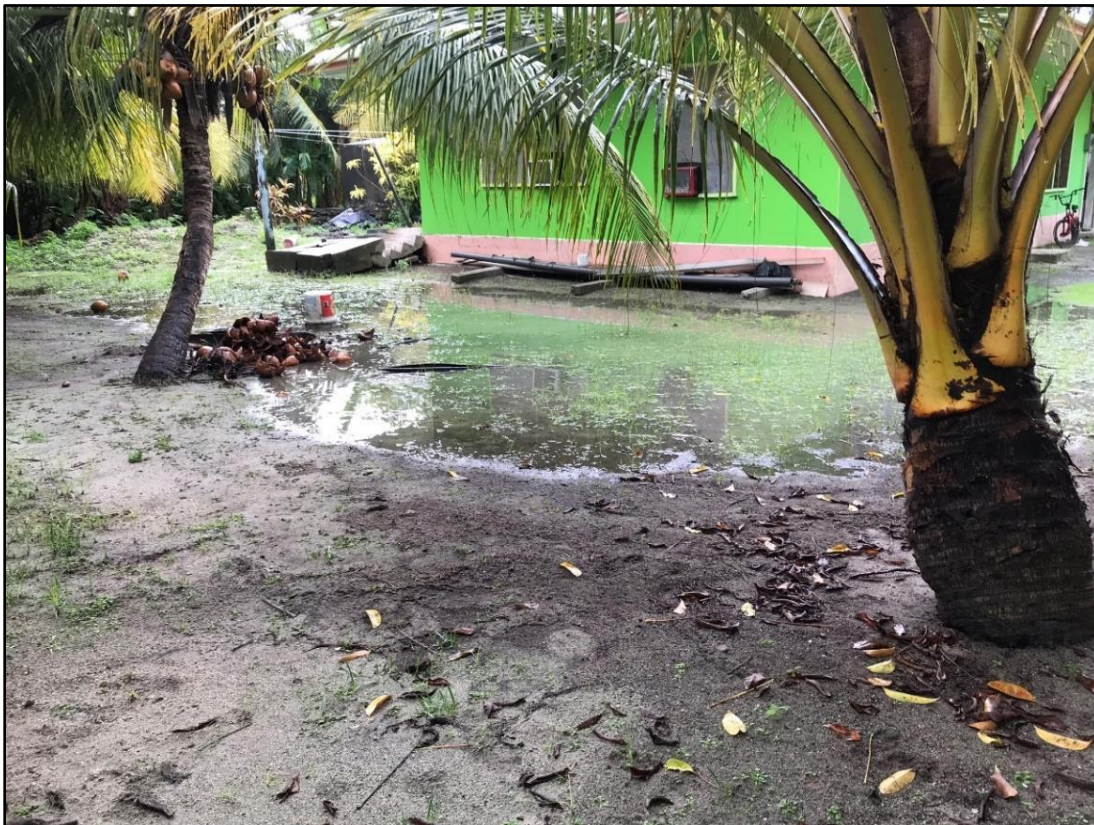
The overall condition and integrity of Beluu er a Ngerdimes (B:NH-1:1) and Beluu er a Ngerdilog (B:NH-1:2) is moderate to good, largely because they are maintained by local residents on a semi-regular basis, though it would be beneficial to clear more frequently. Today, both traditional villages have modern, contemporary dwellings, many of which are constructed using concrete and built on some of the limestone platforms.

Figure 19. *Standing water near a modern residential structure (Photo by Scott M. Fitzpatrick).*

Because Kayangel is a low-lying atoll, key natural threats include king tides, tidal surges, and storm/typhoon surges. As a result of Super Typhoon Bopha in 2012 and Typhoon Haiyan in 2013 striking Palau back-to-back, there was a massive accumulation of coral reef, beach rock, and other debris that transformed the coastline, inundation of the interior with saltwater that affected gardens and homes, and destruction of various features, both prehistoric and modern. Most recently, in April 2021, Kayangel was flooded because of Super Typhoon Surigae. It is recommended that the area around the bathing pools be cleared of vegetation and other debris to help clear the water. Clearing vegetation along the pathways and around features would also help to identify areas that have been disturbed due to natural and/or cultural processes as would limiting how pathways are used. Importantly, plans also need to be put in place if or when freshwater catchment systems are depleted. Given that there are several locations (platforms, cemetery) where human remains have been interred, the shallow depth of the island's soils are likely to negatively impact these features. Overall, while many of the cultural features on Kayangel are relatively intact, in some cases this is due to modern structures being built on top of them. It is recommended that there be a concerted effort to map and excavate sites on the island to help mitigate future climate related impacts.

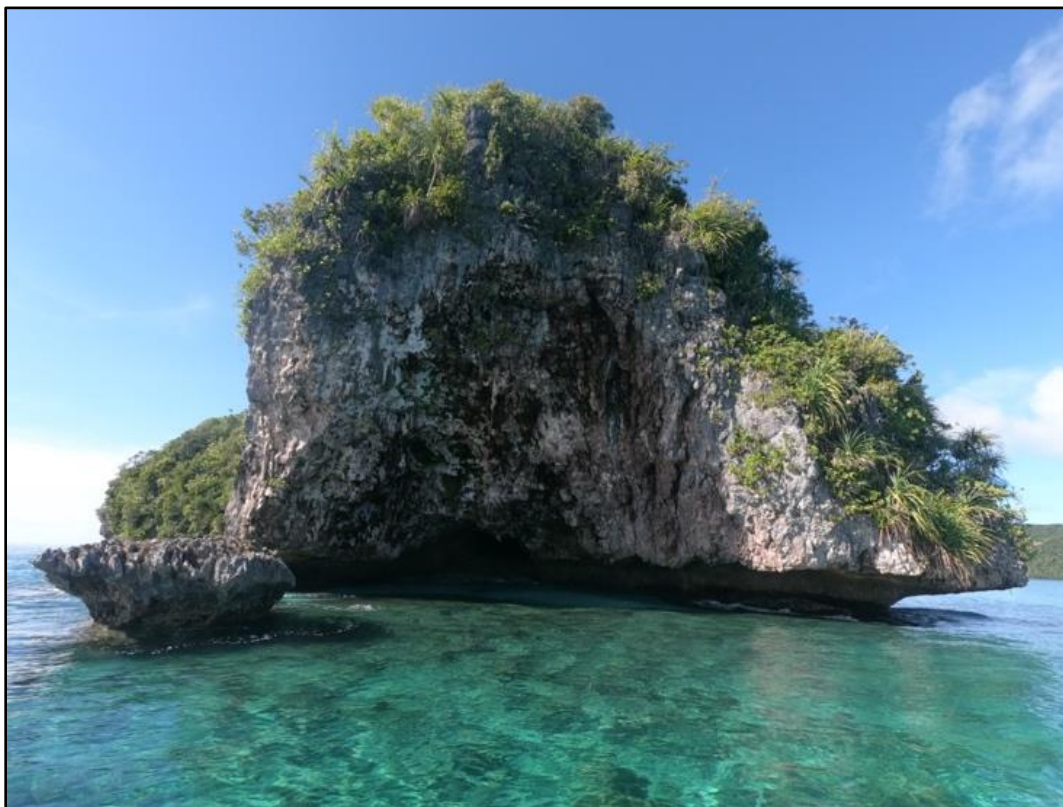
Figure 20. Cave entrance to Omedokel, accessible only by boat from an entrance on the northern side or a small opening on the opposite side (Photo by Matthew F. Napolitano).

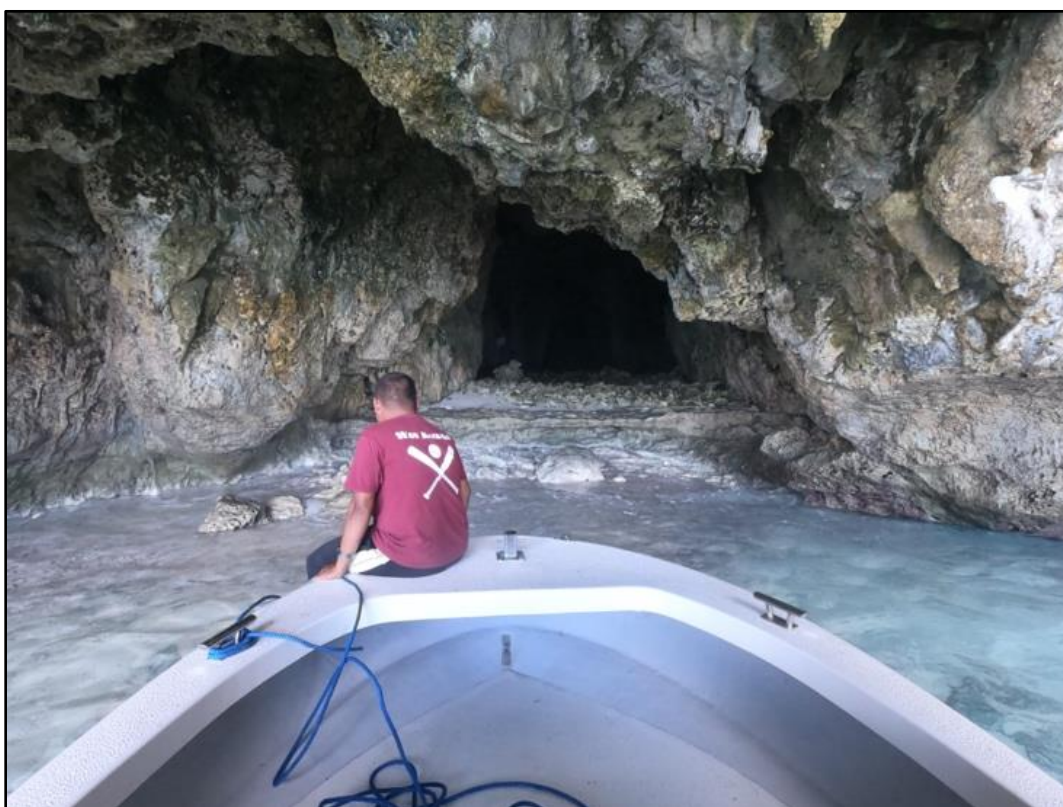
Figure 21. The cave entrance to Omedokel (Photo by Matthew F. Napolitano).

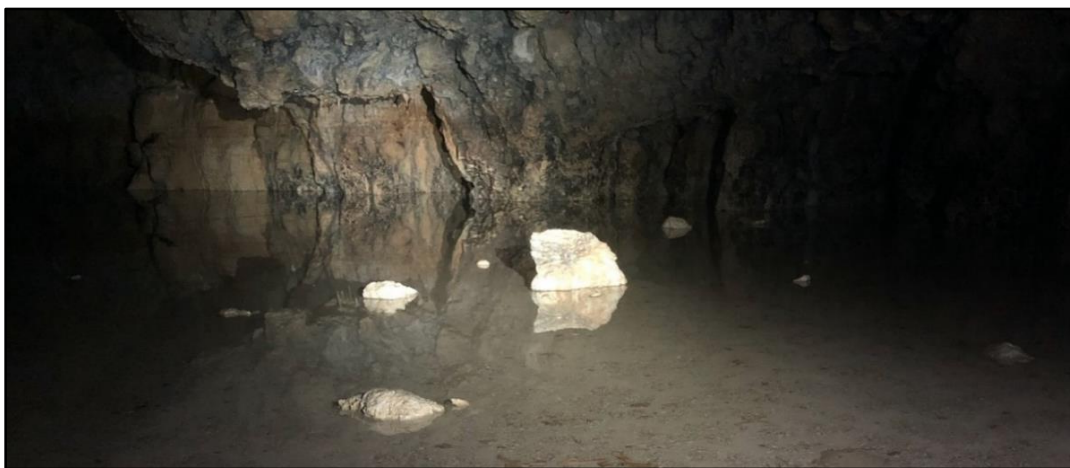
Human remains are fragmented and appear scattered, but have likely been moved due to a combination of modern tourist activity and possible wave action or storm surges washing water into the cave. Currently, there is a moderate impact to the condition, integrity, and cultural value of the site, as portions of the cave floor already show a shallow level of seawater seeping up through the cave floor, and in portions of the site, remains can already be seen underwater (*Figure 22*). This

impact will likely become more severe in the future, as storm surges and rising sea levels will continue to flood the cave floor, disrupting and further damaging human remains.

Figure 22. The interior of Omedokel showing tidal inundation of cultural remains (Photo by Matthew F. Napolitano).

If the intention is to ensure long-term preservation of the remains that are currently in place, removal and relocation will likely be necessary. However, if the burials are to remain *in situ*, it is recommended to manage the changing exposure with documentation and mapping of those that are still at the site. If requested by the stakeholders, osteological analysis could be conducted. Documentation and mapping of the cave is also recommended, as it may not be easily accessible once the cave floor is submerged. Two possible approaches are to use photogrammetry to create a three-dimensional model of the cave for a permanent record of the cave by building a digital model using overlapping high-resolution photographs or a 3D total station.

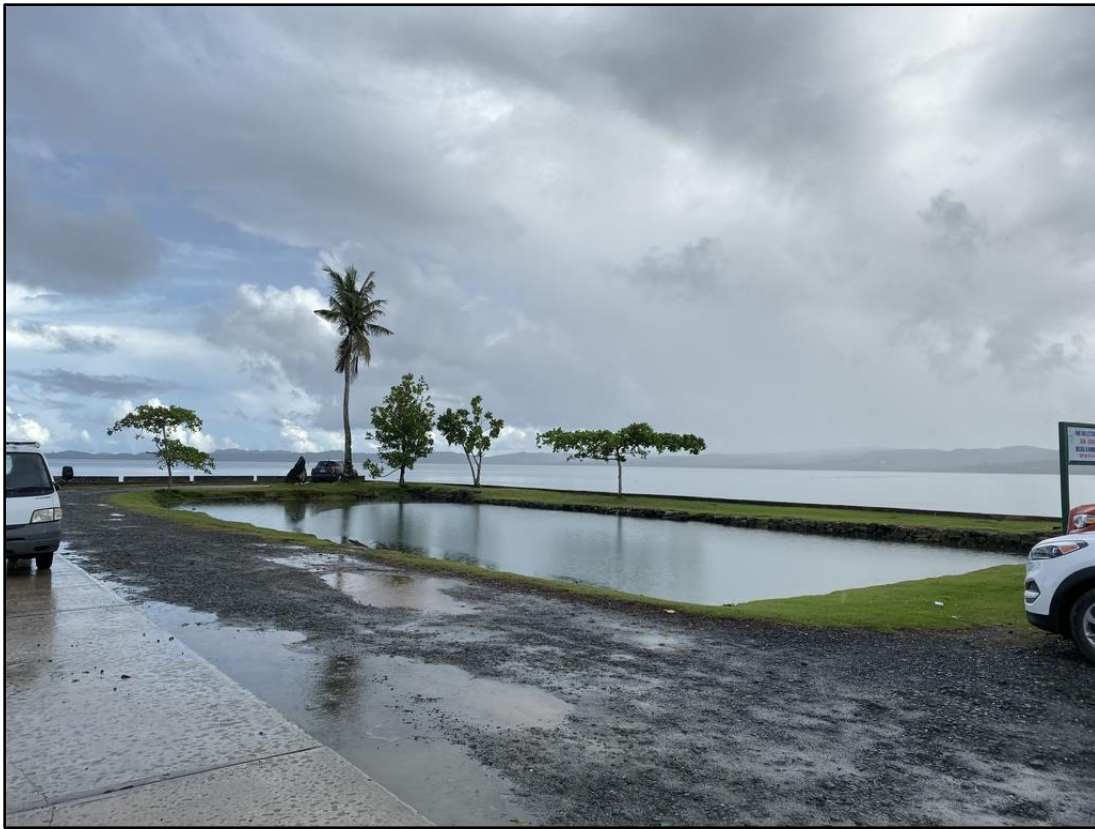
Figure 24. Japanese pool (looking west/northwest) (Photo by Jessica Stone).

The site should be continue being kept clear of debris and detritus. Increasing sea level around the T-Dock facility will inundate the pool and cause property damage. The T-Dock facility will have to be raised again within the next decade, which will be a large and costly construction project, but does not offer a permanent solution. A protective retaining wall build around the pool may be another temporary solution, but could disrupt shipping access to the dock.

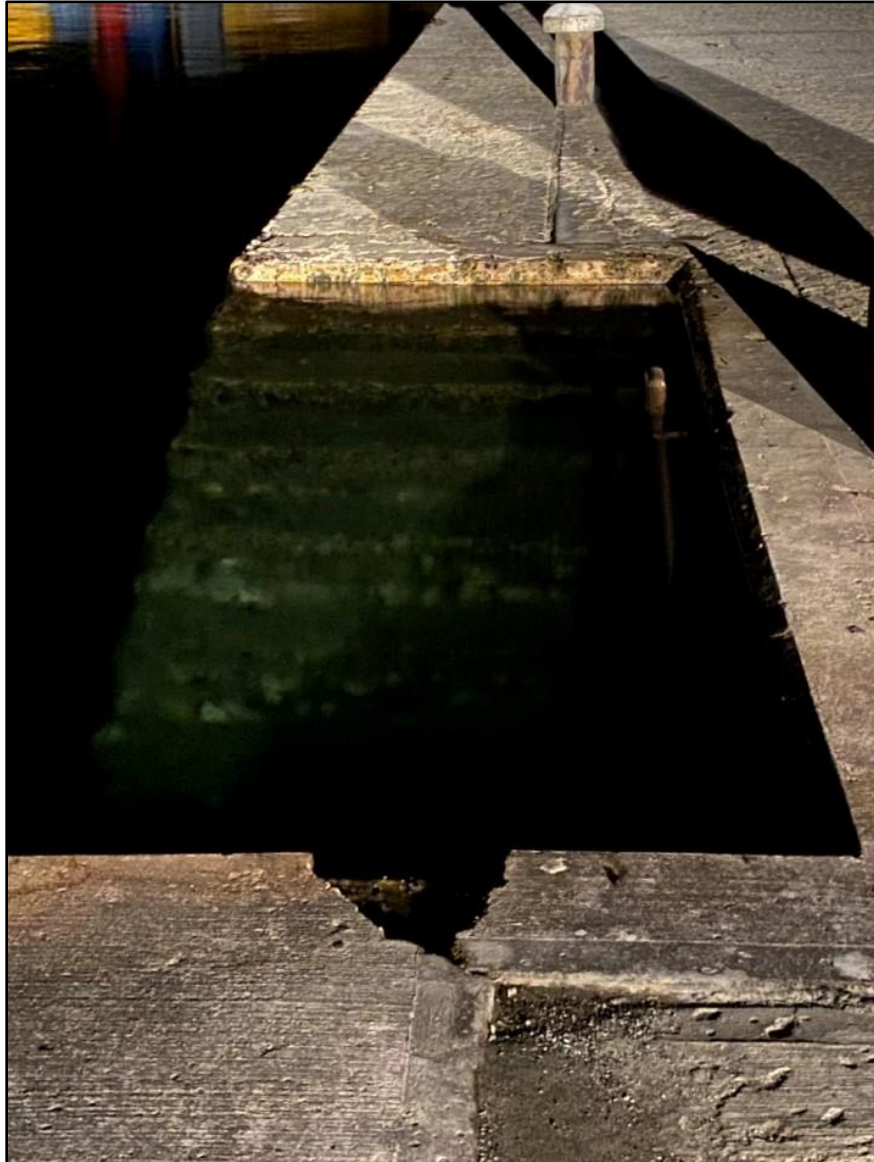
The features at the T-dock facility are all part of a single cluster. There is a good integrity of the site overall; however, there are moderate impacts to the site because the water is at ground level at high tide and during king tides. Features 2-4 are water features, but Feature 4 (the pool) is not built into the water. When rising sea level eventually inundates the concrete, the entire cluster will be compromised because the connecting walkway will be lost. The site is maintained and cleaned regularly. With the exception of a new boathouse built at the end of the facility, the site looks roughly the same as it was when mapped by Erlich (1984).

Figure 25. View of T-dock (looking east) at high tide on October 30, 2019 showing spillage and inundation (Photo by Jessica Stone).

Figure 26. *B:OR-5:9 at high tide on October 30, 2019 (Photo by Jessica Stone).*

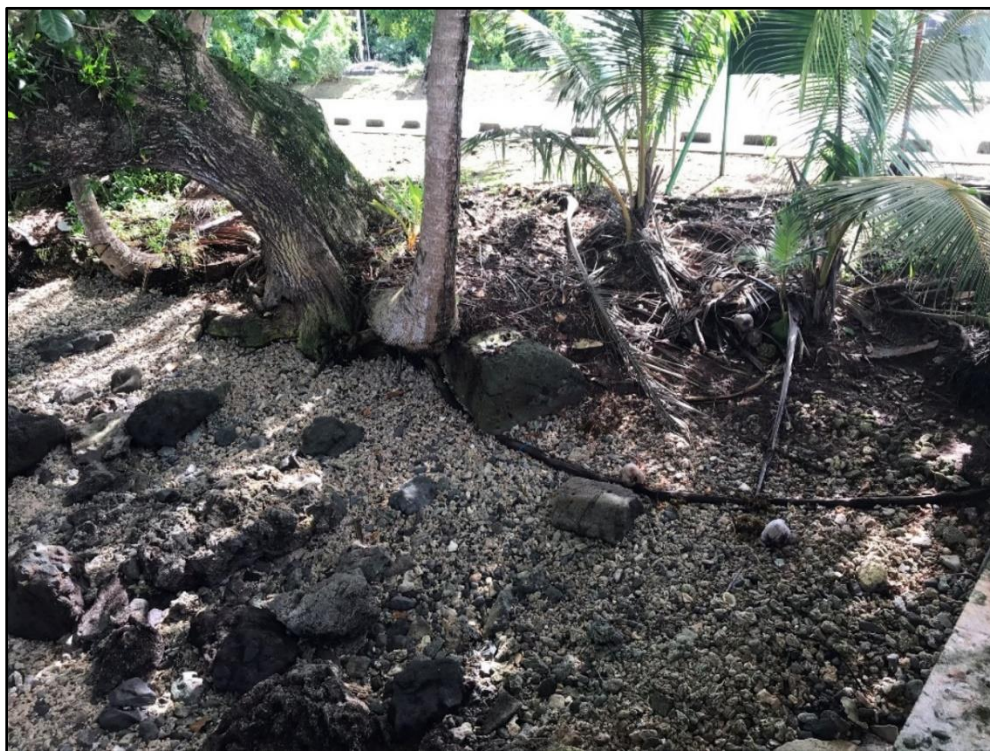
Today, there are seven monoliths that are near a dock, but the ground under the eastern monoliths has eroded and four are now on the beach in a tidal area. The monoliths were originally resting on the surface. There are additional traditional stonework features around the stones that are still in their original place. A road now goes through the center of the monolith arrangement (*Figures 27-29*). There might be vegetation removal around the monoliths. There is a modern culvert between the road and the monoliths to direct water flow.

Figure 27. Coastline east of main Melekeok road showing disturbed monolith features (Photo by Scott M. Fitzpatrick).

The monoliths on the beach are between 1-2 m in elevation and within the tidal area while the monoliths on the other side of the road are about 5-6 m above mean tide. The monoliths are located adjacent to terraces and residential gardens and are all located together with a paved road bisecting the site, though there was probably a traditional path that connected the monoliths and led from the village to this site. The monoliths that are still present are in good condition. However, two are missing and it is unclear for how long. The site appears to be maintained somewhat regularly. The primary issue is that four of the monoliths have been undercut by erosion and are now resting on the beach.

Given the significance of the monoliths and surrounding area, as well as its close proximity to the sea, the area east of the road should be restored and reinforced with concrete so that the monoliths can be placed on the same level surface and in their former positions as seen in Morgan's (1988) map. The monoliths themselves appear to be in good shape, but they should be restored to their original place. Secondary vegetation should continue to be cleared from around the monoliths prior to restoration and the culvert should be kept clean to maintain good water flow. The area east of the road should be constructed similarly to the concrete parking spot nearby. Building a protective wall out of concrete would offset the stress of wave action although it will be necessary at some point to raise the road.

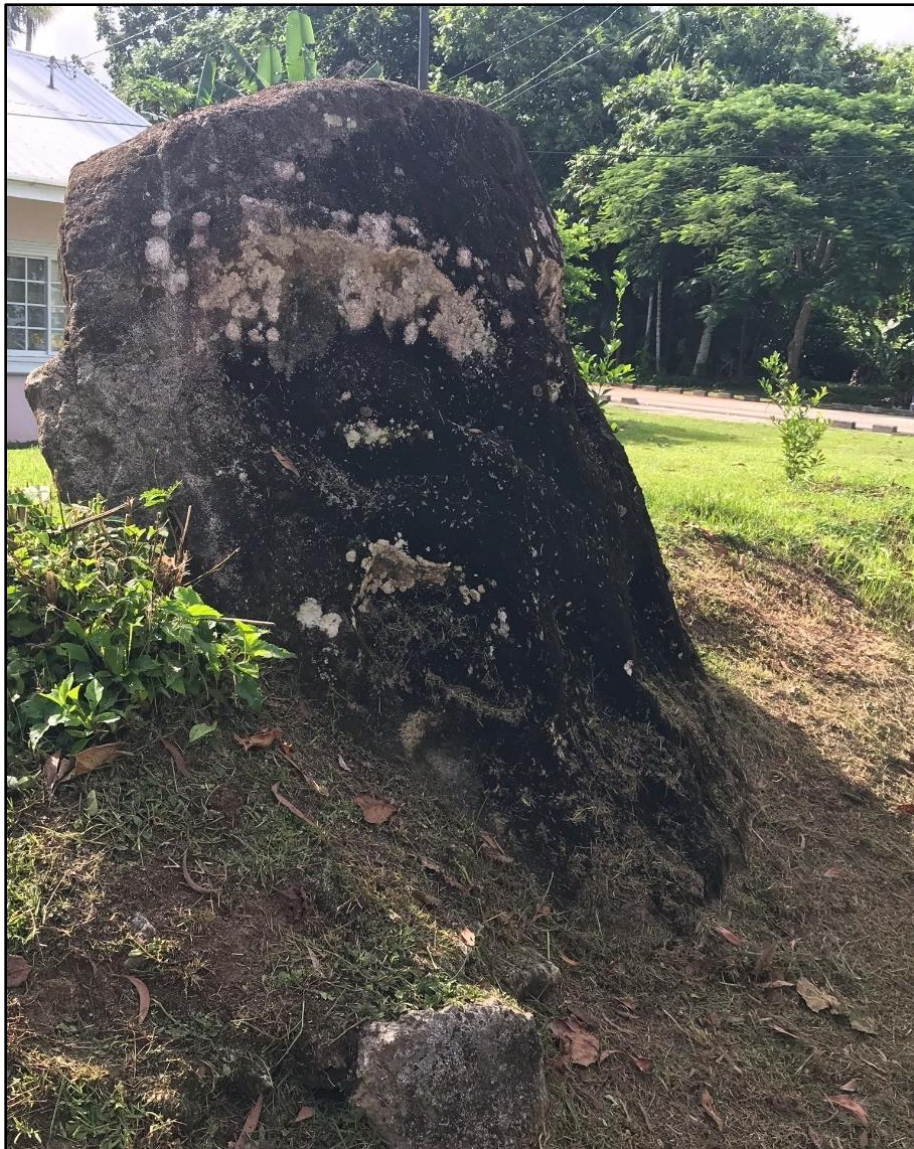
Figure 28. *Odalmelech monolith (Photo by Matthew F. Napolitano).*

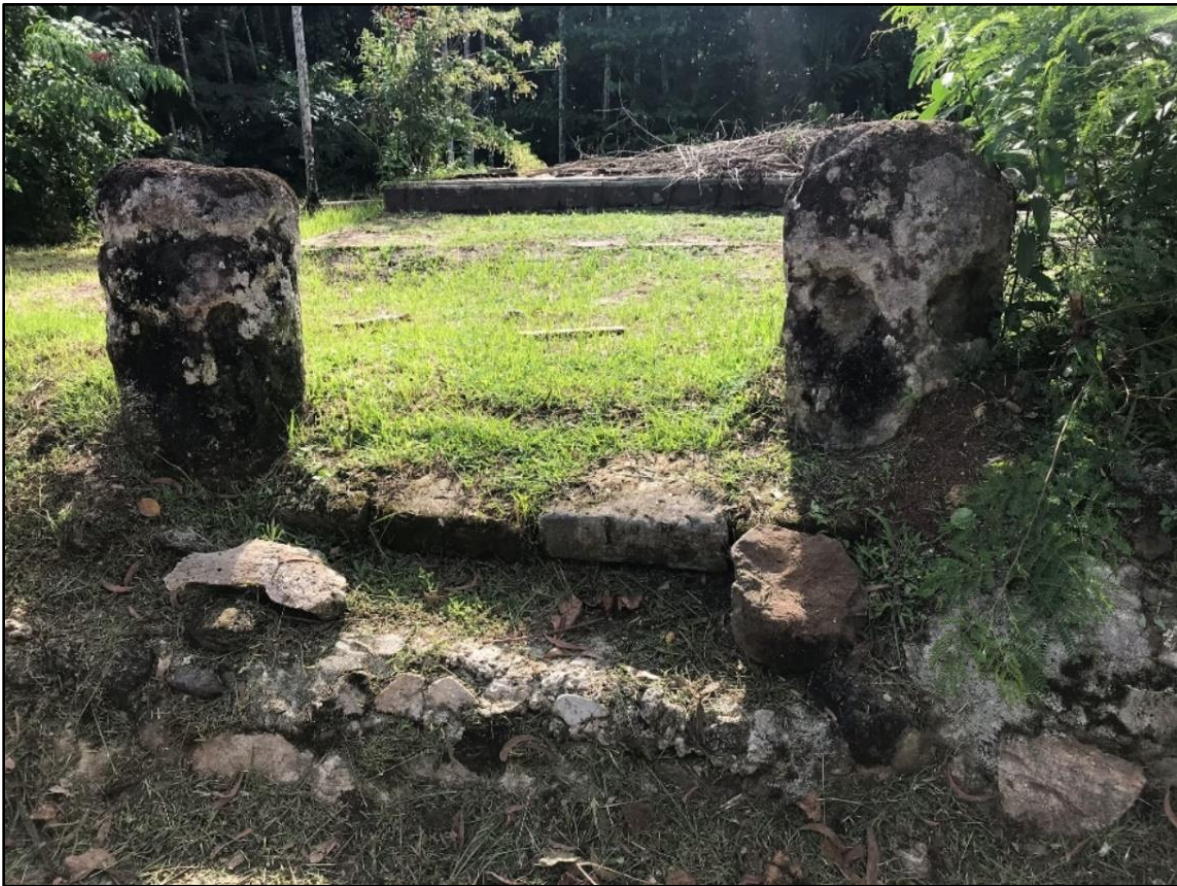
Figure 29. Two of the “councilman” monoliths in Melekeok (Photo by Matthew F. Napolitano).
