Disaster Risk and Climate Change Impact Survey in the Republic of Palau, Phase I

Executive Summary

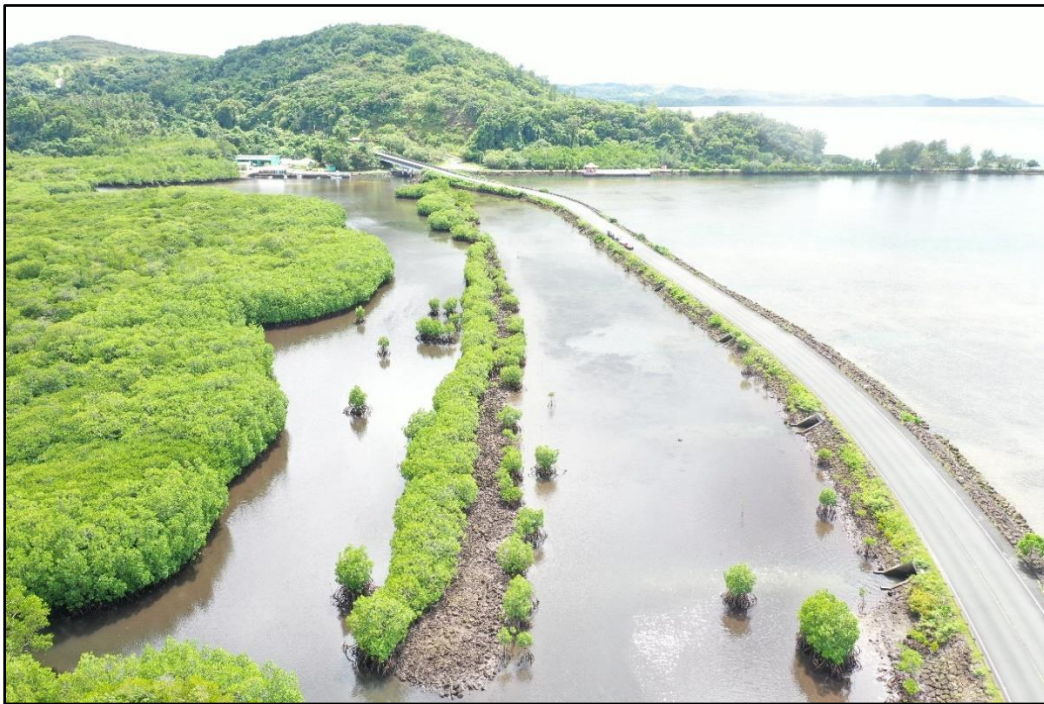
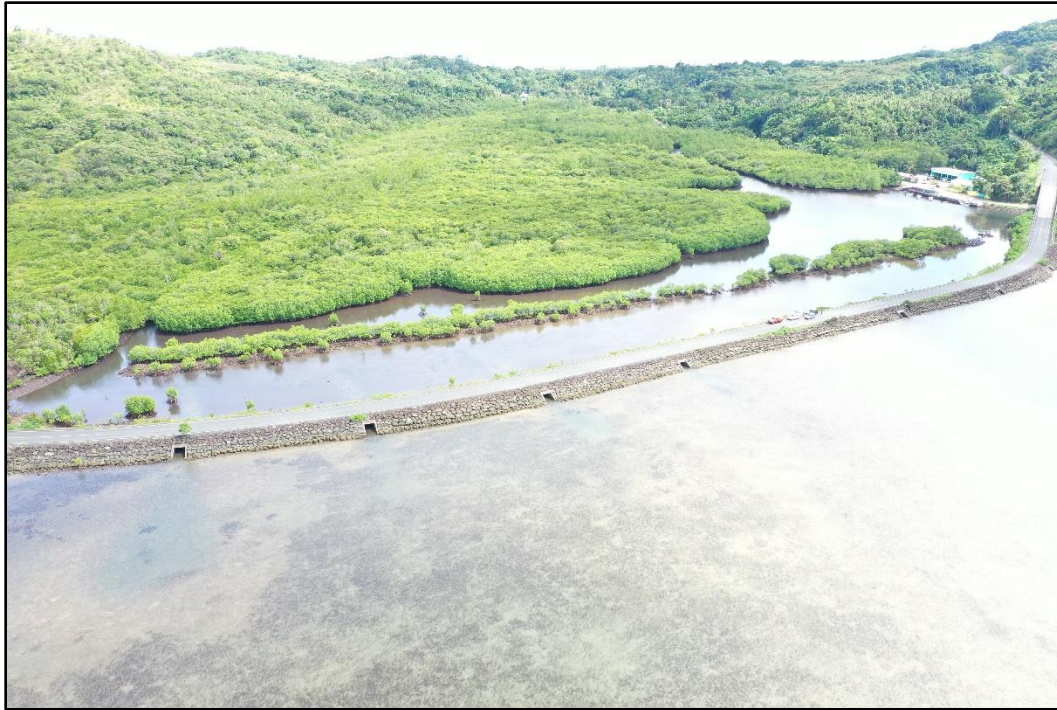
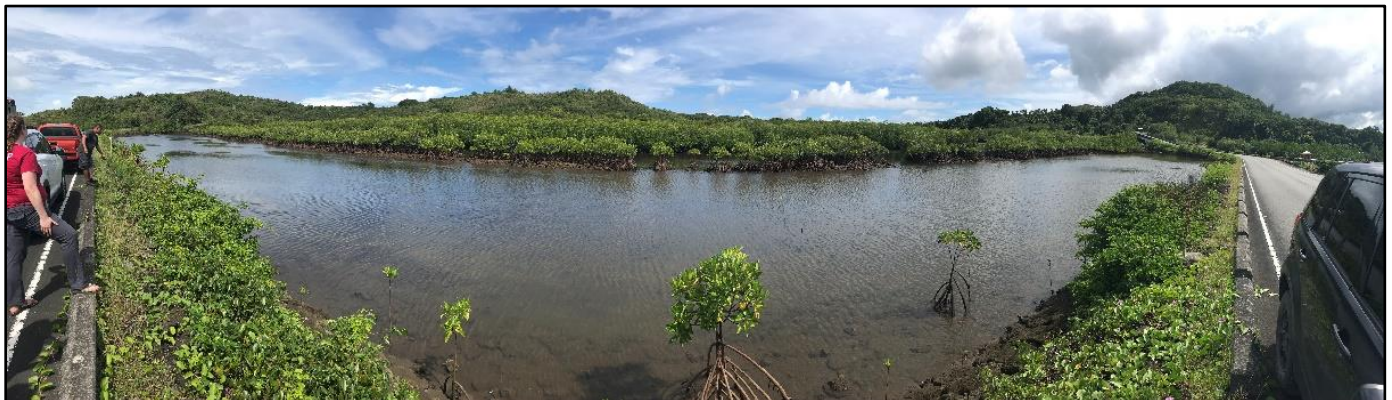
This “fortress” or traditional causeway is today covered in mangrove vegetation and is not currently maintained. At low tide, the coral block construction is exposed, but becomes inundated at higher tides. Generally, the integrity of the site is fair to good as features are more or less intact, but not currently maintained. The mangrove vegetation growing on top and surrounding the site has likely aided in holding some of the coral blocks in place when the site is inundated at higher tides.

Figure 30. View of Cheldeklel a Dilrengulbai (looking south) (Photo by Calvin Emesiochel).

Figure 31. *View of Cheldeklel a Dilrengulbai (looking south/southwest) (Photo by Calvin Emesiochel).*

Figure 32. *View of Cheldeklel a Dilrengulbai (Photo by Calvin Emesiochel).*

Though the site itself is inundated daily by tidal action given its coastal location, the placement was purposeful to manage access and traffic by local villagers and appears robust. It is unclear how the establishment of mangrove vegetation has affected the integrity of the structure (or whether ancient Palauans expected this growth, which would have been part of the overall design incentive). Regardless of whether the growth of mangroves here was intentional or not, their forced removal would likely lead to damage. It is recommended that occasional monitoring take place to ensure that the structure has not been damaged by storm surges, etc.

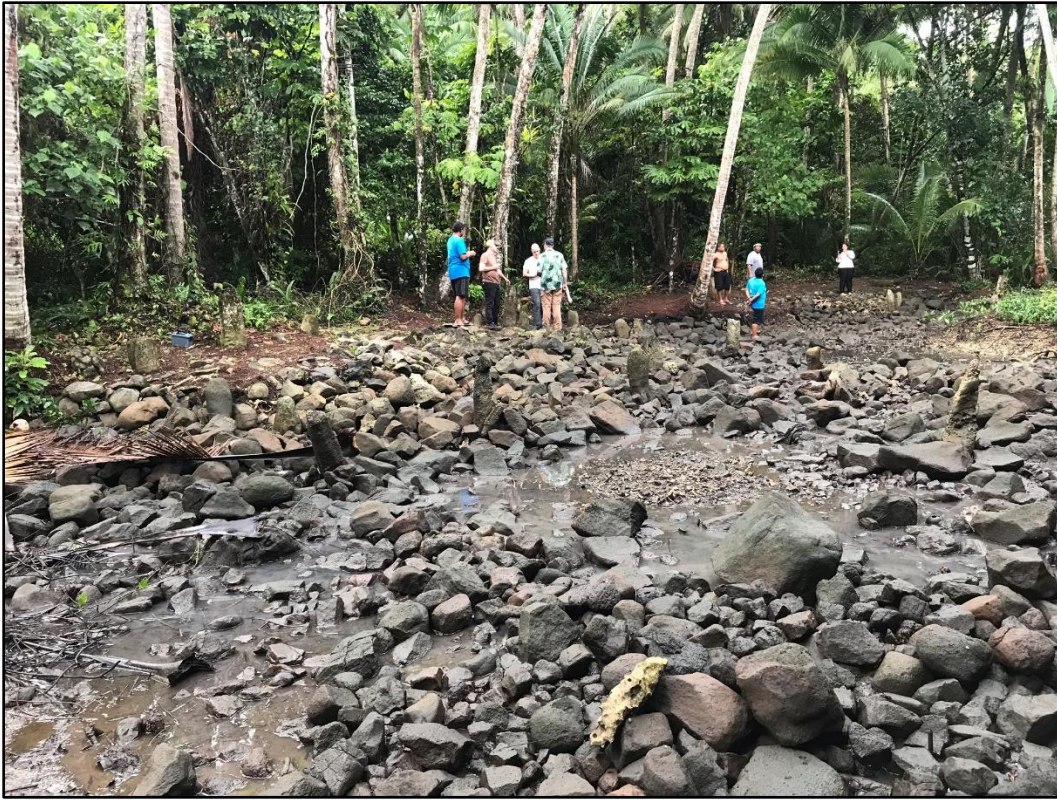
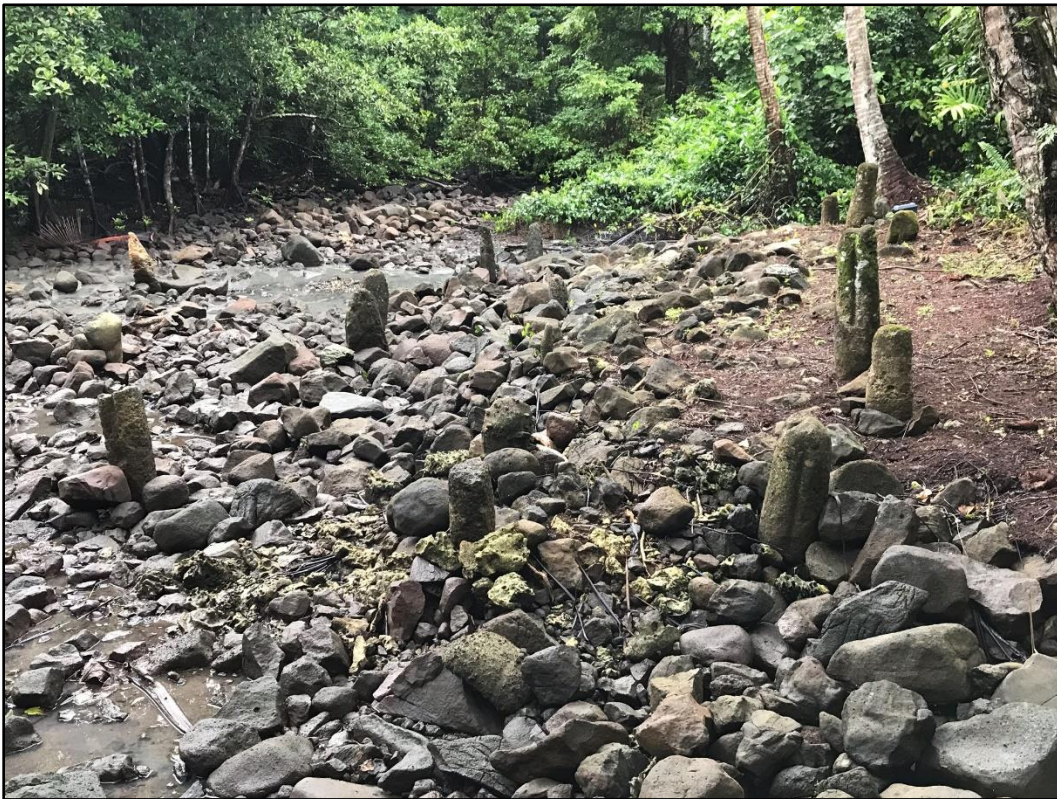
The integrity of the site is moderate. Because it is situated within a tidal area, the features are regularly inundated. As a result, some of the monoliths have moved slightly, though many are still in their original location. Other monoliths have been moved slightly back in their original position instead of lying down when Hijikata mapped them. The site was recently repaired and cleaned, which facilitated visibility and mapping during our survey.

Figure 33. *View of Kukau el Bad (Photo by Calvin Emesiochel).*

Figure 34. *View of Kukau el Bad showing many of the feature's monoliths (Photo by Scott M. Fitzpatrick).*

It is recommended that the site receive regular cleaning and monitoring to ensure that the monoliths remain upright. Given the importance of the site and relative accessibility, it will need to be determined whether there is any potential for tourism (e.g., walking tours through the traditional village or boat rides). Overall, the condition of the site is fair to good. There needs to be maintenance and community engagement to keep the mangrove channel clear and monitoring secondary vegetation that could obscure the site and needs to be fairly well documented with photos and mapping. There is a high potential for further damage given regular tidal influx.

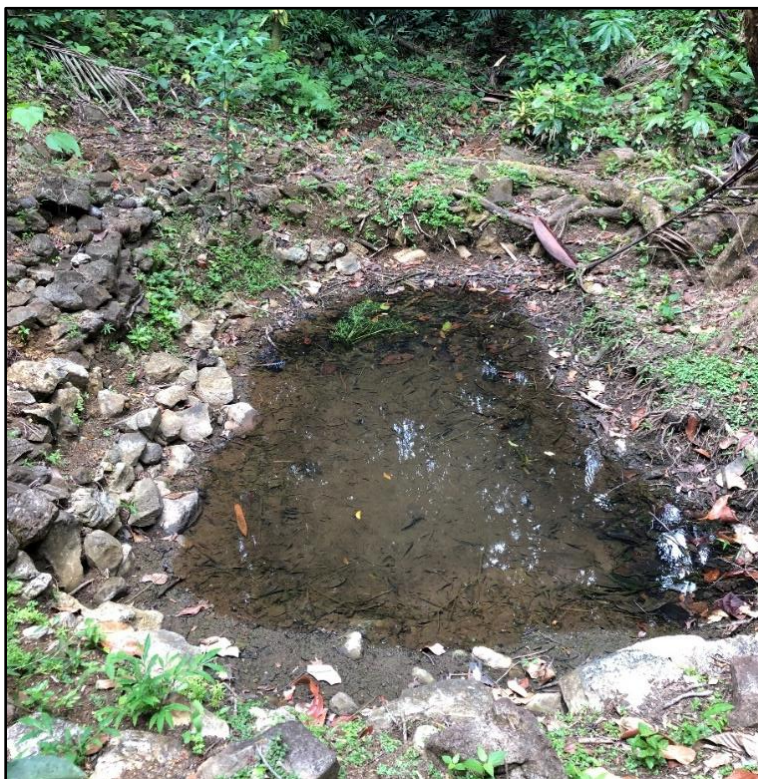
Significant features at the site include *Diong ra Imeched*, a stone-lined bathing pool (Figure 35), three *uang* (canoe landings), monoliths including *esuch* (owl), multiple stone paths, platforms, and a bridge. The *esuch* faces the water and offers protection to the village. The site's original bridge, *Did ra Ibai*, has recently been restored (Figure 36). According to informants at the site, *Did ra Ibai* was more than 100 years old. The landscape has been modified in numerous ways, including the bathing pool, which was built into the stream, diversion of waterways, including the construction of multiple culverts to facilitate irrigation, terraced landscapes, and mangrove removal and modification to create channels to allow for canoe travel and to connect to the fringing reef. *Klekat* (smoke signal locations) face the other villages. At the time the village was constructed, it was likely coastal and had a view of the seascape.

Figure 35. *Diong ra Imeched*, a stone-lined bathing pool at Ngerutechei (Photo by Matthew F. Napolitano).

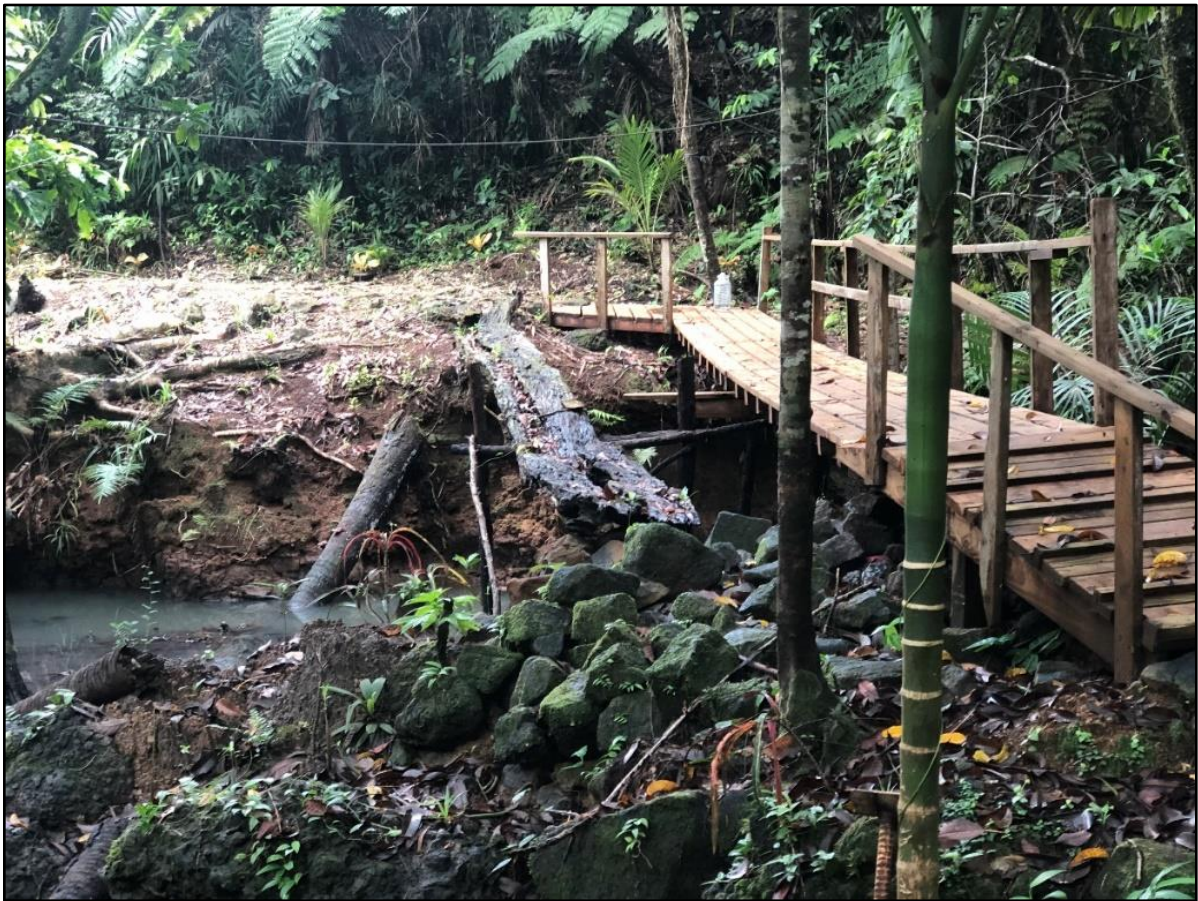
Figure 36. NM.2. *Did ra Ibai* is the site's original bridge that allows access to the site (Photo by Matthew F. Napolitano).

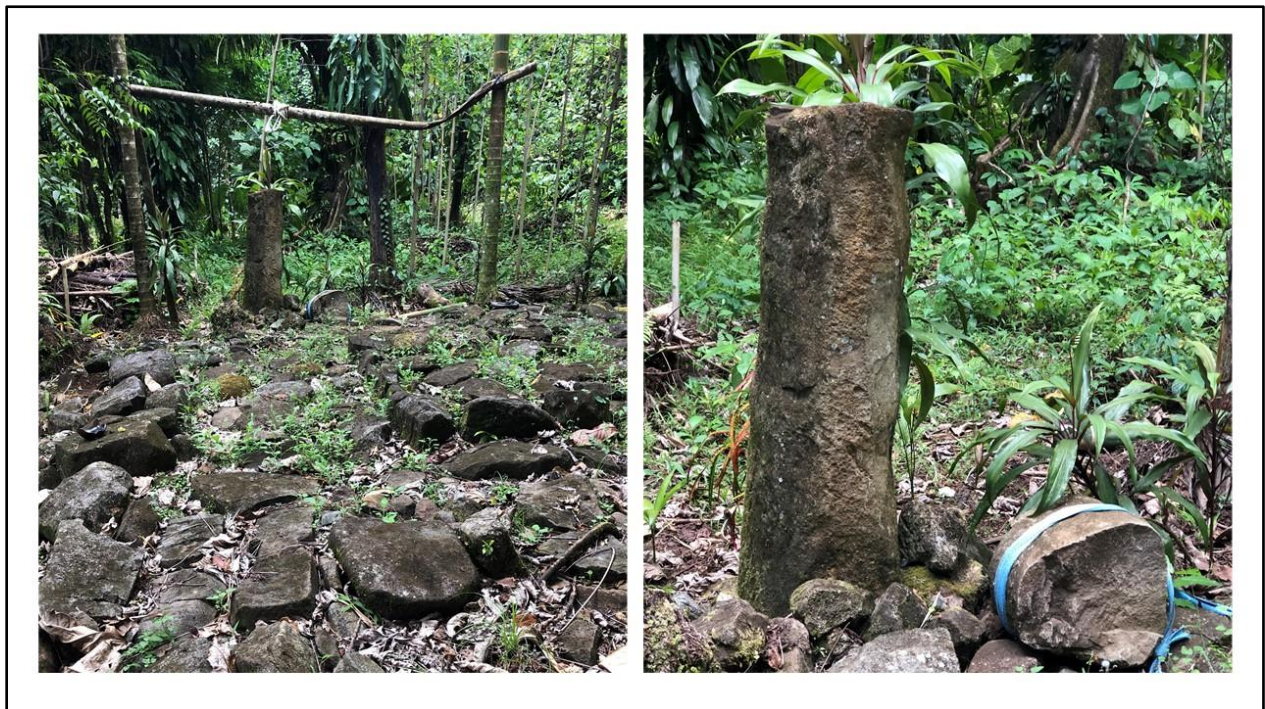
Figure 37. *Olekelek a Meducherutechei* (Photos by Matthew F. Napolitano)

There are numerous photographs of the site and oral histories are well documented. The village site is considered to be the oldest and most sacred in Palau. Several features are included on the Palau Register of Historic Places, although the entire site is not designated. *Uchul a Rebong* is an elevated platform that is significant because it is the place where Milad gave the chiefly titles for Imeungs. Feature 15 (stone platform with a fallen monolith) is called *Olekull er a Ruchel*, which is the sacred site considered to the burials of the demigods. Feature 20, *Olekelek a Meducherutechei* (stone platform), is said to be the burial place of *Meducherutechei*, a brave warrior from Ngerutechei (*Figure 37*).

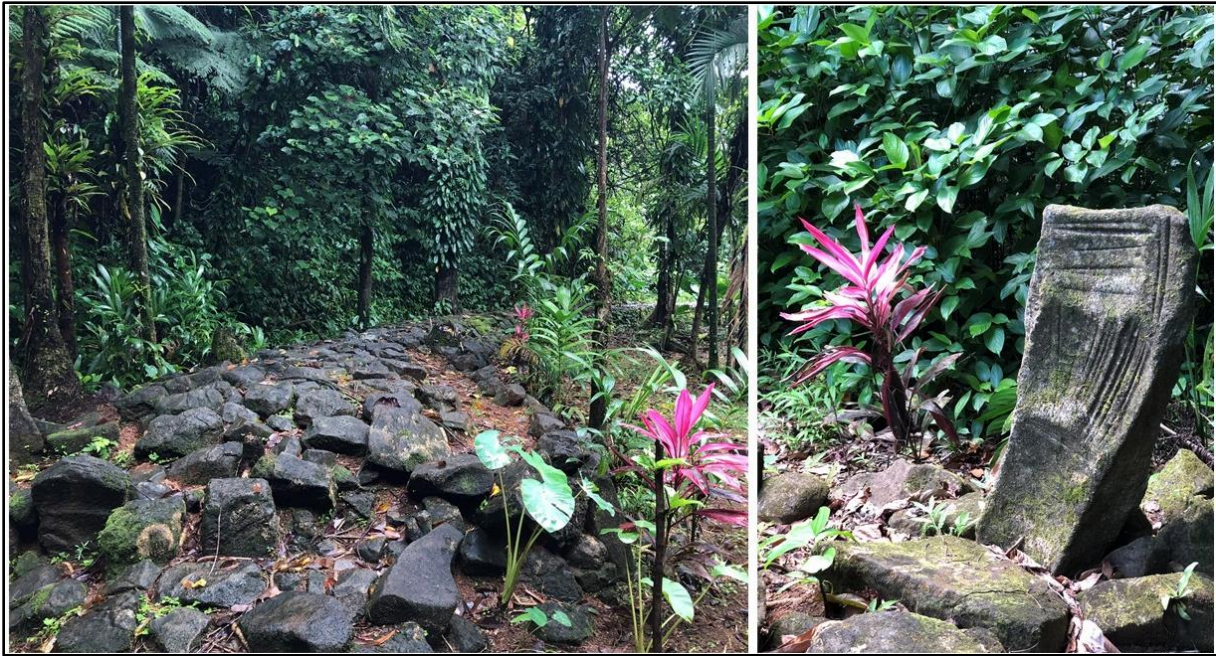
The site is moderately intact and has high integrity; however, there are moderate impacts to the condition, integrity, and cultural value due to its current condition. Even though it is currently maintained and was recently cleaned by the state and the community, increased mitigation is needed before conditions and impacts of the site worsen. Overall, the village site is on the coastal area and has been uninhabited for many years so it has become overgrown and covered with secondary vegetation. This has caused the buildup of silt and dirt that blocks and covers all of the site's irrigation systems, forcing the buildup of sediment that has covered features. The overgrowth of vegetation on top of features has also dislodged rocks. Overgrown mangroves have covered stone paths and blocked waterways as well as the mangrove channel. Sea level rise has inundated features, causing them to fall apart.

Figure 38. Left: v, the stone pathway (Feature 22). Right: a monolith with thin grooves on it is located on top of the Iliud (Feature 21) (Photos by Matthew F. Napolitano).

Based on our assessment in the field, we recommend intervention to manage the changing exposure of the site and improving the resilience/resistance to the exposure through the following stabilization measures:
