Solomon Islands – Fisheries Livelihoods Recovery Project

Preliminary Assessment of the Impacts of Reef Uplift on the Aquatic Environment in the Rarumana Lagoon.

Prepared for NZAID
By
The WorldFish Center
Solomon Islands

April 2008

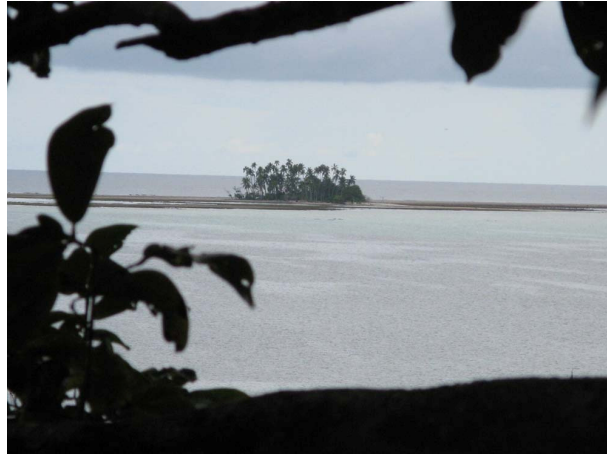
Figure 1. Uplifted fringing reef viewed from Rarumana Village, May 2007

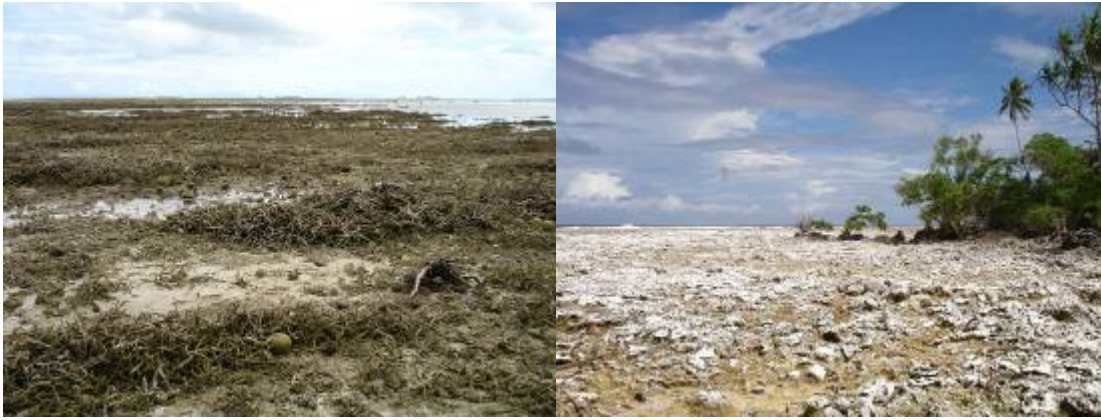
Figure 3. Left: Dead branching corals on uplifted fringing reef opposite Rarumana Village, August 2007 and Right: channel indicated by black arrow in Figure 2F, August 2007.

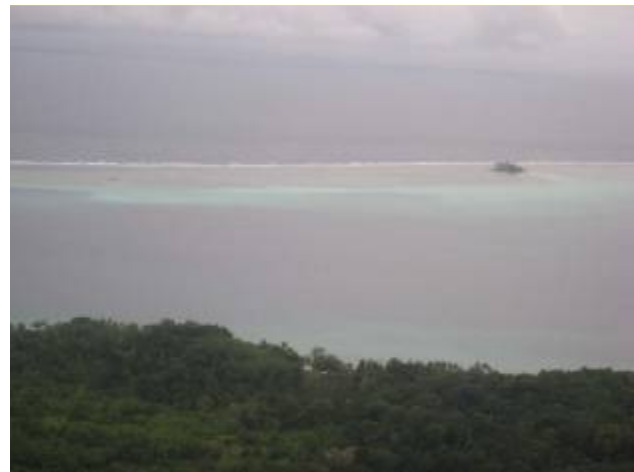
Figure 4. Fringing reef opposite Rarumana village, November 2007.

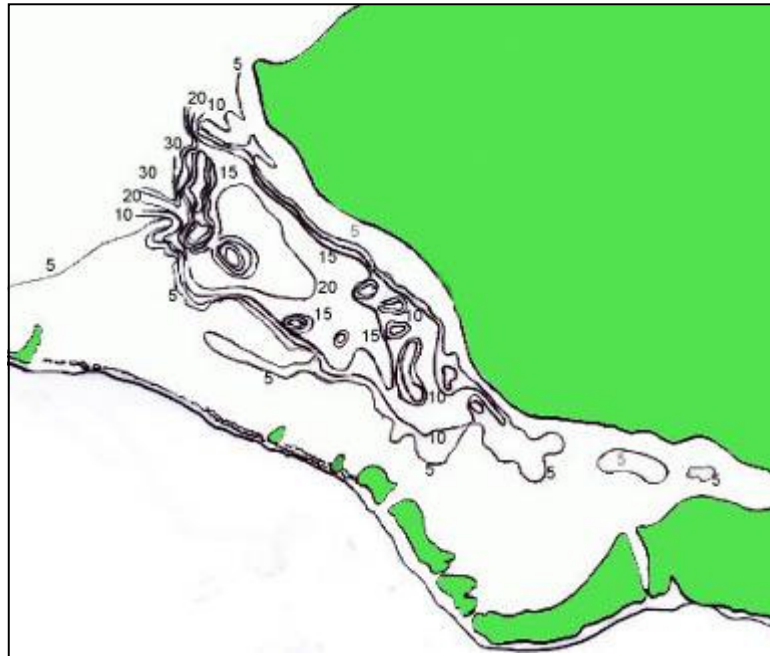
The Rarumana Lagoon is 7.4 km long and 3.9 km wide at the entrance. Lagoon area is 15.43 km², with the area deeper than 5 m, estimated as 5.51 km². Approximate depth contours based on the bathymetric survey, existing maps and images are shown below (Fig. 8). The picture that emerges is of a steep sided basin, 15-20 m deep, filling the centre of the western half of the lagoon, with extensive shallow shelves on both north and (especially) south shores. The outer section of the lagoon has deep (to 20 m) channels constricted by series of submerged coral outcrops at the entrance. The inner half of the lagoon is by contrast shallow, with a few deeper pockets of water.

Integration of contours in Figure 8 yields an estimation for the volume of the lagoon as $100 \times 10^6 \text{ m}^3$.

Figure 8. Approximate bathymetry of Rarumana Lagoon based on survey data and images. Contours are at 5 m intervals

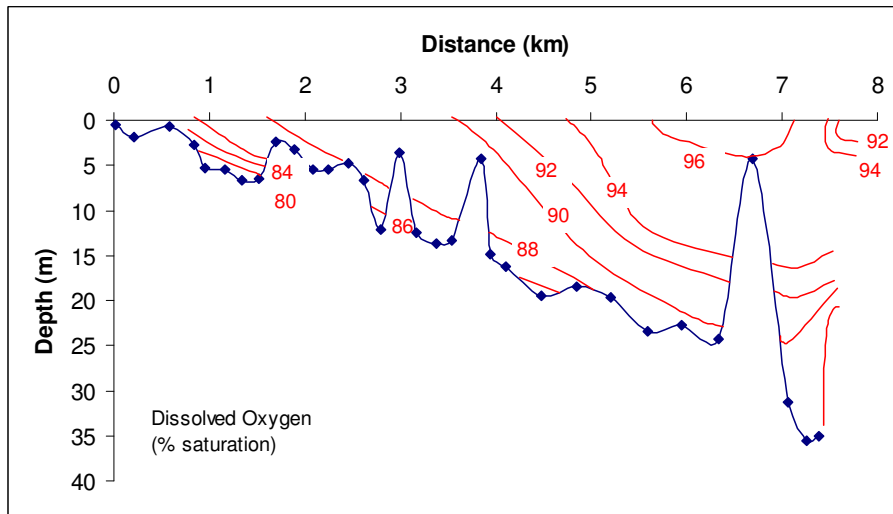
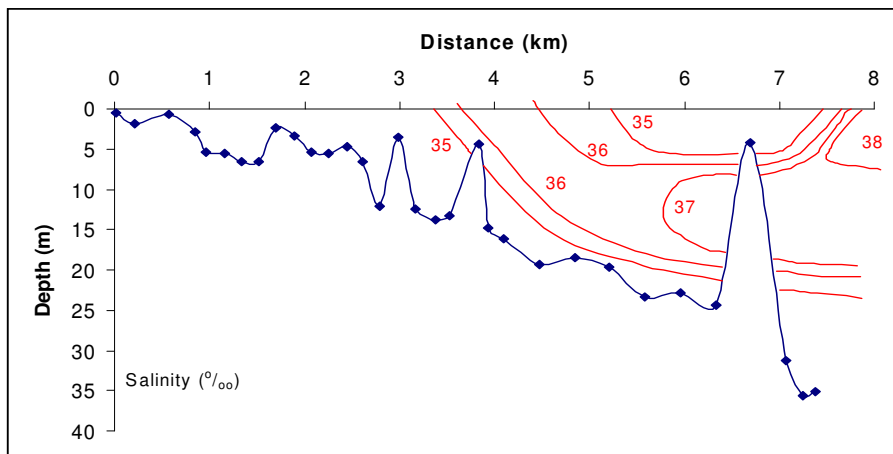
The three water quality variables measured in this survey show little horizontal or vertical change (Fig. 10). Temperature was highest at the inward end of the transect, where it reached

34°C, but at the mouth of the lagoon was only 2° cooler. Over the 30 m of water column sampled at the outer sites temperature varied only by 1°C. Within the lagoon there was no evidence of strong diel or longer term temperature stratification. Salinity also indicated no strong gradients within the lagoon and there was no evidence of pooling of lower salinity run-off water within the sites occupied. Warming of water would be expected in the shallow, sheltered part of the inner lagoon under the calm, sunny sampling conditions.

When combined with temperature, salinity shows evidence of discreet water masses at the entrance. A well oxygenated, warm and slightly lower salinity water mass was found floating just inside the lagoon and in the lagoon entrance passages, while outside the lagoon there was a shift to slightly cooler, more saline water at the surface. However, none of the water inside or immediately outside of the deep western part of the lagoon, in either water mass showed any major oxygen deficit.

Oxygen concentration was lowest at the head of the lagoon and tended to increase towards the entrance. However, the lowest oxygen concentration was still 80% of saturation, and this was in the narrowest, warmest and most sheltered part of the lagoon, close to the highly reducing sediments of the fringing mangrove forest, and is not indicative of a severe water quality problem. Nowhere in the deeper western part of the lagoon was there any evidence for an alarming oxygen deficit.

Figure 10. Aspects of water quality in the Rarumana Lagoon along the longitudinal section R-T (inner to outer lagoon). The top figure shows dissolved oxygen concentration as % saturation, middle panel water temperature and lower salinity.

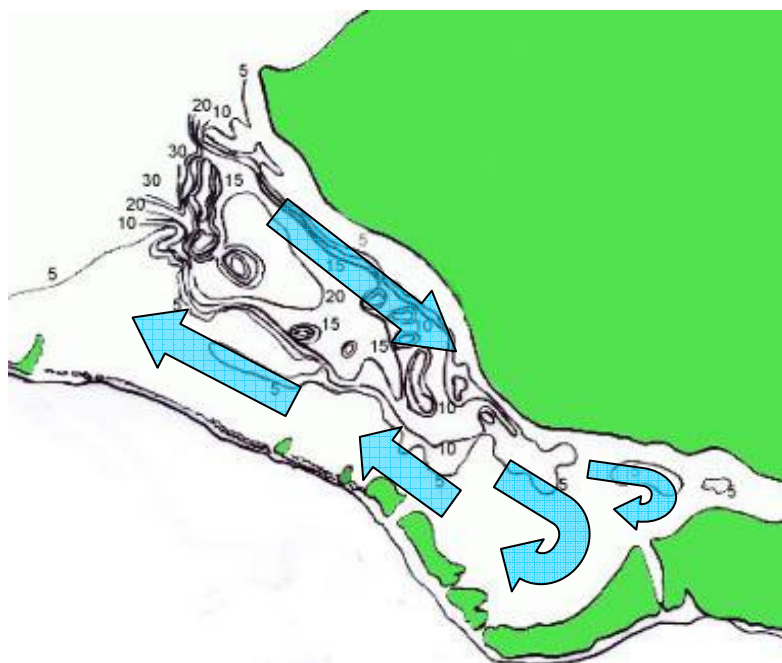
Prevailing SE and NW winds would both be expected to set up a general clockwise rotation within the lagoon (Fig. 11). Surface tidal currents entering the lagoon over the southern reef prior to uplift would have tended to drift to the left under Coriolis Effect and join the NW flowing current along that shore, while outflowing currents at ebbing tide would have tended to drain water from that current. Shallow water flowing in and out over the reef prior to the uplift

Figure 11. Likely general wind-induced surface currents within the lagoon under current conditions. These would be modified by tidally induced currents (see text).
