Nutrient Levels and Macro-Algal Outbreaks in Fiji's Coastal Water.

IAS TECHNICAL REPORT NUMBER: 2005/01

**Nutrient levels and macro-algal outbreaks in Fiji's coastal water**

Luke Mosley and Bill Aalbersberg

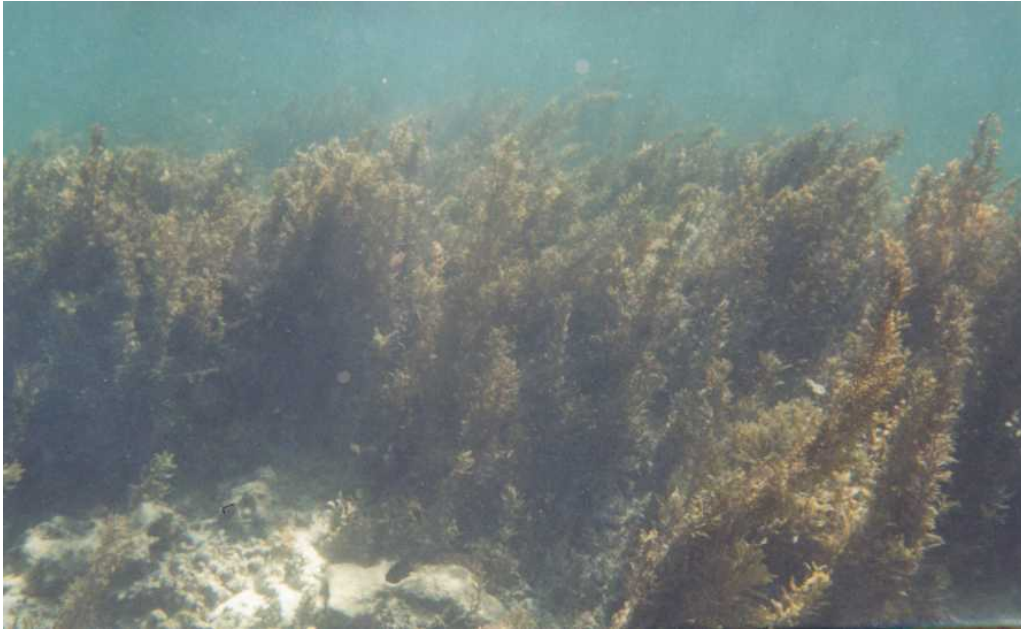
**Fig. 2: *Sargassum* smothering back reef area at Qalito Back Reef (1-2 m depth)**

In the course of our nutrient sampling we made several qualitative observations of reef health, which given the lack of more rigorous long-term biological monitoring data, we outline below. On the Coral Coast, high levels of algae, dominated by *Sargassum* sp. as well as other species such as *Turbinaria ornata*, *Padina* sp., *Gracilaria maramae*, *Dictyota* sp. and *Enteromorpha flexuosa* are currently found in the back reef and lagoonal areas at many locations. In some locations, notably those in the vicinity of sewage inputs, *Sargassum* sp. have obtained almost complete coverage of the inner reef flat, and are particularly abundant on dead or dying coral heads (Figs. 2 and 3). Earlier reports from unimpacted reef sites on the Coral Coast noted that *Sargassum* sp. was dominant only on a narrow band on the seaward edge of the reef summit and was close-growing (Morton and Raj, 1980), although it was noted at a few sites near large tourist hotels with increased sediment and nutrient inputs that *Sargassum* sp. was present at high levels close to the shoreline (Raj *et al.* 1981; Gawel and Seeto, 1982). Recently (last 5-10 years), the *Sargassum* and other algal species appear to have greatly increased in range and severity. Although algal species are more dominant and larger at sites receiving direct nutrient inputs from septic tank and sewage discharges, high levels of algae are also present in areas not obviously affected by nutrient discharges. At sites we revisited from earlier reports (Morton and Raj, 1980) we have observed a great loss of coral diversity. For example, we resurveyed the Korolevu reef platform and found few living corals (<10%, mainly *Porites* sp.) whereas Morton and Raj (1980) noted a wide variety of coral species dominated by large table species (*Porites* sp., *Millepora* sp., faviids, *Symphyllia* sp., *Galaxea* sp.) and sub-canopy species (e.g. several *Acropora* sp., several *Pavona* sp., *Merulina ampliata*, *Fungia fungites*, *Echinopora horrida*, *Hydnopora mayeri*, *Acrhelia horrescens*, *Turbinaria peltata*). Instead what we found was large canopy species were mostly bleached and covered in algae (Fig. 4), high levels of coral rubble substrate and algae were present (Fig. 5), and sub-canopy coral species were

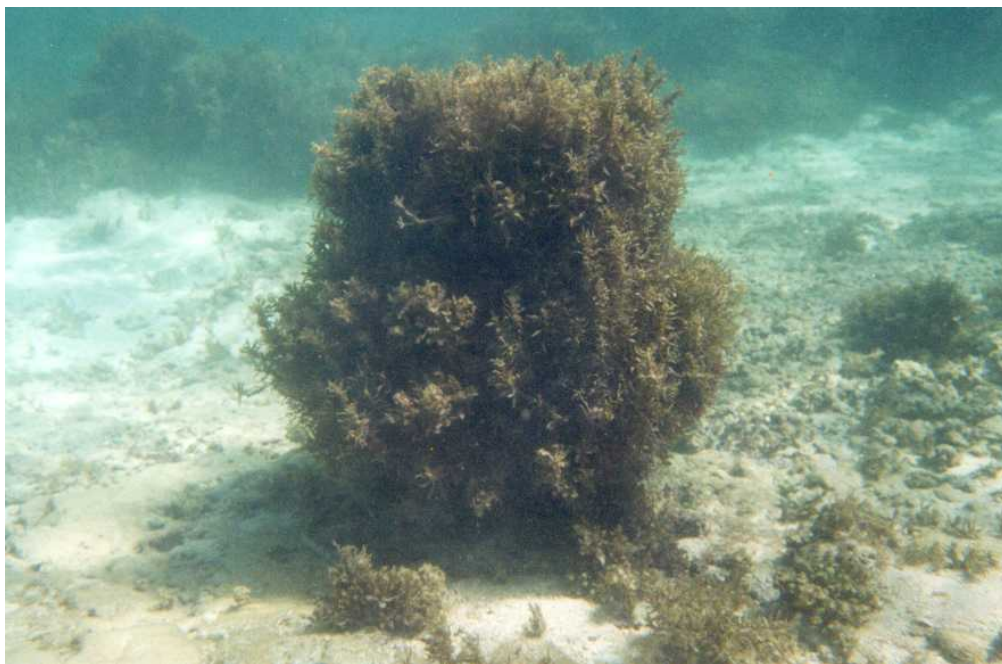
**Fig. 3: Algal overgrowth (*Sargassum* sp.) on a *Porites* sp. coral head at a back reef site.**

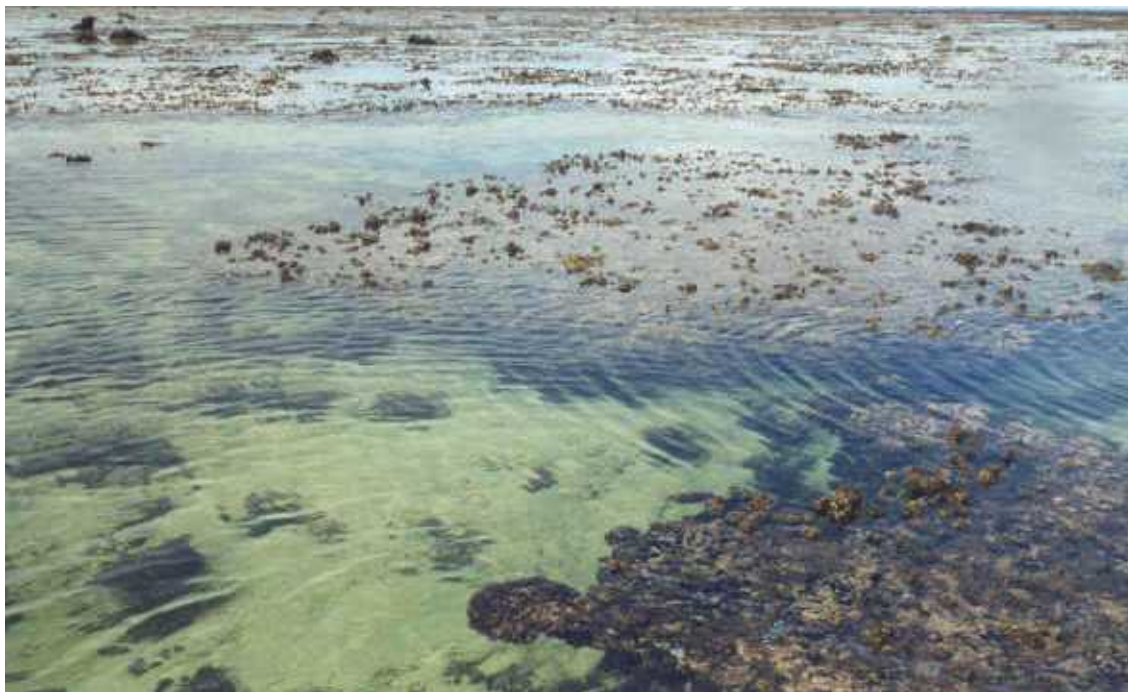
**Fig. 4: Channels in the inner-reef flat near Korolevu showing algal coverage extending over mostly dead coral surfaces.**

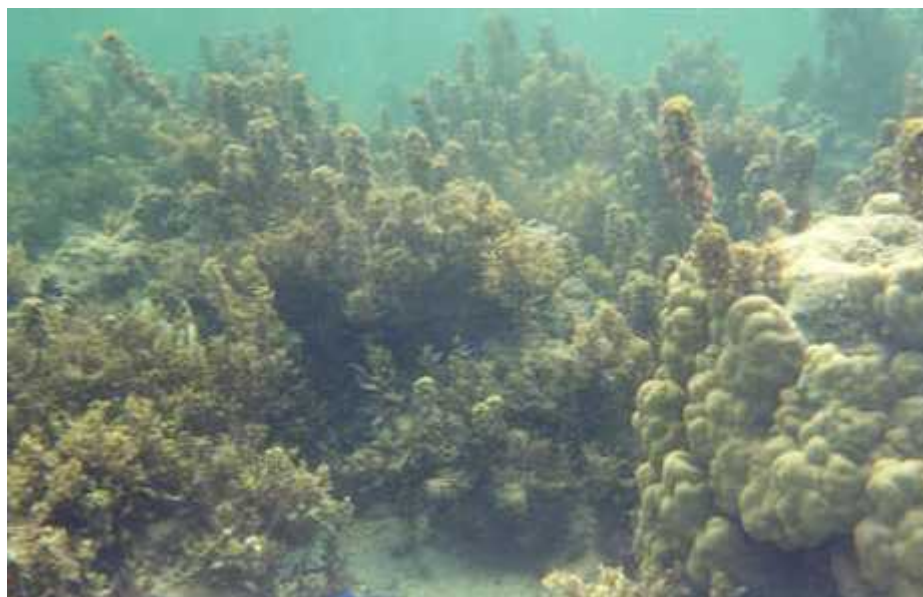
**Fig. 5: *Turbinaria* and *Sargassum* sp. on the inner reef flat at Korolevu Reef Platform**

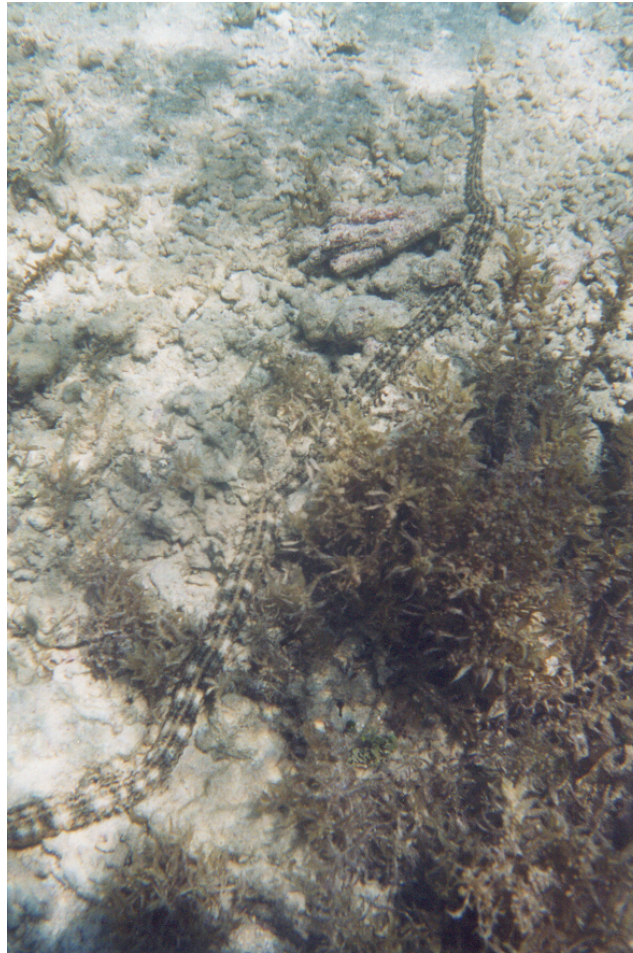
**Fig. 6: A synaptid grazing at a site dominated by *Sargassum* sp. with large amounts of coral rubble.**

nearly non-existent. Some herbivore species are present (see Fig. 6) but others (e.g sea urchins, *cawaki*) appear to be sparse, except in marine protected (*tabu*) areas.

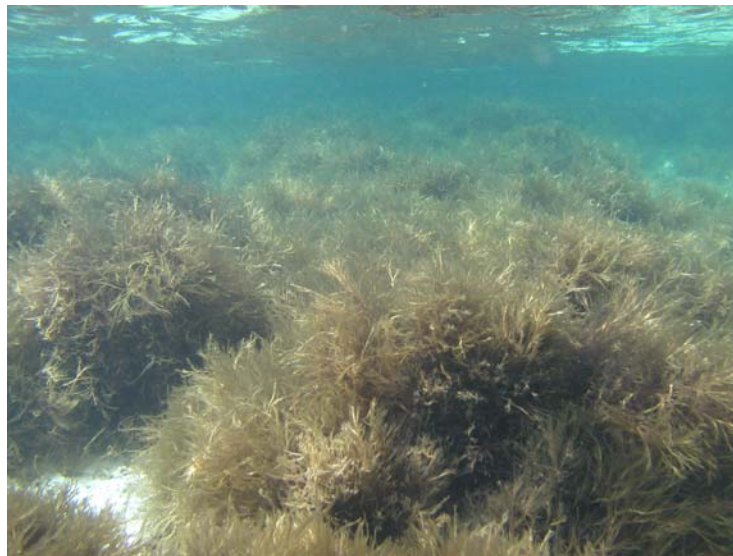
**Fig. 7: Algae (*Gracilaria* sp.) growing on a reef flat nearby to a resort**

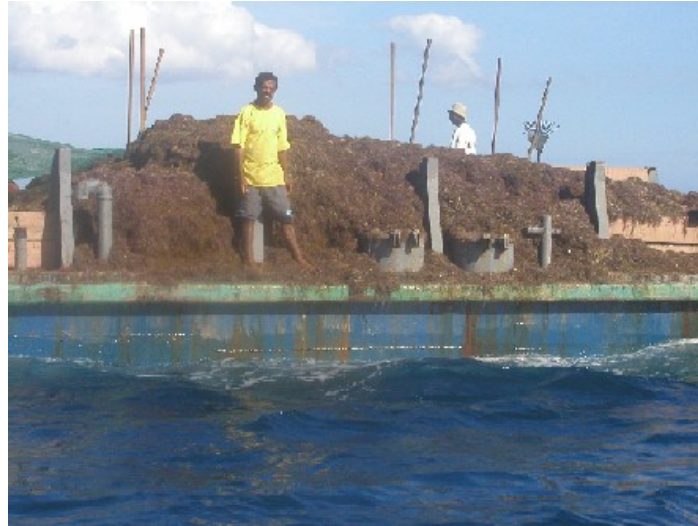
**Fig. 9: Algae (*Gracilaria* sp.) having to be barged and dumped from a resort after it collects and decomposes on their beach presenting an unattractive sight and smell**

3. More marine protected (*tabu*) sites should be established and tighter controls put on the taking of undersize fish.
4. Resorts that currently collect and dump and/or bury algae that washes up on their beaches should try and find alternative means of disposal. This might include contained composting on land, possible use for agar manufacture, and if marine disposal is necessary, do so far away (several km) from any island. The problem with burying or dumping waste is that the nutrients within the algae are eventually released when the algae decompose. They are then released back into the water and cause the problem to re-occur by stimulating more algal growth.
