**A REVIEW OF COASTAL PROCESSES AND
ANALYSIS OF HISTORICAL COASTAL CHANGE IN THE
VICINITY OF APIA, WESTERN SAMOA**

Steve M. Solomon*
Geological Survey of Canada

June 1994

SOPAC Technical Report 208

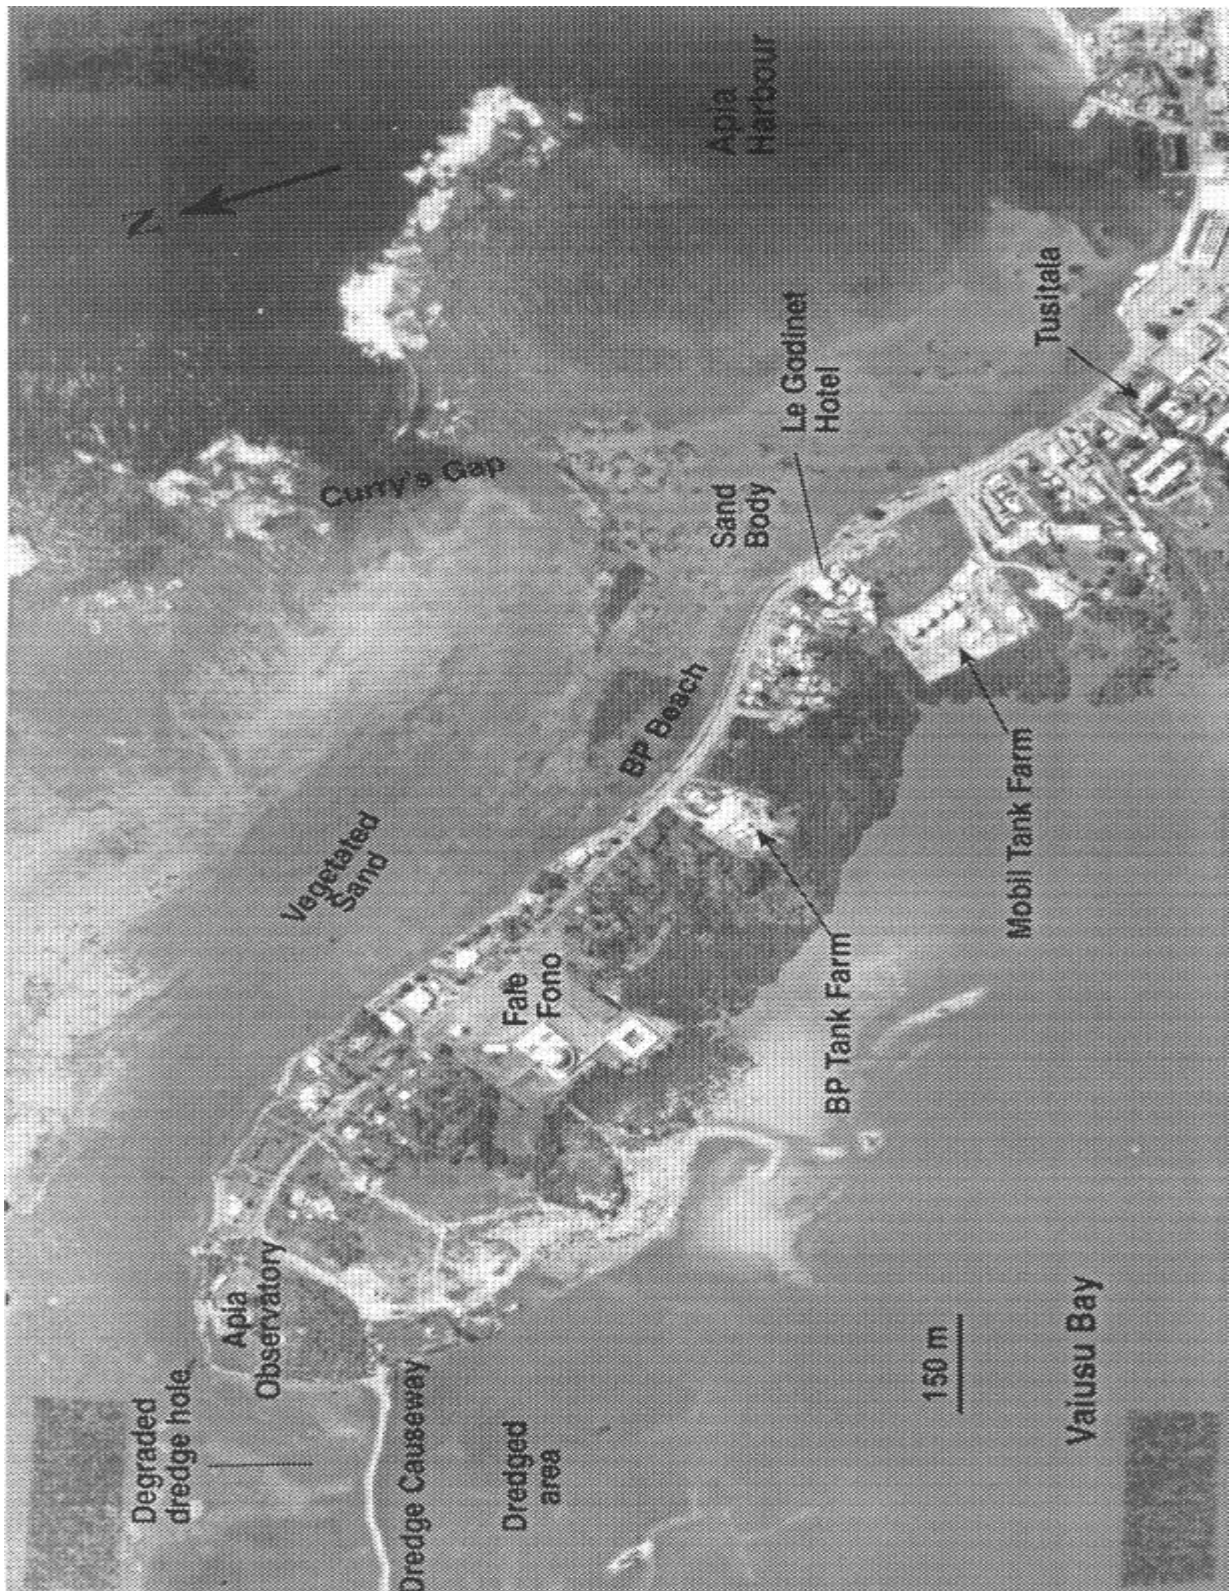
Figure 3. Air Photo of the Mulinu'u Peninsula taken in 1992 showing place names referred to in the text.

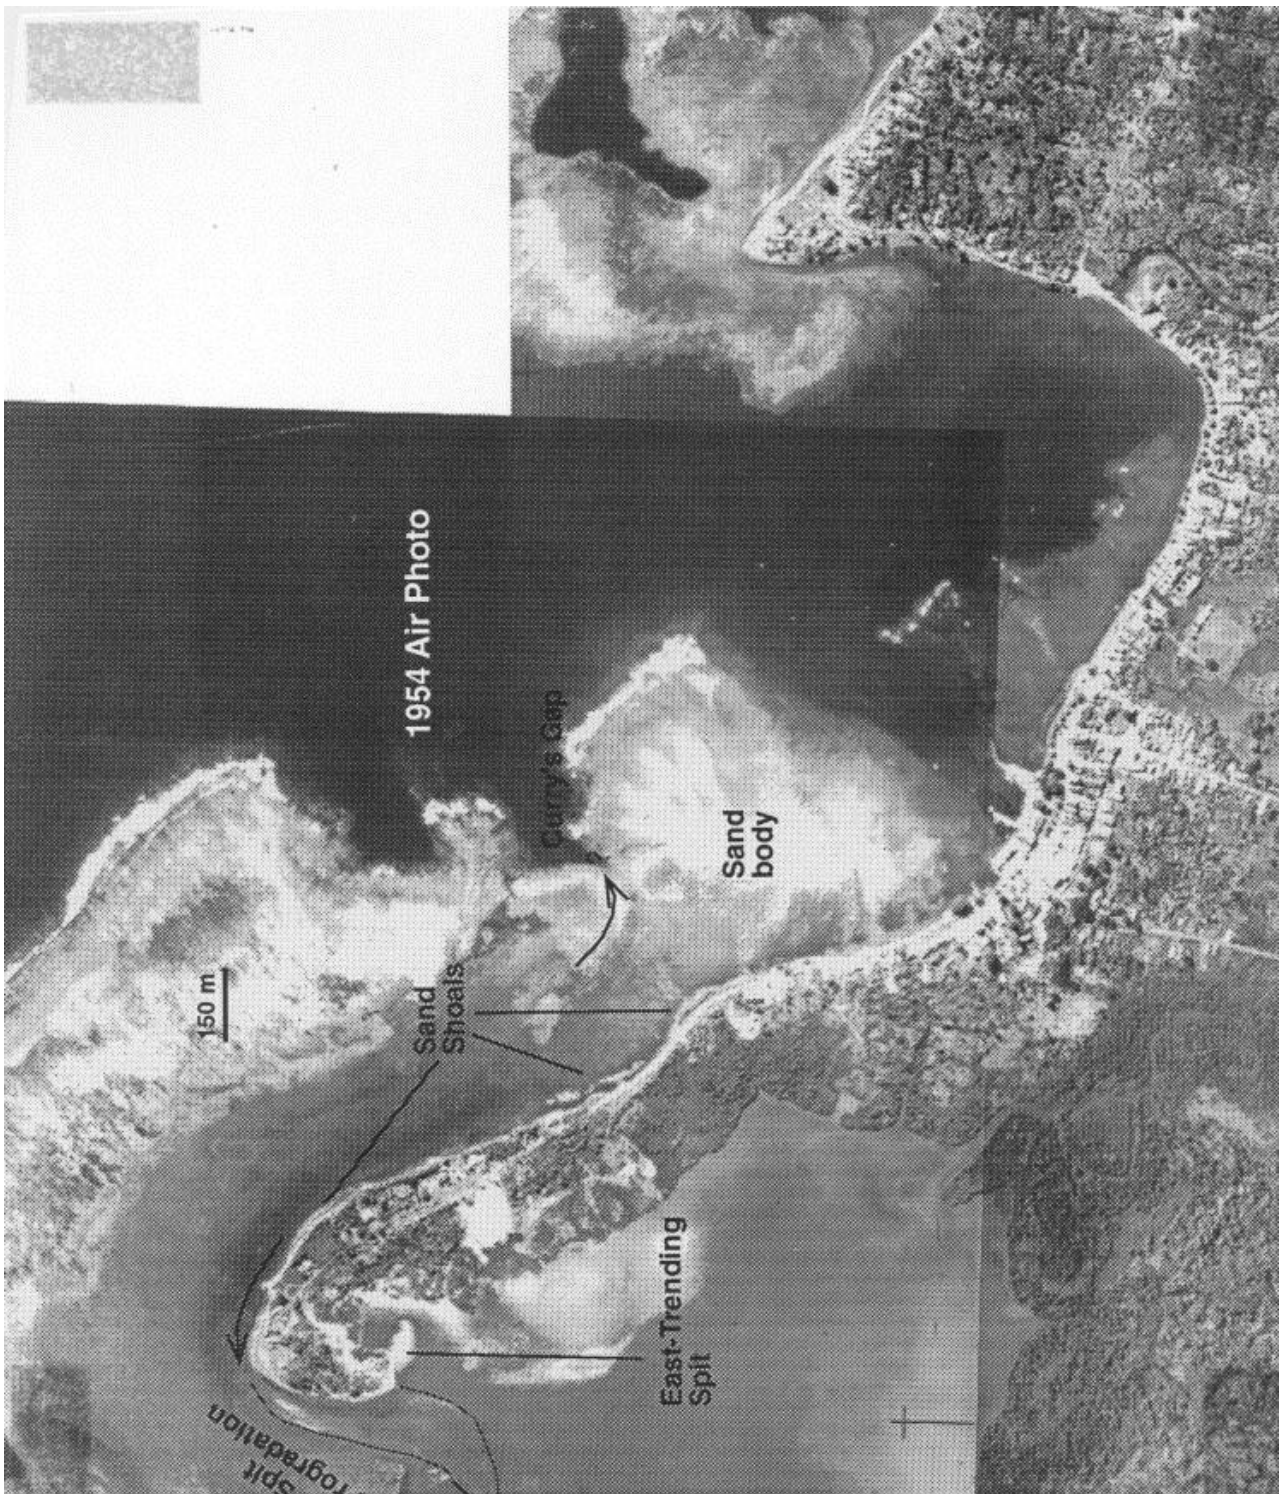
Figure 8. 1954 air photo of the study area.

On the southwestern side of the Peninsula, land reclamation was not yet extensive, however, it is difficult to ascertain how much of the natural spit form has been retained. As mentioned above there is a recurved portion of the spit which appears to be related to deposition of westerly directed longshore drift. In addition there is a easterly trending spit off the tip of the peninsula which may be caused by eastward flowing currents caused by less frequent north and west winds.

Port and land reclamation has not yet commenced in the Harbour at the time of the photography, however, several wharves are present off the area now occupied by the market. Although no sediment is seen accumulating against them, these wharves would have been an effective barrier to sediment movement alongshore from the east (e.g. from the Vaisagano and Mulivai Rivers). Much of the harbour appears to be protected by either vertical seawalls or rubble revetments.

It is interesting to note the presence of a Mulinu'u-type of spit developed at Moata'a. In this case, the lagoon is virtually filled and protected from the easterly winds by the barrier spit. As in the case of the Mulinu'u Peninsula, the source of the spit is not an eroding headland. The source appears to be a combination of erosion of an east facing coast further to the south, and sand derived from the reef flat. It would be interesting to compare the composition of the spit material to the Mulinu'u Peninsula.

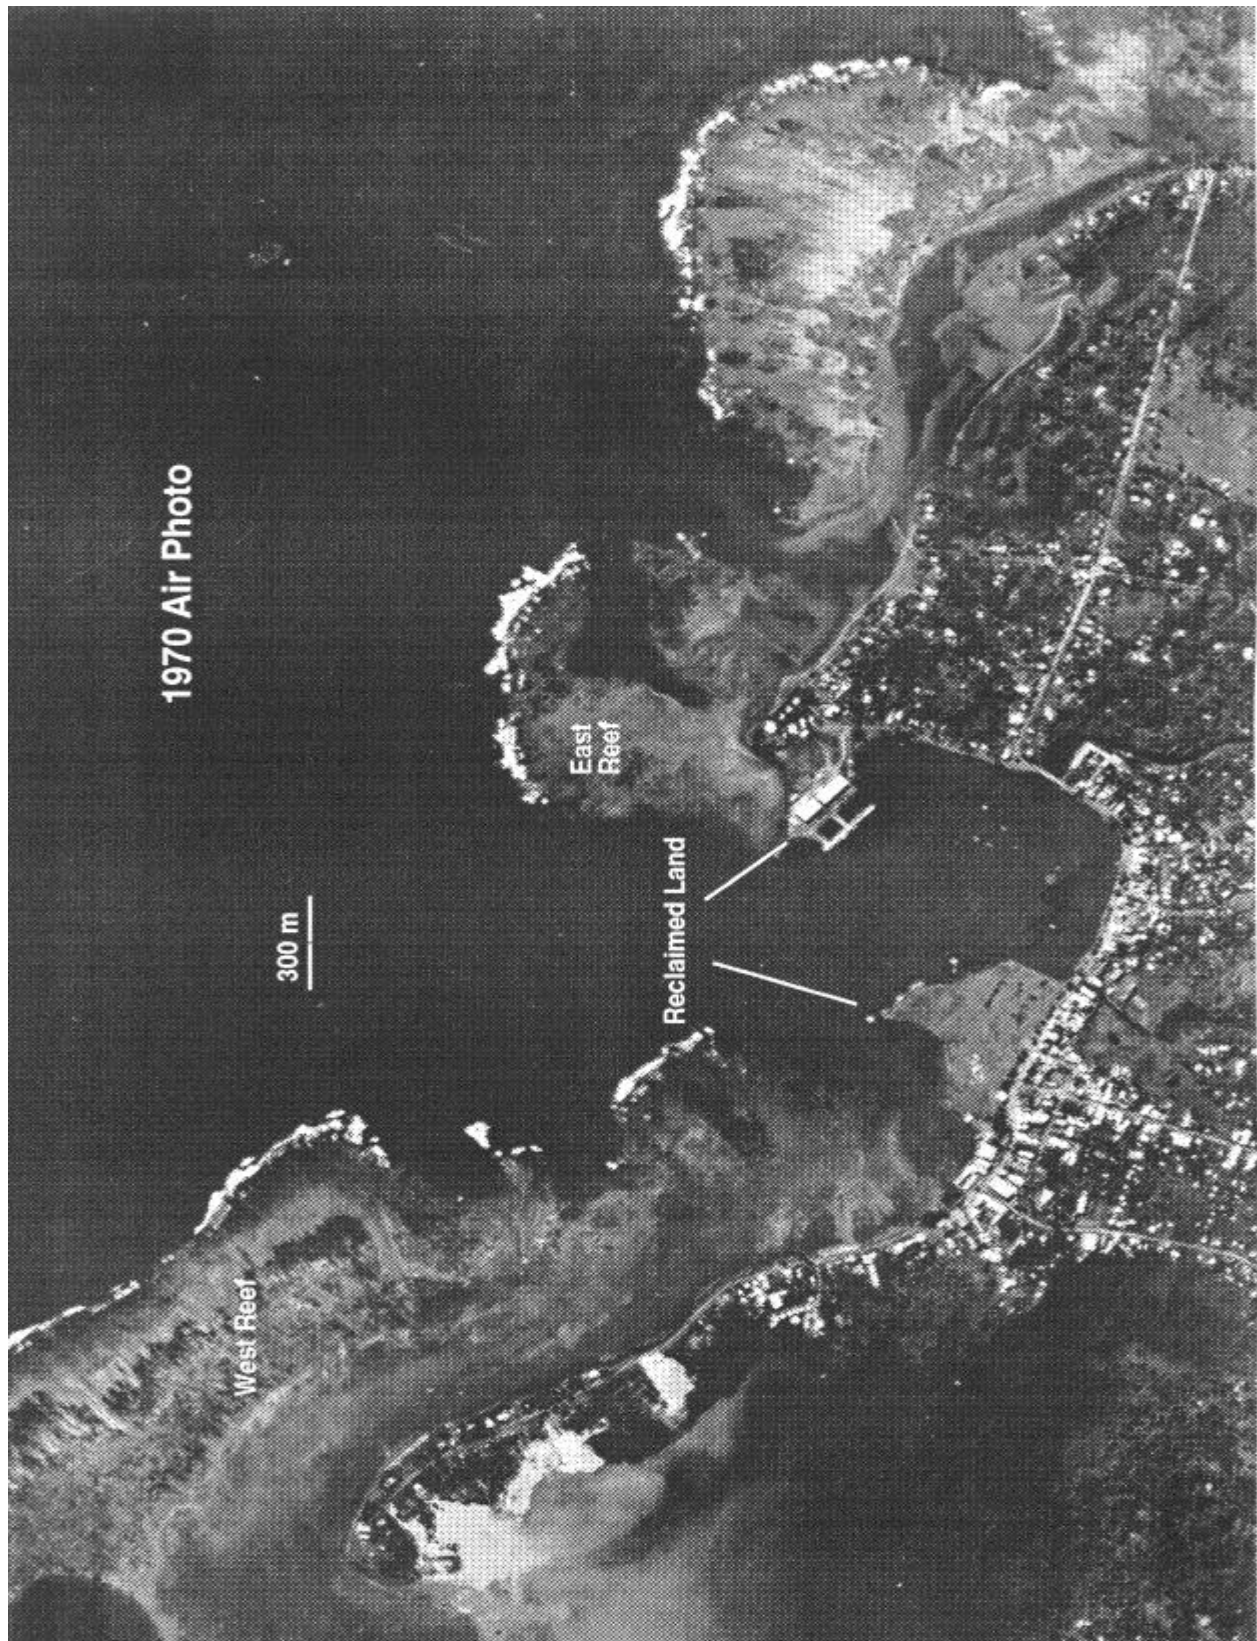
Figure 9. 1970 air photo of the study area.

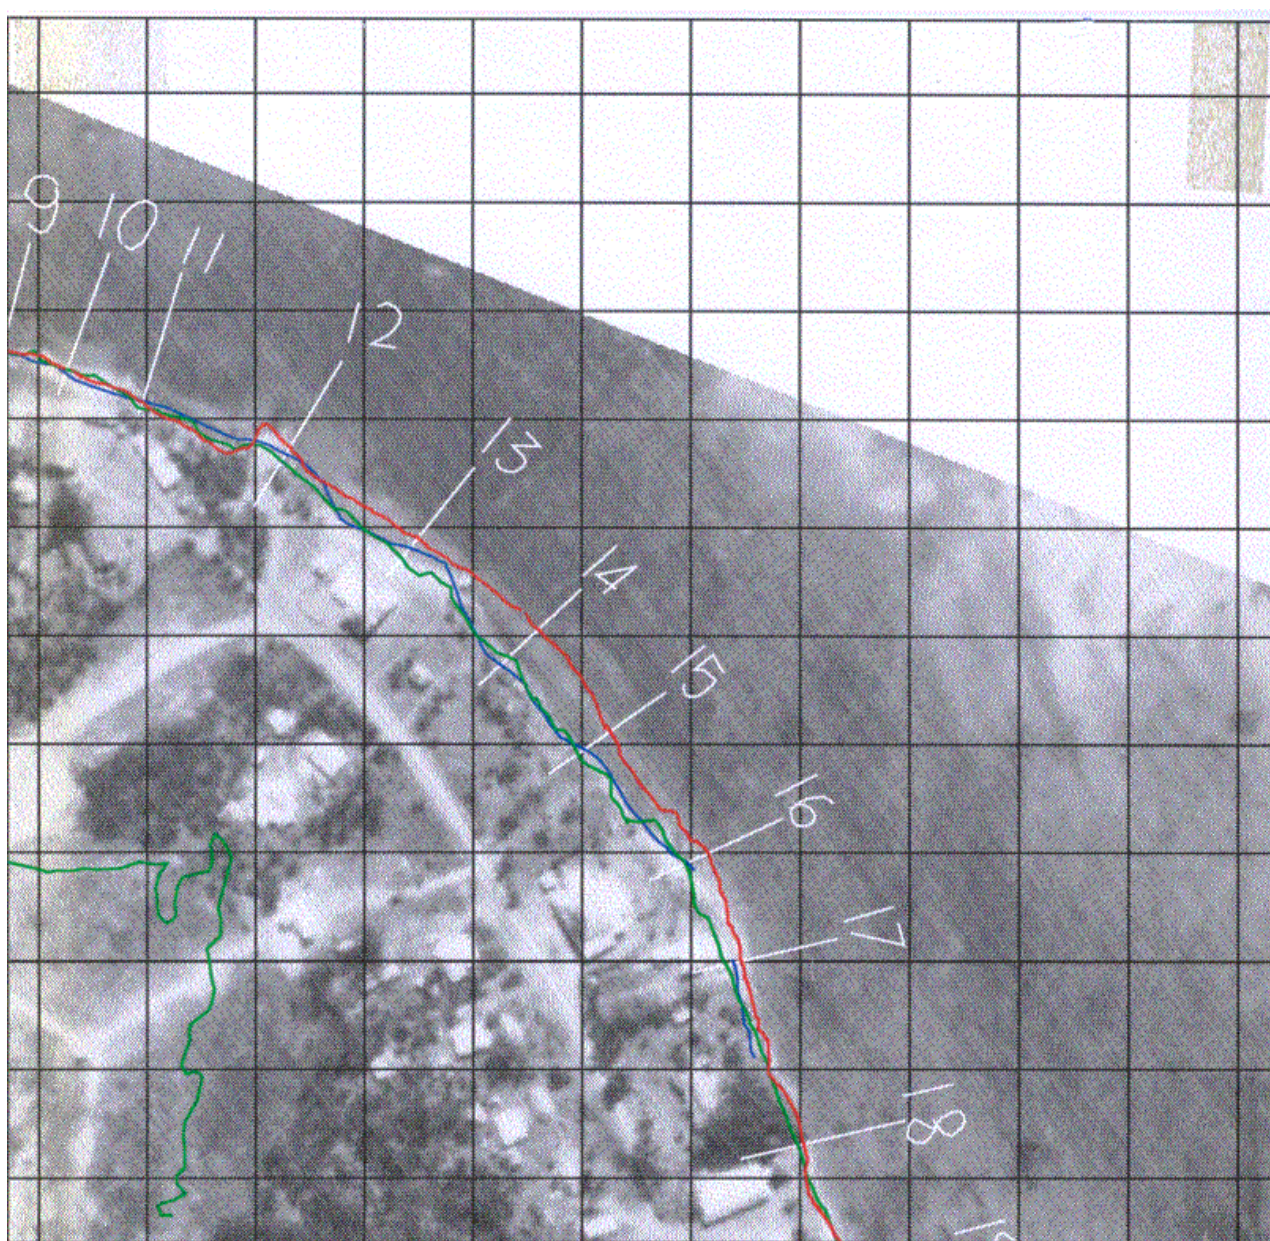
Figure 15. Shorelines at site D on the Mulinu'u Peninsula based on vegetation for the years 1954 (red), 1970 (green), 1980 (blue) superimposed on the 1990 air photo. The gridlines are 50 m apart. The measurement transects are illustrated in white.

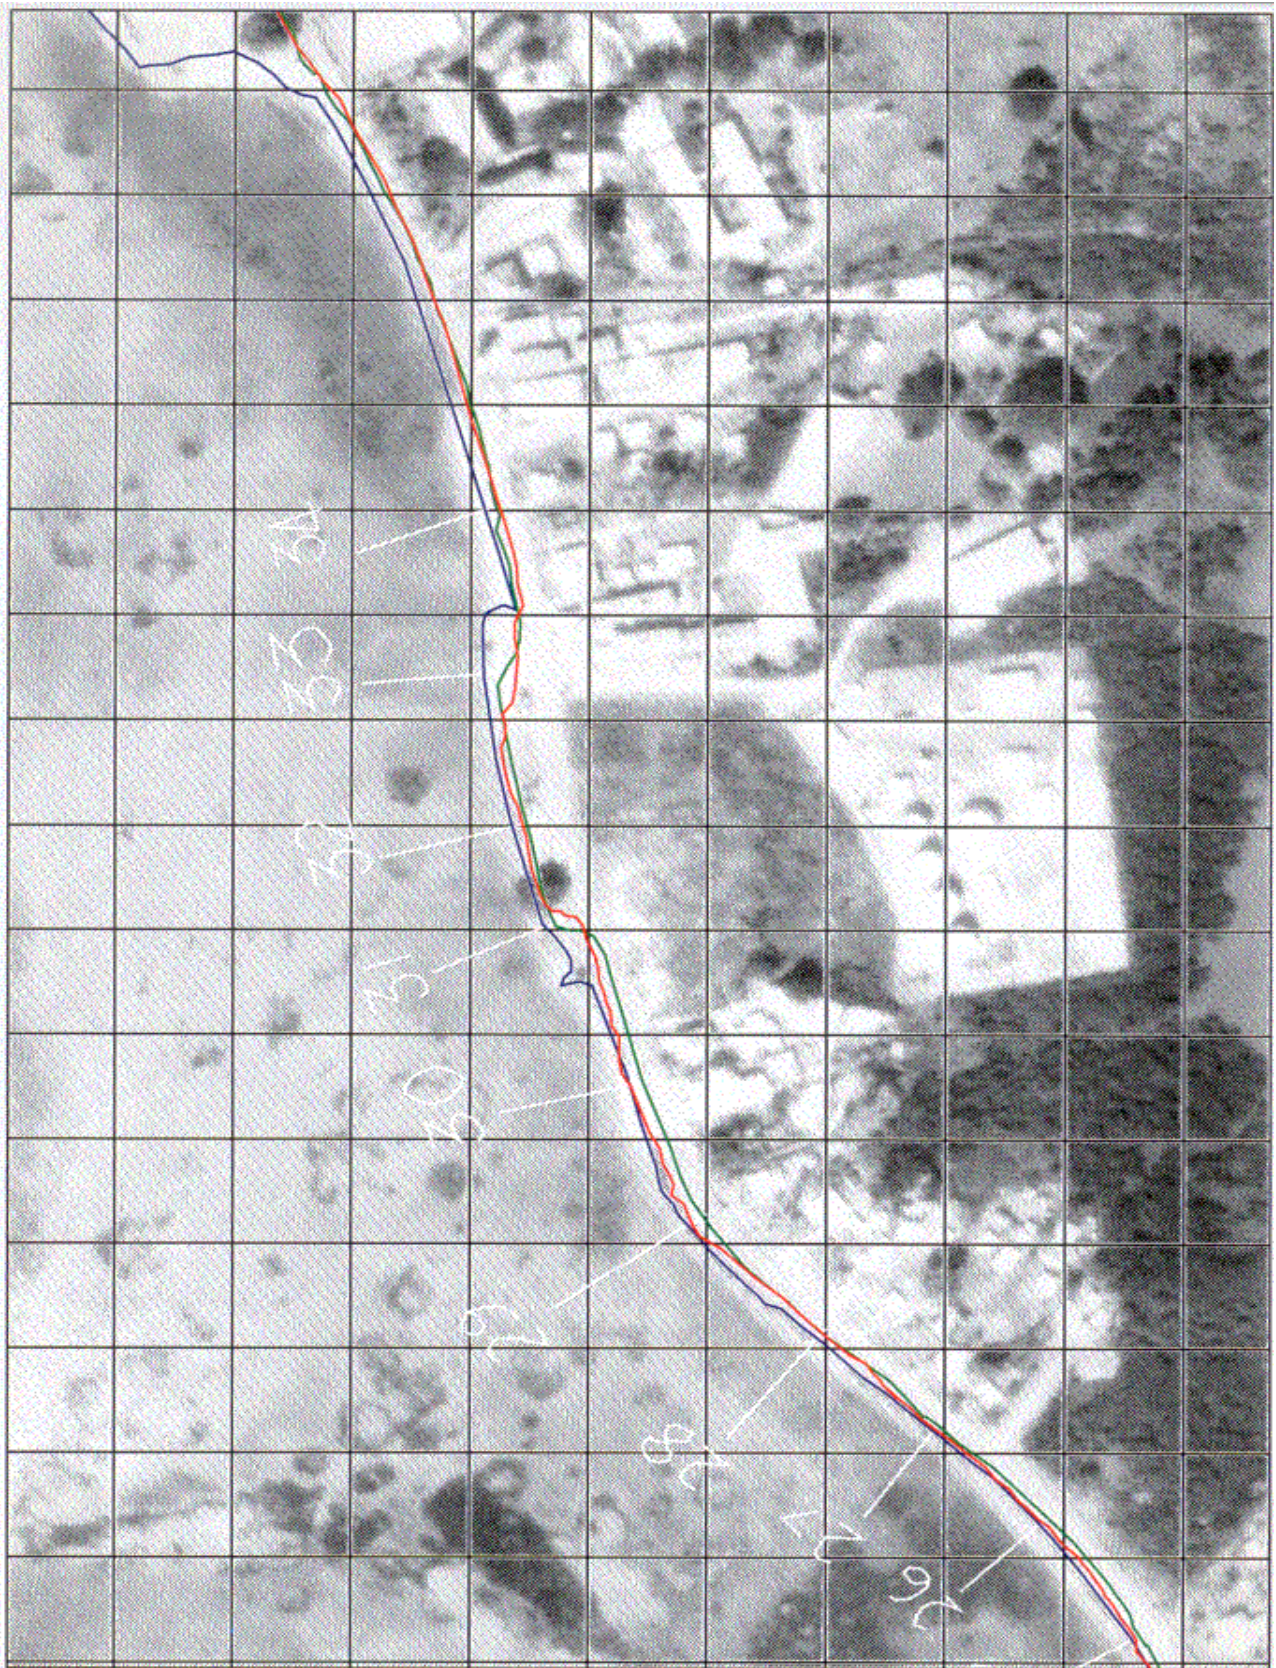
Figure 17. Shorelines at sites F, G, and H on the Mulinu'u Peninsula based on vegetation for the years 1954 (red), 1970 (green), 1980 (blue) superimposed on the 1990 air photo. The gridlines are 50 m apart. The measurement transects are illustrated in white.
