**Coastal Management Adaptation to Climate Change  
using Ecosystem-based Adaptation Strategies  
(Samoa Component)**

Prepared for  
the Secretariat of the Pacific Regional Environment Programme (SPREP)  
by

Courtney Schupp  
13 January 2014

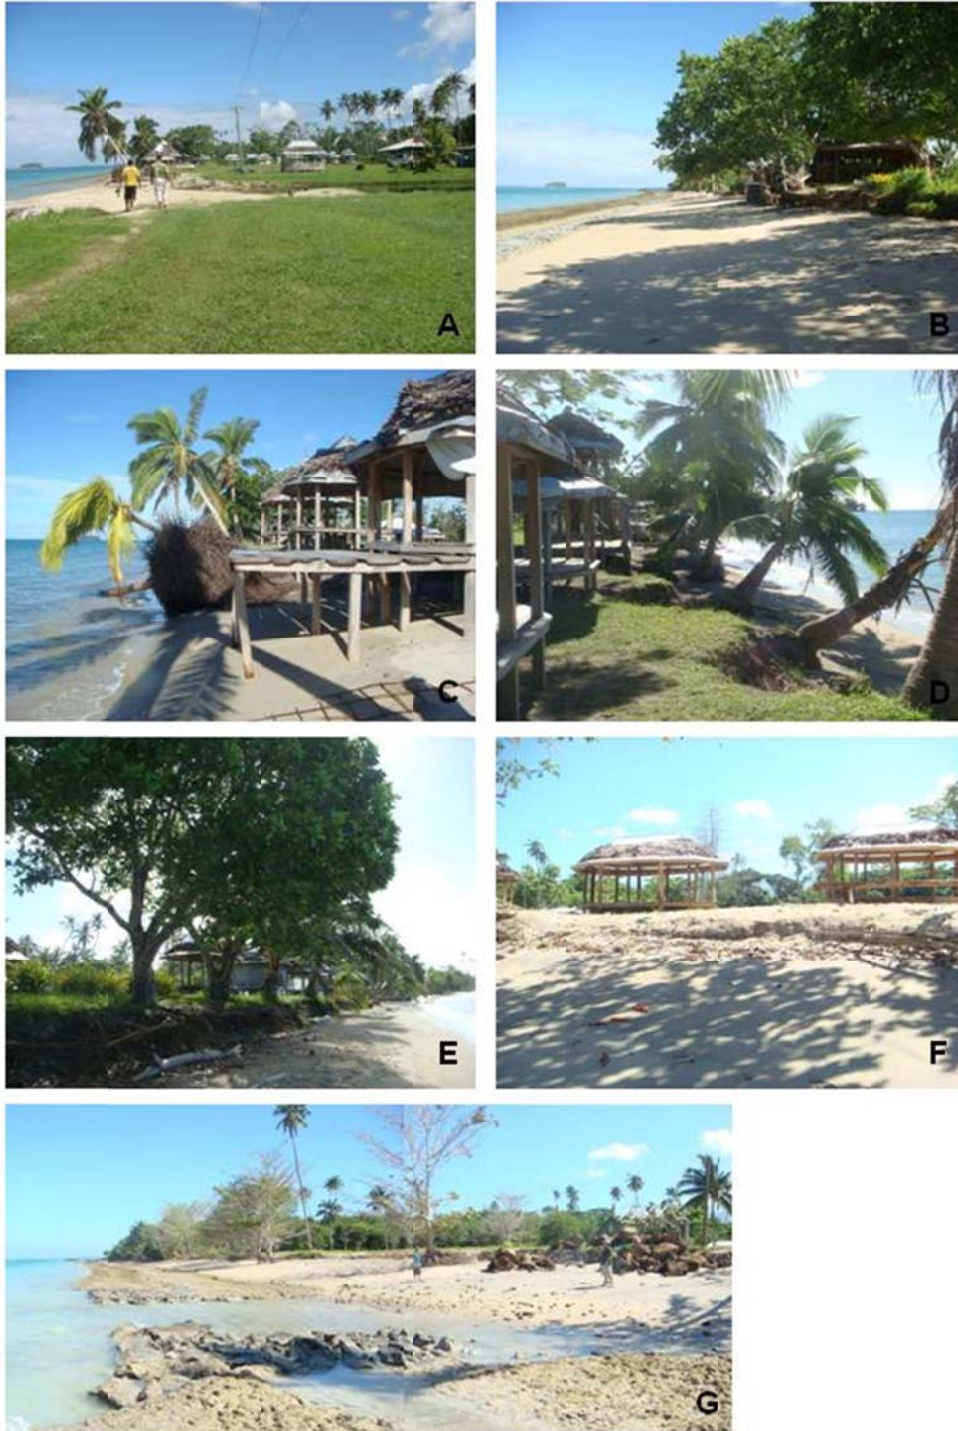
Figure 4. A) The site includes visitor-use open fales, larger enclosed fales including the landowner's home, and toilet and shower blocks, and the main fale in which the landowner and his family live. Vaiula River mouth (now closed by sand) is in the foreground, with ponding evident. B) The line of beachrock is particularly close to the beach at this site. C) Waves wash underneath some fales. D) Other fales sit along an eroding sand bank lined by coconut and E) fetau trees. F) The adjacent property is eroding following removal of trees and other vegetation. G) To mitigate erosion following removal of beachrock at a nearby property, rocks have been piled along the eroding bank.

roots of fetau (*Calophyllum inophyllum*) and talie (*Terminalia catappa*) trees had been exposed (Figures 4C, 4D, 4E).

After heavy rains in 2012 connected the Vaiula River to the ocean, the landowner filled the river mouth with boulders and sand to restore vehicle access. This action caused water to pond (Figure 4A) and reduced the sediment contribution to the nearshore. Future river openings will likely wash some of these boulders out into the ocean, where they could damage the reef.

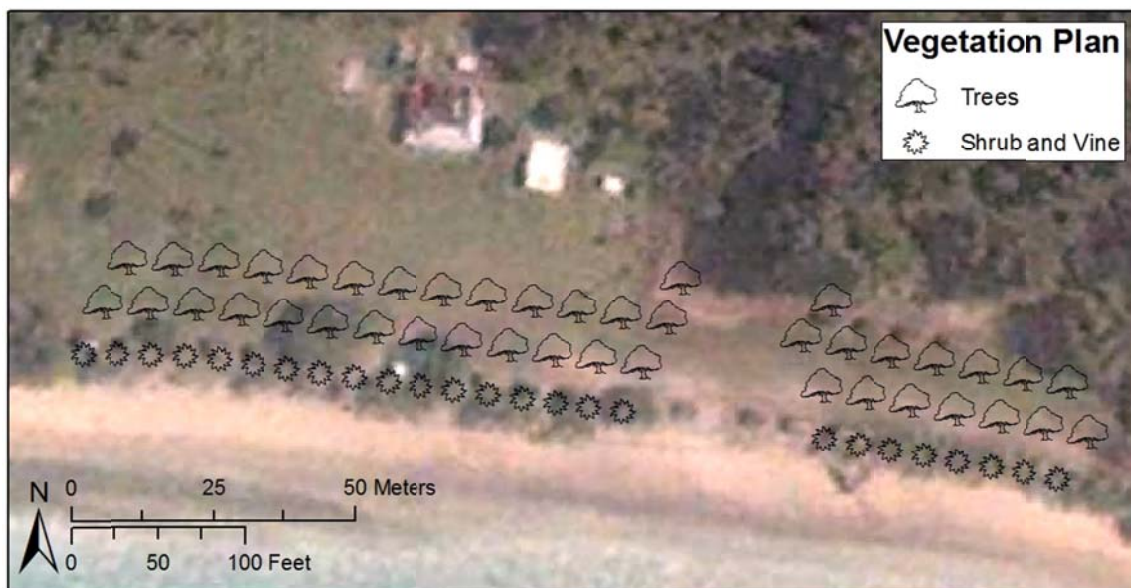
Figure 5. The site restoration plan calls for shrubs, vines, and coconut trees to be planted along the eroding bank, and for tree seedlings to be planted behind the existing fale locations. Photo of conditions on 27 January 2010 from Google Earth (2013).

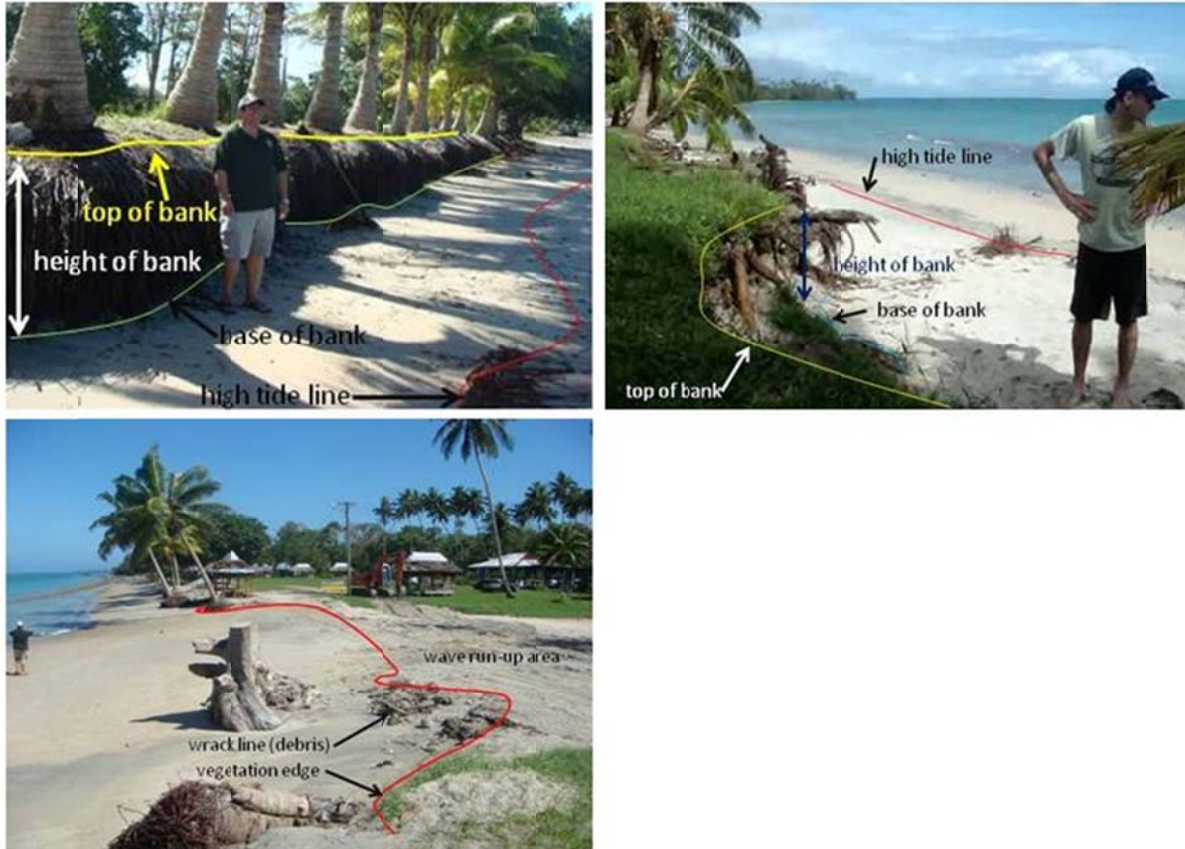
Figure 8. Several characteristics assist in the identification of shoreline features including the top, base, and height of the eroding bank, and the normal high tide line as a proxy for shoreline position.

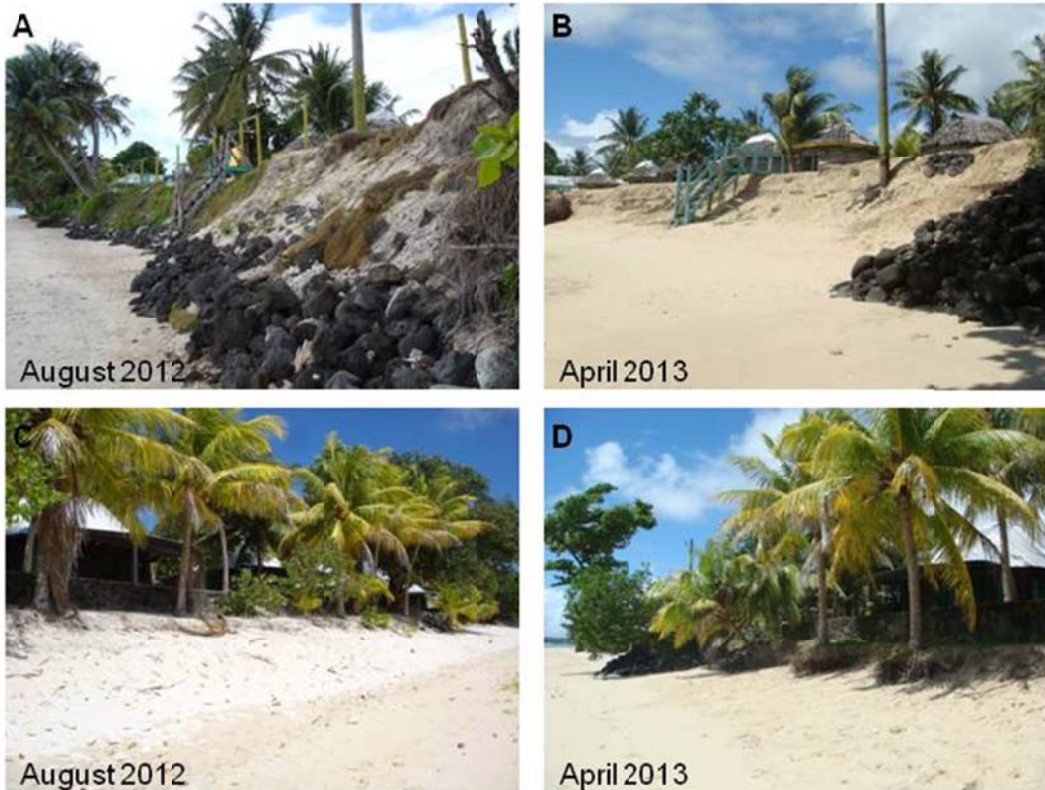
Figure 3. Erosion along the Manase shoreline is attributed to the December 2012 cyclone, as evidenced by these photos taken before (August 2012) and after (April 2013) the impacts at Tanu Fales (A, B, looking eastward) and Stevensons Resort (C looking westward, D looking eastward).

Cyclone Evan, which hit Samoa in December 2012, is widely blamed as the cause of recent severe erosion along the Samoa coast (Figure 3), although some sand appears to have returned to the beach during early 2013 (personal communication, Trevor Stevenson, Stevensons Resort, 17 April 2013). The resort manager's personal observations are that the beach has narrowed over the last ten years, and that the erosion rate has accelerated within the last few years (personal communication, Tuipolua Elizabeth Betham, Stevensons Resort, 23 April 2013). Previous cyclones have impacted this beach; in 1991, Cyclone Val destroyed a honeymoon suite and the small spit of land on which it had been built at the eastern end of the property (personal communication, Paul Anderson, SPREP, 2 May 2013, recounting his personal communication with Trevor Stevenson, 25 April 2013). An informal reconnaissance survey (i.e., mask and snorkel observation on 28 September 2013) revealed a subaqueous remnant of this land; it is composed of gravel and coral rubble, elongated in a cross-shore direction and separated from the beach by deeper water (personal communication, Paul Anderson, SPREP, 1 October 2013). This feature likely affects the local hydrodynamics by attenuating incident waves and perhaps by channelizing alongshore flow with the effect of accelerating the flow of water through the narrow channel; nearshore current measurements would need to be collected to verify this hypothesis. Another hypothesis is that the wave protection offered by this feature over the last decade has been diminishing as the feature degrades (personal communication, Dr. Doug Ramsay, NIWA, 4 October 2013).

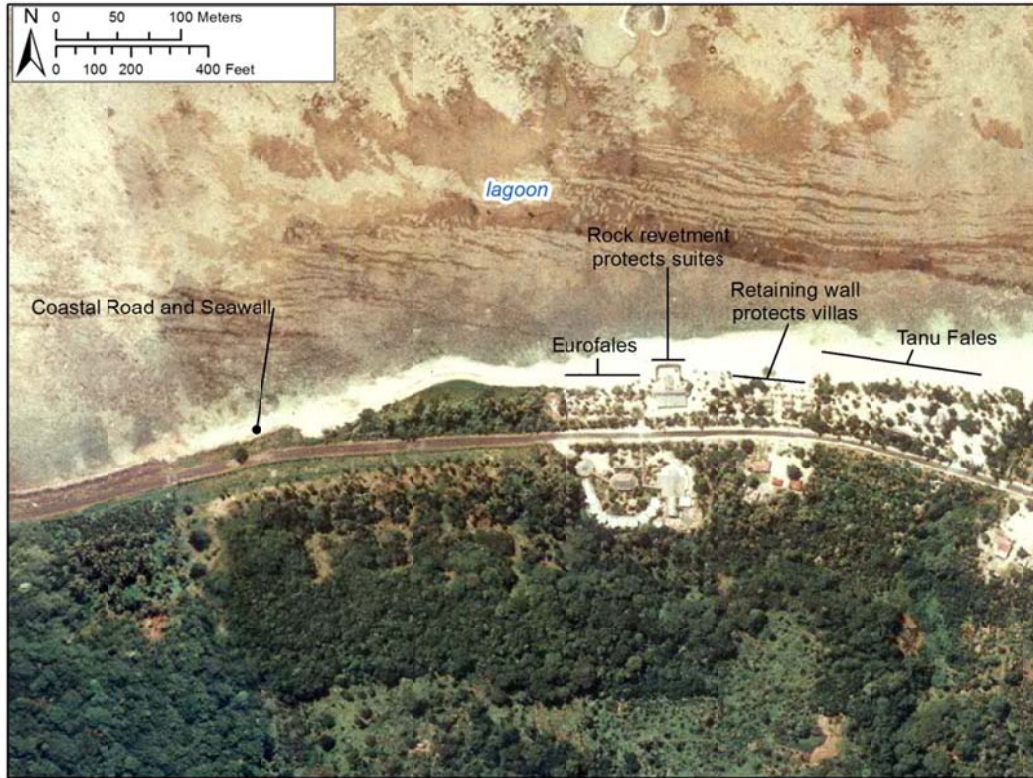
Figure 4. Structures at Stevensons Resort include Eurofales, new suites protected by an uncemented rock revetment, and older villas protected by a retaining wall and tree roots. The site is bounded to the west by a seawall that protects the coastal road, and to the east by another beach accommodation. Photo of ground conditions in 2004 courtesy of SPREP.

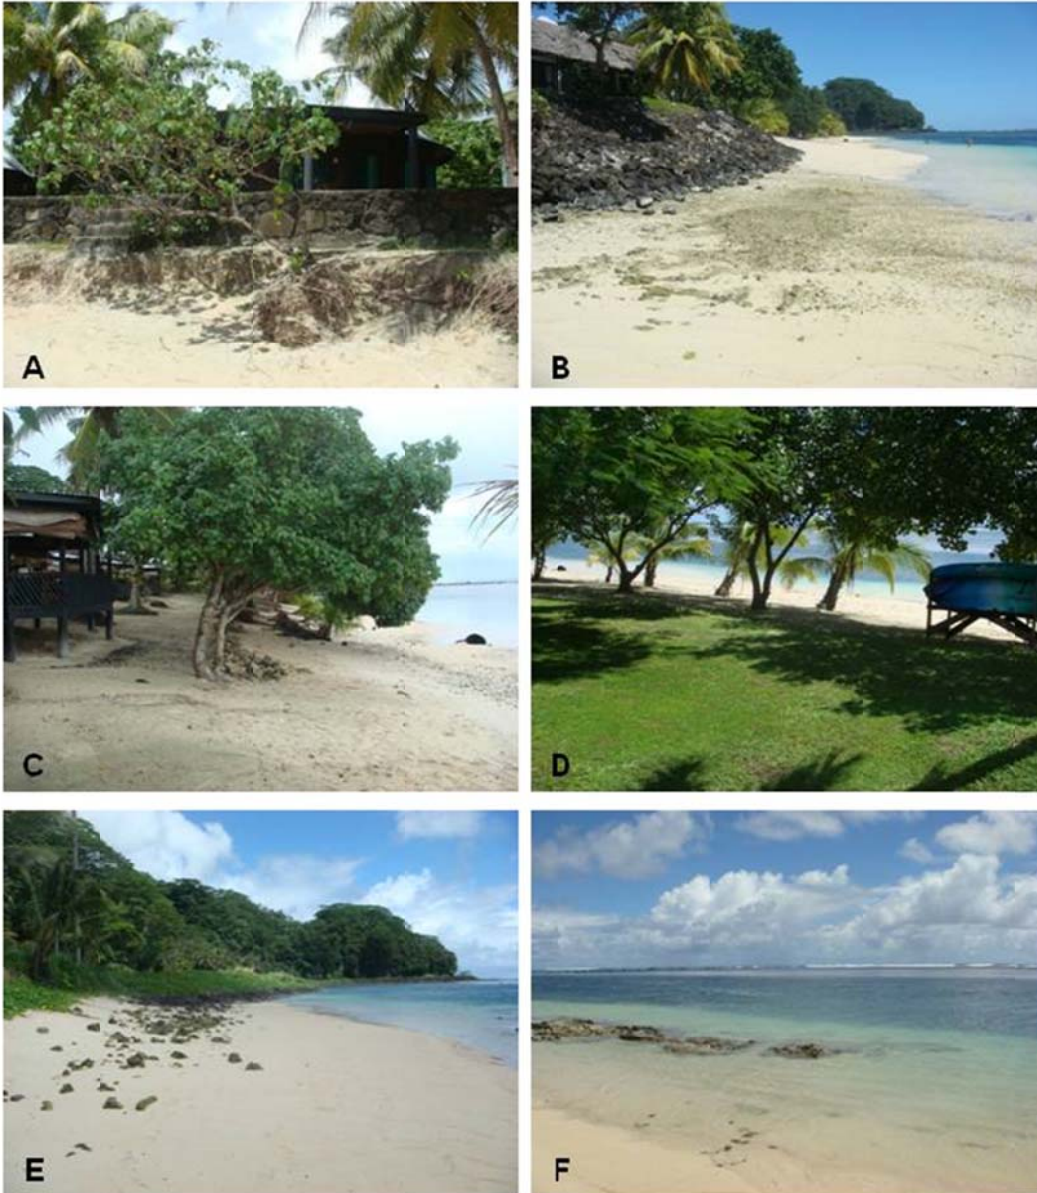
Figure 5. Site features as of April 2013. A) The villas are protected by a retaining wall and tree roots, which stabilize sediment but are being exposed by erosion. Concrete steps allow foot traffic to erode the upper beach. B) The rock revetment protecting new suites is uncemented, allowing large rocks to escape and damage coral. Freshwater flows from beneath the revetment. C) Eurofales are fronted by trees and open beach. D) On the western edge, the beach tapers to meet the seawall protecting the coastal road. The upper beach is covered by fue. E) West of the rock revetment, an open grass-covered lawn slopes gently to the beach, with no erosional scarp along the upper beach. F) Beachrock provides coastal protection, but is removed for aesthetic purposes.

Along the middle of the Stevensons Resort beach is an uncemented rock revetment built to protect new suites (Figure 5B). During the site visit on 26 April 2013, at low tide, freshwater was seen flowing in several places from beneath the revetment and across the beach into the ocean; at high tide, the ocean water covered the base of the revetment. Rocks often come loose from the mound and are replaced by staff when found. Some of these large rocks (up to 30 cm diameter) have migrated into the shallow ocean water, where they can damage live coral when strong waves move them; each of the loose submerged rocks was observed to be surrounded by broken coral debris.

The roots of fau trees that were planted along the Stevensons Resort coastline in 1996 have been exposed by beach erosion, but the root systems clearly play an important role in stabilizing the bank (Figure 5A). A line of coconut trees planted in front of the fau trees have also been impacted by erosion; most of the trees that have not yet fallen have exposed roots. The villas along the eastern side of the property have experienced settling and erosion, which has resulted in cracking of the foundation and some tiles (personal communication, Tuipoloa Elizabeth Betham, Stevensons Resort, 23 April 2013).

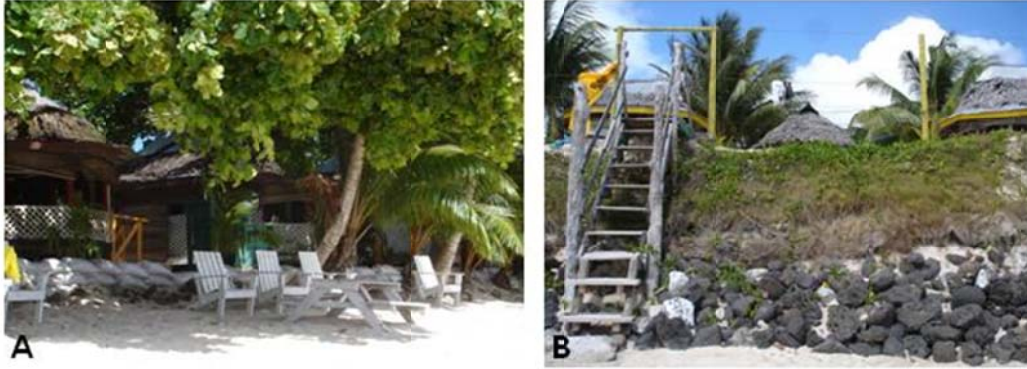
Figure 6. The Manase beach is impacted by hard-stabilization structures built to protect specific properties, including A) sandbags at Vacations Resort, towards the eastern end of Manase beach, and B) rock revetment at Tanu Fales, adjacent to the eastern edge of Stevensons Resort.

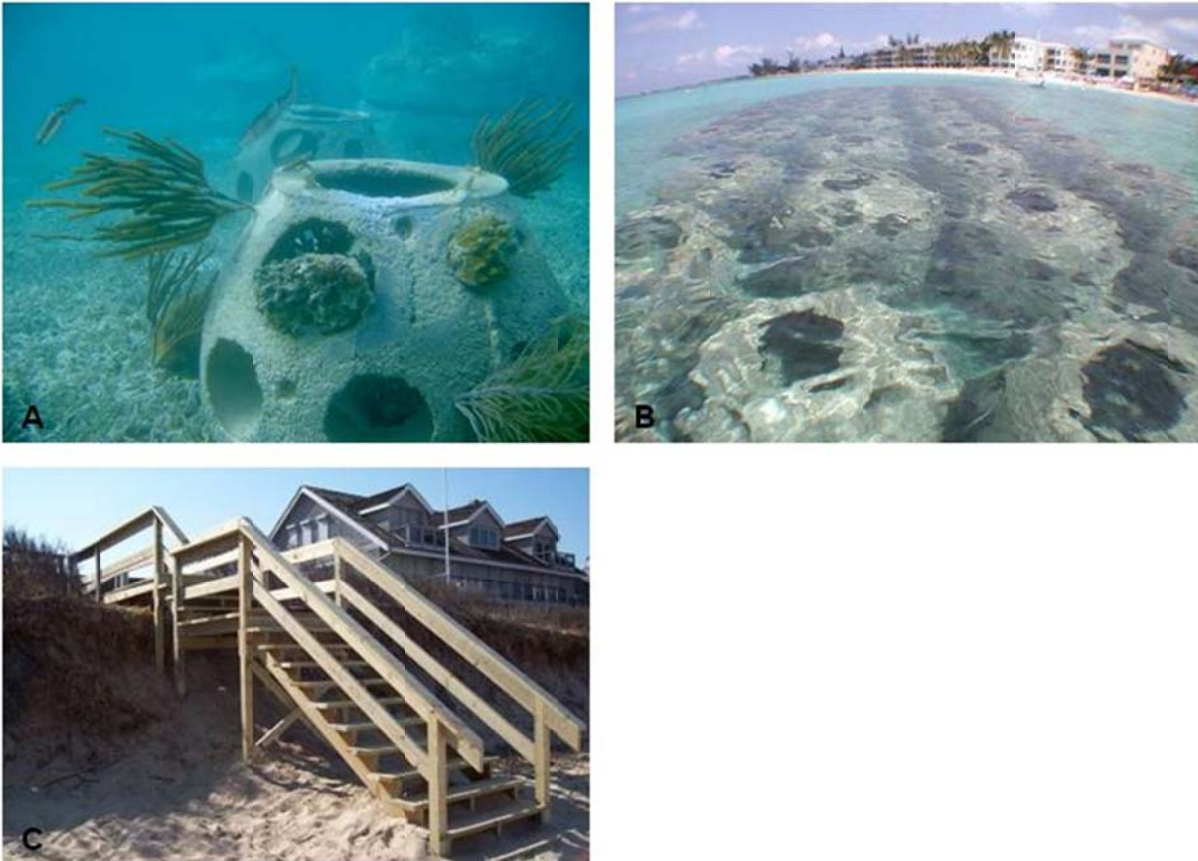
Figure 7. Alternatives considered included nearshore and beach structures including A) underwater reef balls that would provide marine habitat and B) as a group, would reduce incoming wave energy and associated shoreline erosion, and C) stairways that would reduce foot traffic and associated sediment loss on the upper beach. Photos of reef balls from Harris (2009).

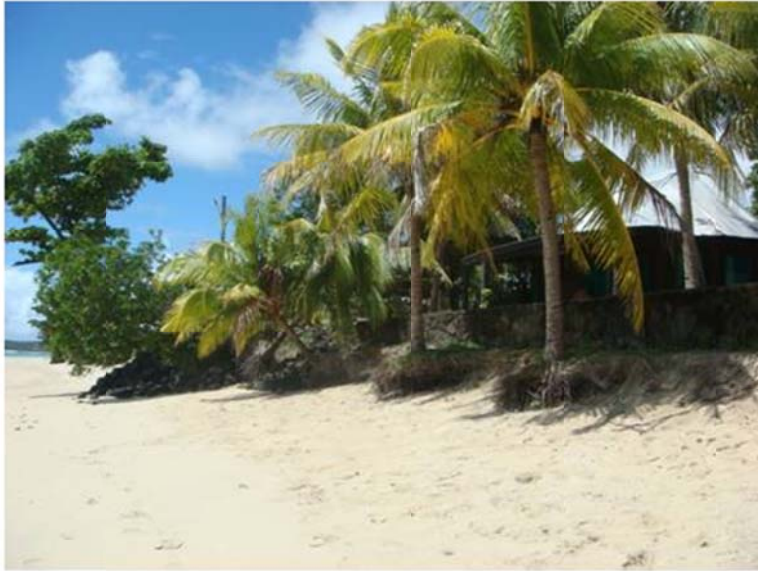
Figure 9. Native coastal trees, shrub, and vines will be planted to help stabilize sediments.

No vegetation will be planted in front of the rock revetment, because seedlings would not survive the wave action at the toe of this revetment, and none will be planted west of the Eurofales, because this area is well vegetated and has no vulnerable infrastructure. Vegetation will be planted along the back beach, landward of the storm tide line, along the 80 m stretch of beach immediately in front of and behind the retaining wall protecting the villas, the 20 m of grassy lawn west of the rock revetment, and the 50 m in front of the Eurofales. As illustrated in Figure 9, a row of fetau and leva will be planted with spacing of approximately 8 m between seedlings. Seaward of these trees, to'ito'i will be planted with spacing of approximately 4 m between seedlings, fronted and interspersed with fue moa transplanted from the western end of the property. This will require approximately 12 fetau seedlings, 12 leva seedlings, 40 to'ito'i seedlings, and 70 fue moa rooted cuttings.

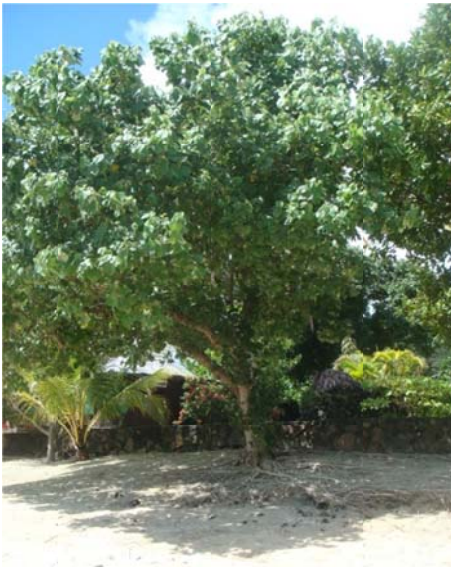
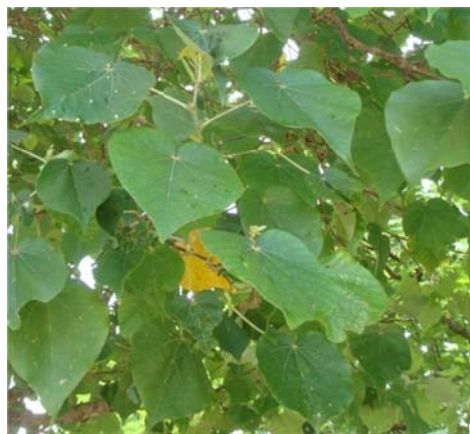
### Fau or beach hibiscus (*Hibiscus tiliaceus*)

This plant grows as a shrub or a tree at about 0.75 – 1.5 m/year up to 10 m or more in height (Elevitch and Thomson 2006). It withstands salt spray and is adapted to a wide range of soils, but can fall over when subjected to high winds. It has a highly spreading, near-surface lateral root system that often has only a few main roots (Elevitch and Thomson 2006). Its long, spreading branches root where they touch the

ground, enhancing the tree's ability to stabilize soil on slopes and shores exposed to moderate coastal tides. It has some potential to invade undisturbed native plant communities, particularly when introduced into moist environments, and it is difficult to control its spread (Elevitch and Thomson 2006). Its wood is used for timber, fish-net floats, firewood, and kirikiti (cricket) bats; inner bark fibers are used to make traditional dancing skirts, cordage, mats, and fishing line; and leaves are used for wrapping food (Whistler 1992). Parts of the plant are also used in traditional Samoan medicines (Whistler 1992). Mature trees were present at the Stevensons Resort Manase site and elsewhere on the island.

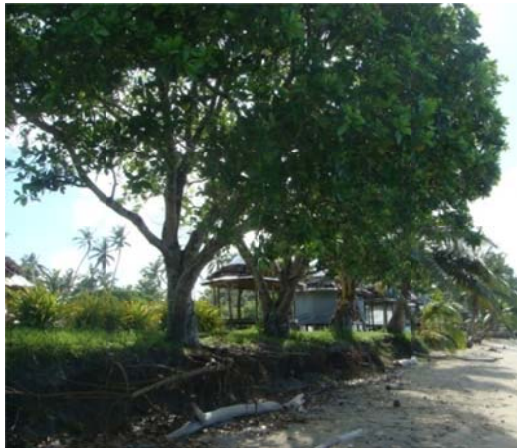
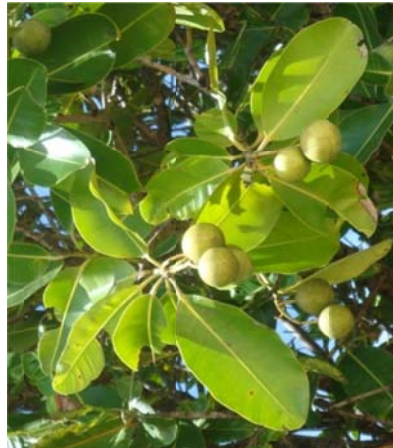
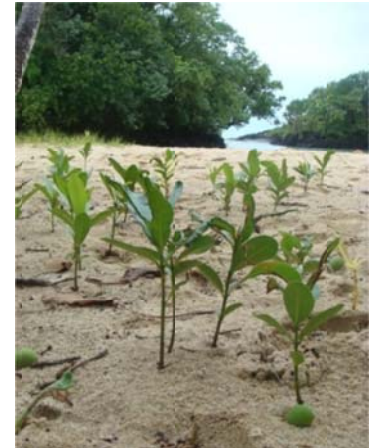
### **Fetau (*Calophyllum inophyllum*)**

This tree protects coastlines and stabilizes sandbanks, and the dense foliage shelters more sensitive plants from salt spray. It withstands cyclones, wind, salt spray, drought, and occasional flooding common to beach environments (Friday and Okano 2006). It may initially grow 1 m per year, although usually much more slowly, up to a height of 8-20 m (Friday and Okano 2006). It grows best in direct sunlight in sandy, well-drained soils on the beach- right down to the high-tide mark-- and in coastal forests. This tree has a shallow, spreading root system that spreads at least as far as the canopy and that rise up above the surface of the soil. The tree provides heavy shade, and has low potential to become invasive (Friday and Okano 2006). An infusion of the leaves (ADAP 2001) and the oil extracted from the nuts are used for external medicinal purposes, but the nuts can be poisonous if eaten (Friday and Okano 2006). The wood is used for making canoes, bowls, furniture, and houses (Whistler 1992). Seedlings were available from the Ministry of Natural Resources and Environment (MNRE) Forestry Division nurseries at Togitogiga, Upolu and Maota, Savai'i. Mature trees were present at the Stevensons Resort Manase site, the Vaiula Beach Fales Tafatafa site, and elsewhere on the island.

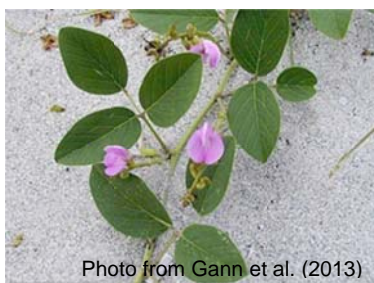
### **Fue fai va'a (*Canavalia rosea*)**

This vine is an important species for beach and dune stabilization (Highland et al. 2010). It grows just above the high tide level, predominantly grows prostrate on sandy beaches and rocky shores, but sometimes climbs into low vegetation (Whistler 1992). It grows quickly and tolerates drought and salt spray, but does not tolerate long-term flooding by salt or brackish water (Gann et al. 2013). The seeds and seed pods are poisonous (Gann et al. 2013). It is one of several species of littoral vines, both native and invasive, that are often not distinguished by Polynesians (Whistler 1992), including Samoans, who use the general term “fue”.

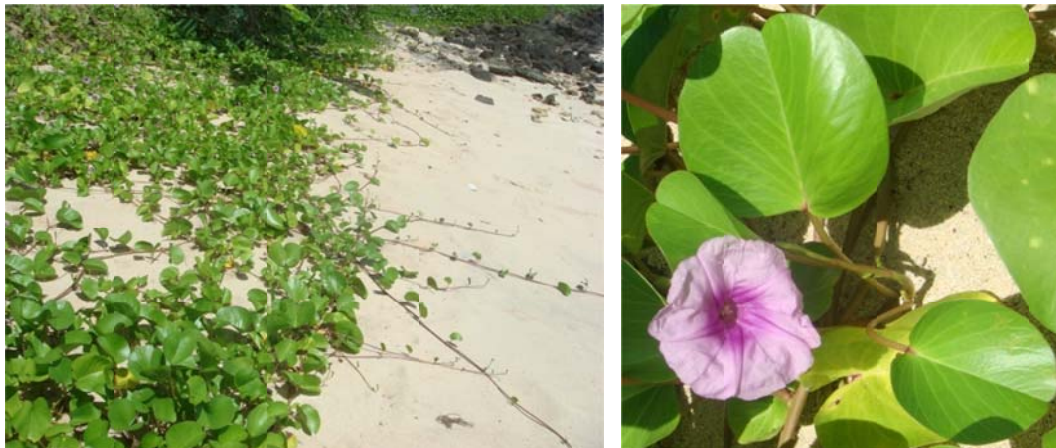
**Fue moa or beach morning glory (*Ipomoea pes-caprae*)**

This trailing vine is abundant on rocky and sandy beaches. It grows just above the high tide line along coastal beaches, forming large mats that assist in stabilizing sands and preventing erosion (Hill 2001). It is also common in scrub areas and some upland areas. Branches may reach 10 m in length while the taproot is deep and fleshy. It withstands salt spray and wave splash, and it recovers well following cyclones and storms that inundate beach areas with sea water and heavy winds (Hill 2001). The leaves are used in traditional Samoan medicines (ADAP 2001). It is one of several species of littoral vines, both native and invasive, that are often not distinguished by Polynesians (Whistler 1992), including Samoans, who use the general term “fue”. This species is present at the western end of the Stevensons Resort Manase site, the middle of the Vaiula Beach Fales Tafatafa site, and elsewhere on the island. There are differing reports over whether it is not invasive (personal communication, Foliga, 19 April 2013) or recently designated as invasive (personal communication, Peteli Pese, MNRE-Forestry, 8 May 2013).

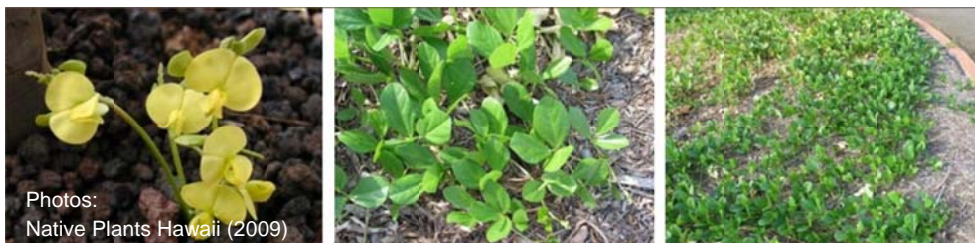
**Fue fue sina or beach pea (*Vigna marina*)**

This vine grows on sandy and sometimes rocky shorelines, growing prostrate or climbing over low vegetation (Whistler 1992). This plant fixes nitrogen, increasing the nitrogen content of the sand and fertilizing the growth of other adjacent plants. It will tolerate some salt spray and sandblast but usually does not survive complete burial under windblown sand (Queensland Government 2013). It prefers full sun. Stems are 2-3 m long. The leaves and roots are used for multiple treatments in traditional Samoan medicines (Whistler 1992, ADAP 2001). It is present at the Vaiula Beach Fales Tafatafa site, the fields around the Ministry of Natural Resources and Environment (MNRE) Forestry Division nursery at Togitogiga, Upolu, and elsewhere on the island.

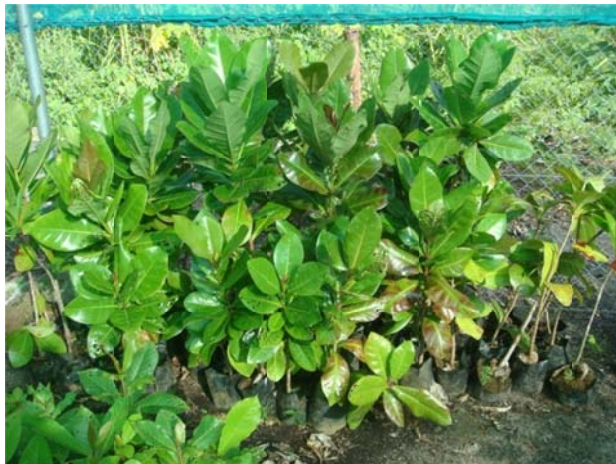
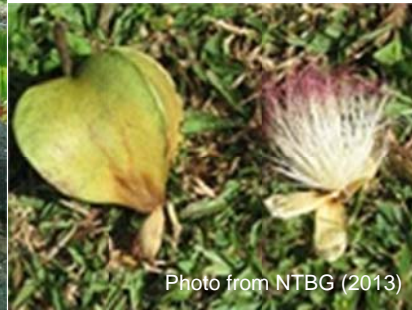
### **Futu (*Barringtonia asiatica*)**

This is a large tree (reaching up to 20 m in height) that grows as a mangrove associate on sandy and rocky shores (NTBG 2013). It grows very quickly (personal communication, Foliga, April 2013). It has no aerial roots, and may have one long tap root. . The flowers open at night (NTBG 2013). All parts of the tree contain saponin, which is poisonous to fish but not humans (NTBG 2013), and is used to stun fish, causing them to float to the surface (Whistler 1992). The leaves are used for external treatments in traditional Samoan medicines (ADAP 2001). Seedlings were available from the Ministry of Natural Resources and Environment (MNRE) Forestry Division nurseries at Togitogiga, Upolu and Maota, Savai'i.

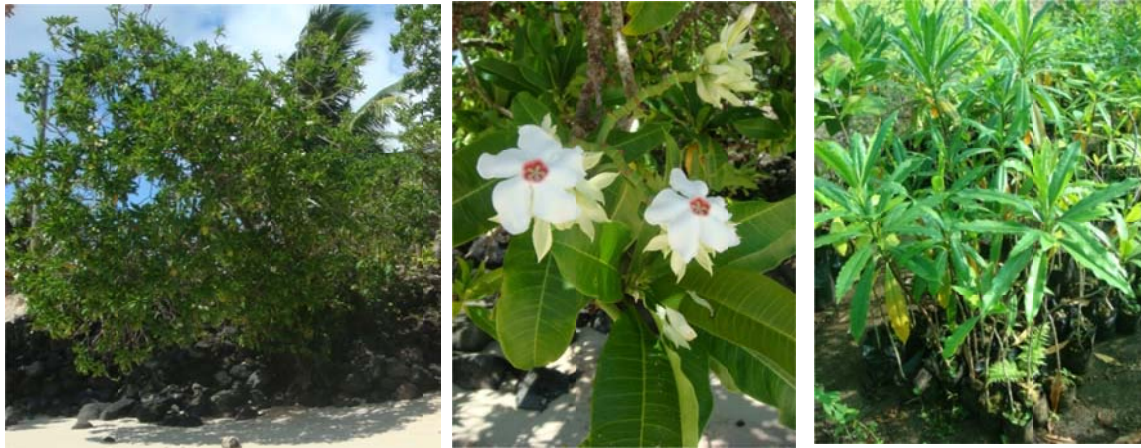
### Leva (*Cerbera manghas*)

This tree can grow up to 12 m tall (Whistler 1992). It grows in littoral forest and disturbed coastal areas (Whistler 1992) and is often associated with mangrove forests (NTBG 2013). *Cerbera* species are generally associated with water and occurs along rivers or streams, in swamp forests and behind mangroves (Globinmed 2013). The milky latex and the fruit are poisonous to humans (Whistler 1992). The roots are used in traditional Samoan medicines (Whistler 1992, ADAP 2001). There is a mature tree currently growing at the eastern end of the Stevensons Resort Manase site and elsewhere on the island. Seedlings were available from the Ministry of Natural Resources and Environment (MNRE) Forestry Division nursery at Togitogiga, Upolu.

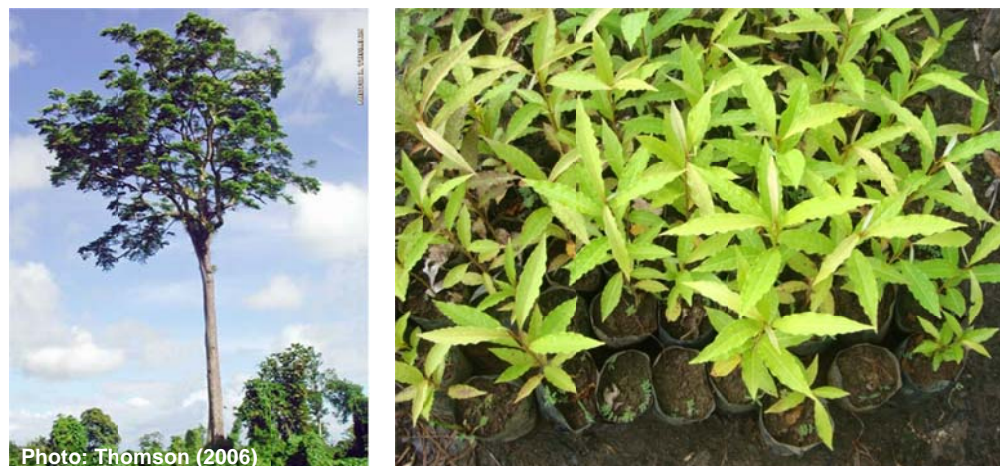
### Malili (*Terminalia richii*)

This tree has good cyclone stability and is used for soil stabilization and windbreak among other purposes (Thomson 2006). Trees have a spreading, near-surface lateral root system and likely also have deep sinker roots. It grows moderately quickly (2 – 2.5 m/yr) in its early years, then more slowly (1.3 – 1.5 m/yr) after 14-22 years. It reaches 25-35 m high when mature. It grows in lowlands and is associated with remnant forest. It prefers fertile, well-drained neutral clay loams but is adapted to most soil types of volcanic origin and those overlying coralline limestone, and can grow on wet or periodically waterlogged sites (Thomson 2006). It has little potential to become invasive and provides moderately heavy shade

(Thomson 2006). Seedlings were available from the Ministry of Natural Resources and Environment (MNRE) Forestry Division nursery at Togitogiga, Upolu.

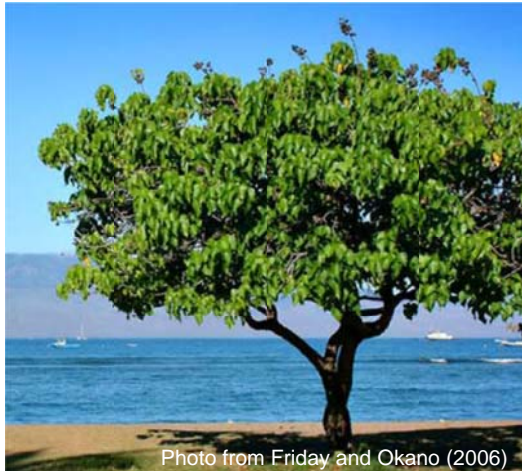
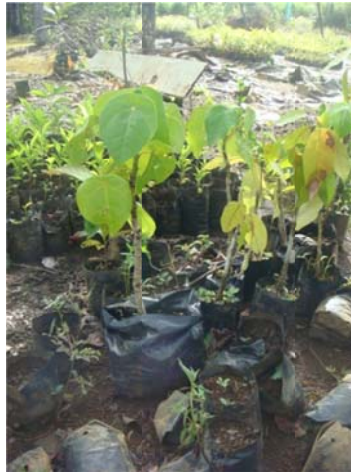
**Milo (*Thespesia populnea*)**

This tree is valuable as a coastal windbreak because it is highly resistant to wind and salt spray and grows well in sandy, saline soils (Friday and Okano 2006). It has shallow roots that spread on the surface, particularly in shallow, rocky, or occasionally flooded soils; in porous soils, it will develop a long taproot to access deep water sources (Friday and Okano 2006). It is a small tree with a moderate growth rate (0.6 – 1 m/yr) for the first few years (Friday and Okano 2006), but can grow up to 12 m in height (Whistler 1992). It grows in littoral forest, on the margins of mangrove swamps, and along estuaries, but rarely becomes a dominant species. It thrives on sandy coastal soils and full sunlight, and tolerates drought conditions. It propagates easily but does not grow well in shade (Friday and Okano 2006). It has the potential to become an invasive weed and should not be introduced to new areas. The wood is used to make bowls, paddles, and handicrafts (Whistler 1992). The leaves and bark are used in traditional Samoan medicines (Whistler 1992, ADAP 2001). Seedlings were available from the Ministry of Natural Resources and Environment (MNRE) Forestry Division nurseries at Togitogiga, Upolu and Maota, Savai'i.

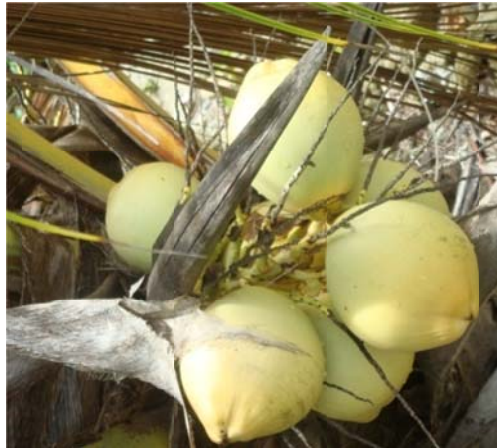
## Niu or coconut (*Cocos nucifera*)

Coconut trees grow up to 500 m in elevation (Whistler 1992) and produce large fruits surrounded by a hard shell with a fibrous husk. It is a valuable agricultural tree; the meat can be used for food and oil; the liquid for drinking; the shells for cups and charcoal; the husks for kindling and to make sennit for ropes and cords; the leaves for weaving and plaiting; and the trunk for timber (Whistler 1992). They have a shallow root system that does stabilize sediment until undermined, but this undermining happens more quickly than for trees with deeper and wider root systems. Several types of coconut grow in Samoa. The hybrids are shorter and produce more nuts, and quickly (within 3-5 years), and so are preferred for agricultural purposes. The coconut proposed for this project is a local variety that produces fewer nuts, and more slowly (5-10 years), but a richer cream; this variety also grows taller and more slowly, and has denser wood (personal communication, Suemalo Talie Foliga, MNRE-Forestry, 19 April 2013). Traditional knowledge indicates that the local variety is better able to withstand coastal erosion and undermining (personal communication, Muliaga David Peterson, Vaiula Beach Fales, 14 April 2013). Seedlings of several varieties of coconuts (local, niu vai, hybrid, and niu afa) were available from the Nu'u nursery run by the Ministry of Agriculture and Fisheries outside Apia.

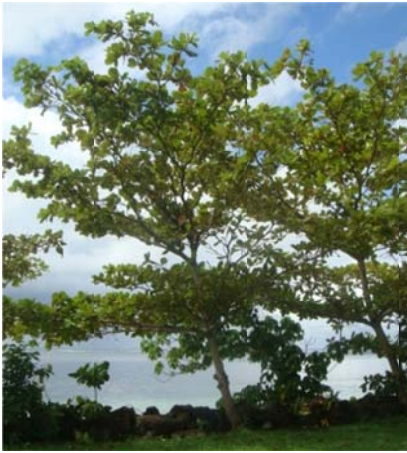
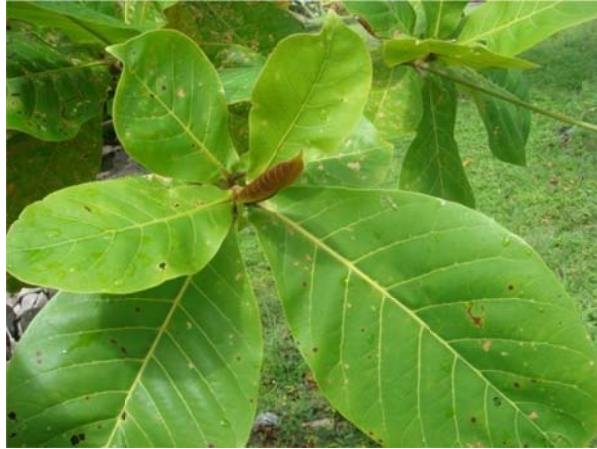
**Talie (*Terminalia catappa* and *Terminalia samoensis*)**

Talie provides good erosion control because it has a spreading, fibrous, near-surface lateral root system that may also be deep rooted in sand (Thomson and Evans 2006). This vast root system binds together both sands and poor soils. The natural habitat of the species is in areas just inland from ocean beaches, near river mouths, and on coastal plains. It is tolerant of drought and salt spray and is a promising species for reforestation of sandy areas (ICRAF 2013). The tree has a fast growth rate in its early years (about 2 m/yr) (ICRAF 2013) and can grow up to 25 m tall (Whistler 1992). It also provides heavy shade (Thomson and Evans 2006). It loses its leaves twice a year in most areas, with a brilliant red-and-yellow display of leaf colour before doing so (ICRAF 2013). This results in a lot of rubbish and may reduce landowner interest in planting it (personal communication, Peterson, 13 February 2013). The edible kernel of the fruit can be eaten, and infusion of the bark is used in traditional Samoan medicines (Whistler 1992, ADAP 2001).

Talie Samoa (*T. samoensis*) grows more slowly than the *T. catappa* species, which can grow up to 25 m in 10 years (personal communication, Foliga, 19 April 2013). There is a mature talie (*T. catappa*) currently growing at the western end of the Vaiula Beach Fales Tafatafa site and elsewhere on the island. Talie Samoa (*T. samoensis*) seedlings were available from the Ministry of Natural Resources and Environment (MNRE) Forestry Division nurseries at Togitogiga, Upolu and Asau, Savai'i.

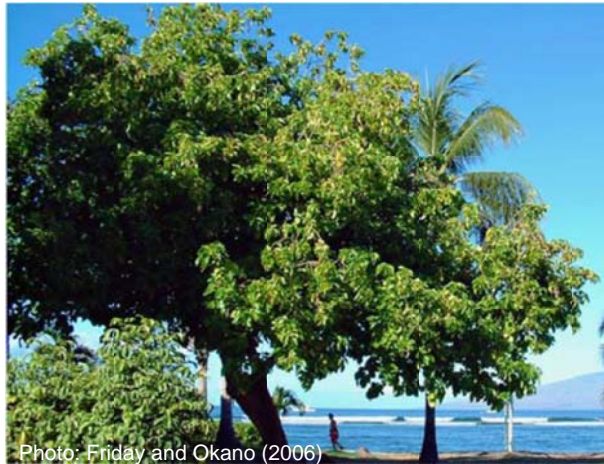
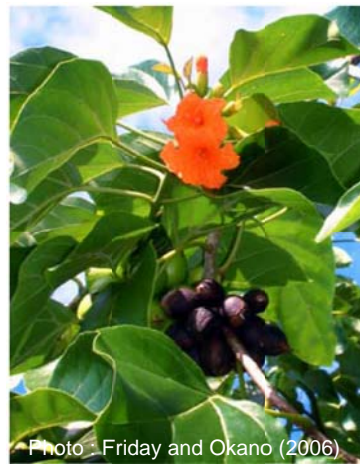
### **Tauanave (*Cordia subcordata*)**

This tree has a shallow and extensive root system that is useful for the conservation of eroding coastal areas (Friday and Okano 2006). Through natural regeneration, it can form dense stands of trees that protect coastal areas. It grows rapidly (1 m/yr) in early years, and mature trees are up to 10 m in height (Whistler 1992). It grows in littoral forest and thickets on sandy shores, but rarely very far inland (Whistler 1992). It prefers direct sunlight and withstands frequent salt spray. It can spread easily by seeds, but is native to Pacific Islands so is not considered invasive (Friday and Okano 2006). The wood is used to make plank canoes, bowls, and paddles; the flowers are used to make leis; and the seeds are edible (Whistler 1992). Seedlings were available from the Ministry of Natural Resources and Environment (MNRE) Forestry Division nursery at Maota, Savai'i.

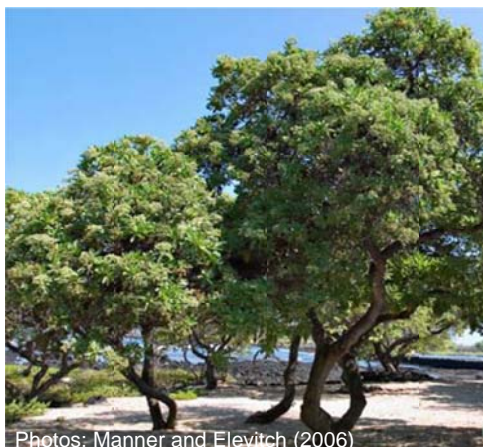
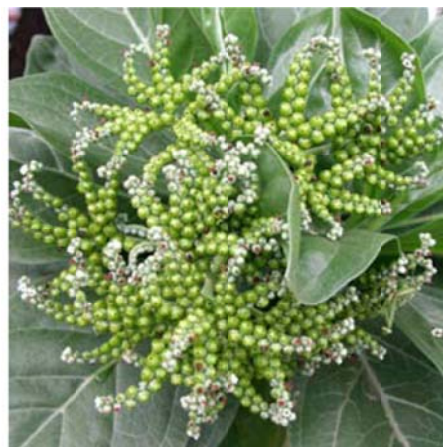
### **Tausuni (*Tournefortia argentea*)**

It provides a barrier to salt spray and is useful as a windbreak and in coastal stabilization. It has very strong vertical and lateral roots that anchor it even in the harshest coastal conditions, including salt spray, strong and steady winds, and occasional waves washing over its root system or battering the lower trunk and roots (Manner and Elevitch 2006). It can grow near the ocean and tolerates shallow, saline, and nutrient-poor sands and rocky soils. It is commonly found on sandy beaches and rocky coral limestone slopes where soils are very thin. This tree is slow-growing (<0.75 m/yr) and can grow up to 6 m tall. It is

rarely considered a pest, but has the potential for becoming invasive when introduced to new coastal environments (Manner and Elevitch 2006). The wood is sometimes used to make tool handles and carved handicrafts (Whistler 1992). The leaves are used in traditional Samoan medicines (ADAP 2001).

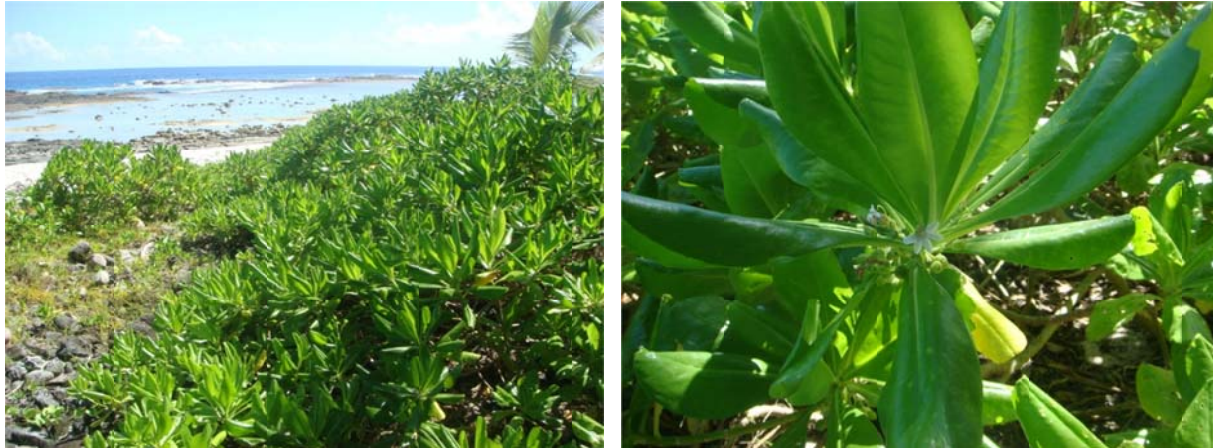
### **To'ito'i (*Scaevola taccada*)**

To'ito'i is a dense, spreading shrub used for coastal stabilization in some parts of the Pacific. It is one of the most common littoral shrubs in Polynesia. It often forms dense thickets on rocky and sandy coasts in the region, with shrubs up to 3 m in height (Whistler 1992). It is adapted to salt-sprayed coastal environments with shifting sandy substrate and variable salinity (GISD 2010), and can survive being inundated by waves (personal communication, Foliga, 19 April 2013). In some countries it has become an invasive plant, and is difficult to remove and to control once established (GISD 2010). The bark and leaves are used in traditional Samoan medicines (ADAP 2001). It would be a suitable choice for focusing foot traffic towards limited beach access points, discouraging foot traffic across these plants. It currently grows along the coastal walk within the MNRE-managed Togitogiga Forest on the south side of Upolu, and elsewhere on the island.

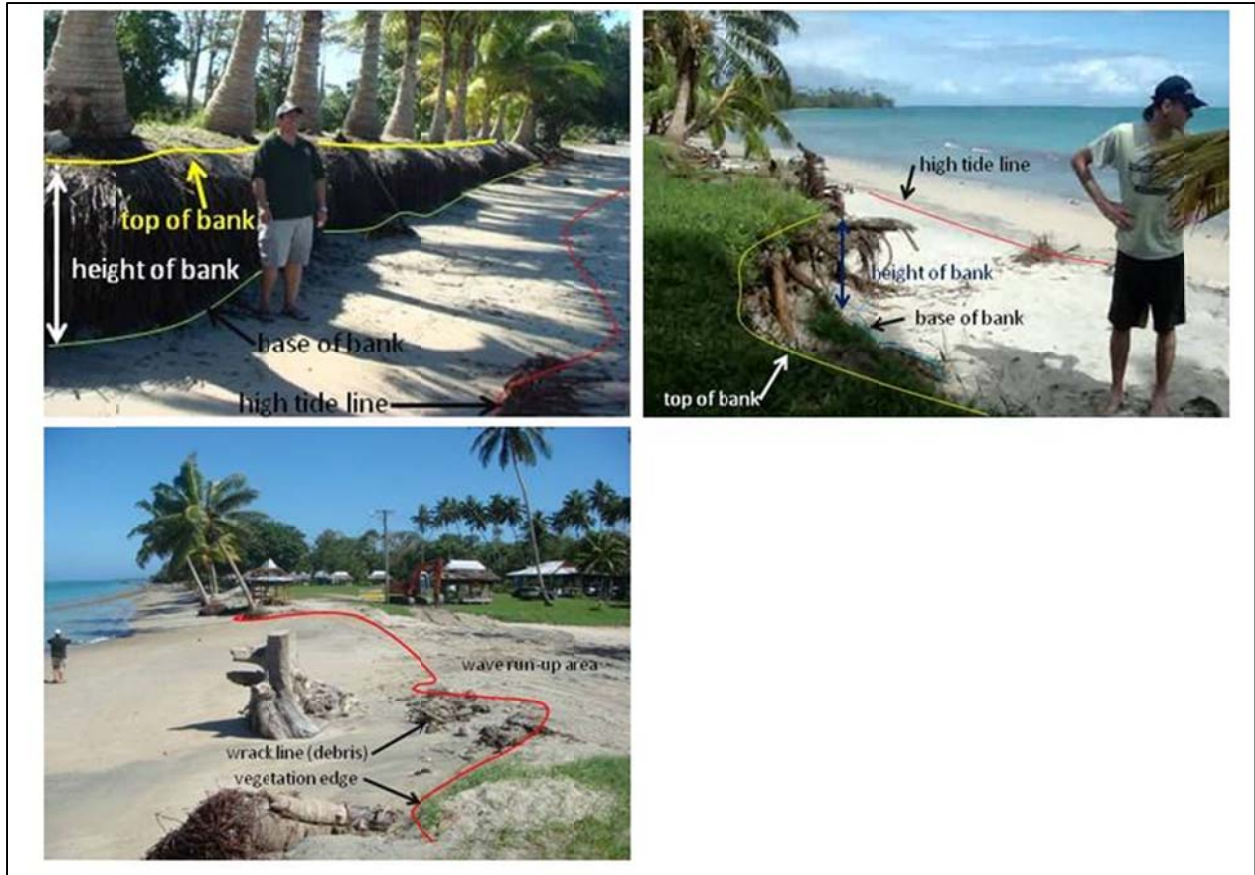
Figure C.3. Several characteristics assist in the identification of shoreline features including the top, base, and height of the eroding bank, and the normal high tide line as a proxy for shoreline position.

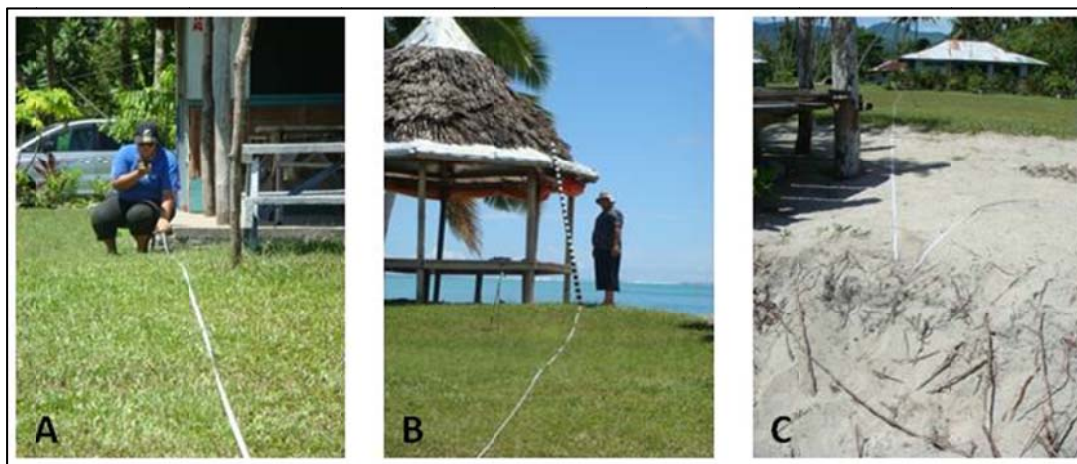
Figure C.4. A) Use the compass to find the appropriate bearing from the reference (start) point (here, the southwestern corner of the fale foundation). B) Lay the measuring tape along the transect line. C) The first shoreline feature to measure is the edge of vegetation (background), which is sometimes but not always concurrent another shoreline feature, the top of the eroding bank (foreground).

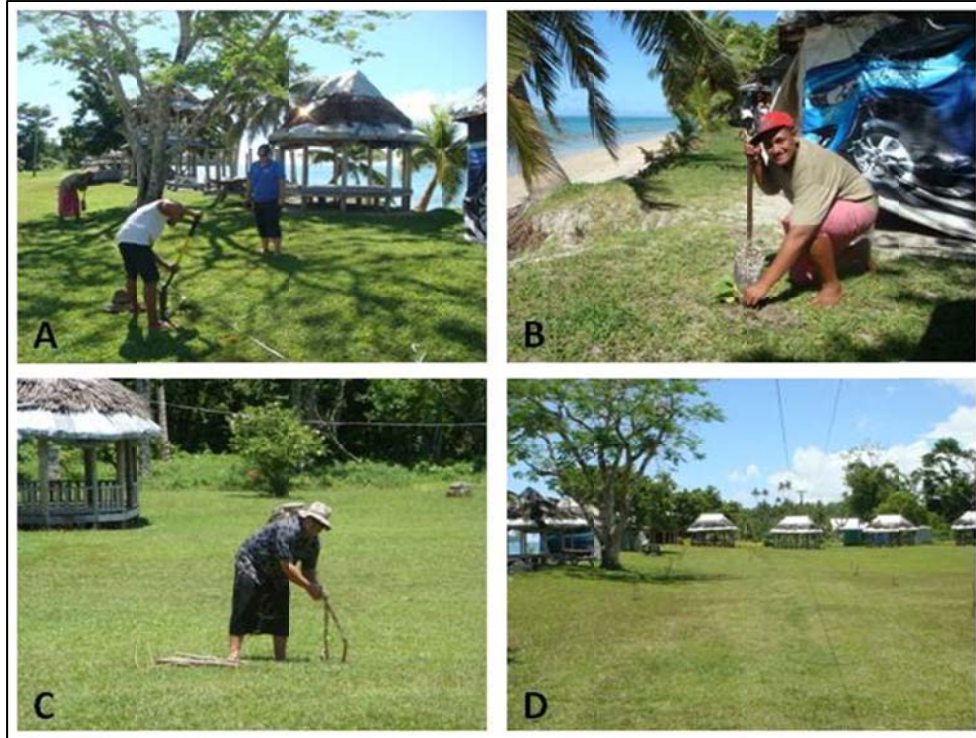
Figure C.5. Three rows of seedlings were planted including A) fetau and milo landward of the fales, and B) to'ito'l and fue moa between and seaward of the fales. C) Seedlings landward of the fales were marked to increase visibility and thereby deter damage by vehicles. D) Two rows of marked seedlings are visible landward of the fales.
