**Coastal Management Adaptation to Climate Change  
using Ecosystem-based Adaptation Strategies  
(Samoa Component)**

Prepared for  
the Secretariat of the Pacific Regional Environment Programme (SPREP)  
by

Courtney Schupp  
13 January 2014

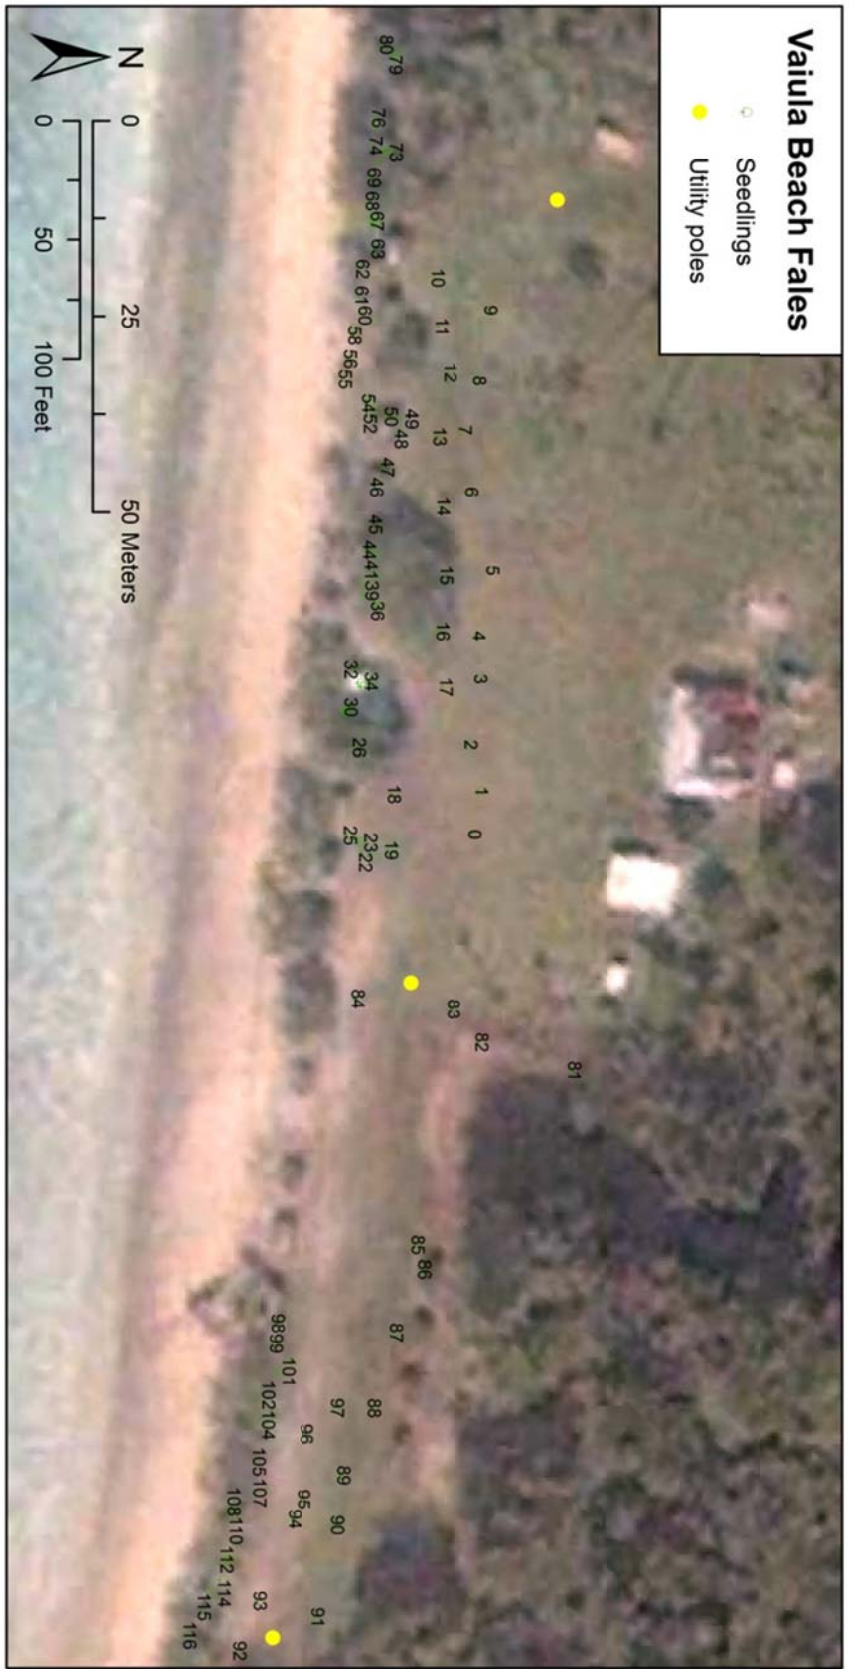
Figure C.6. Location of each seedling with ID numbers for correlation to Table C.3. Current shoreline position is landward of location in this graphic. Photo of conditions on 27 January 2010 from Google Earth (2013).

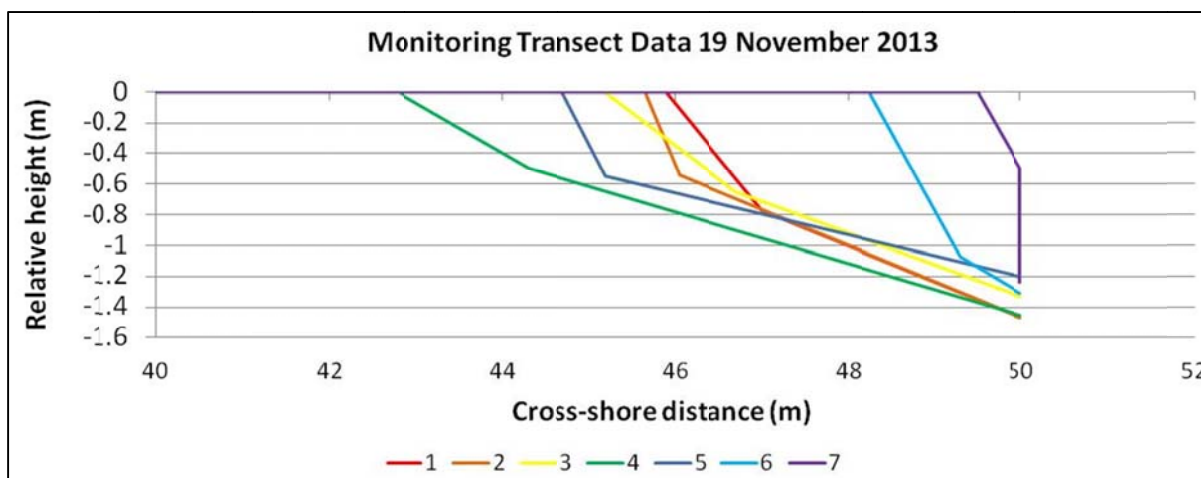
Figure C.7. Comparison of baseline conditions along 7 monitoring transects, shifted in a horizontal direction to overlay the high water line locations for comparison.

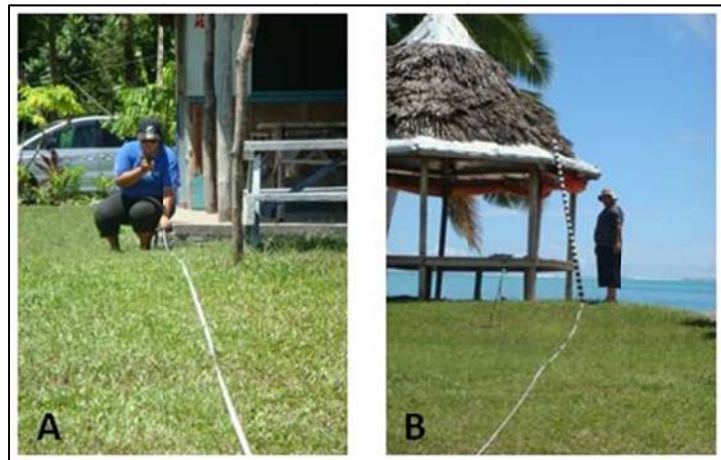
Figure D.4. A) Use the compass to find the appropriate bearing from the reference (start) point (here, the southwestern corner of the fale foundation). B) Lay the measuring tape along the transect line.
