ENVIRONMENTAL IMPACT ASSESSMENT

PROPOSED REPLACEMENT CAUSEWAY FOR FOA ISLAND, KINGDOM OF TONGA

Proposed rehabilitation works on Foa Causeway

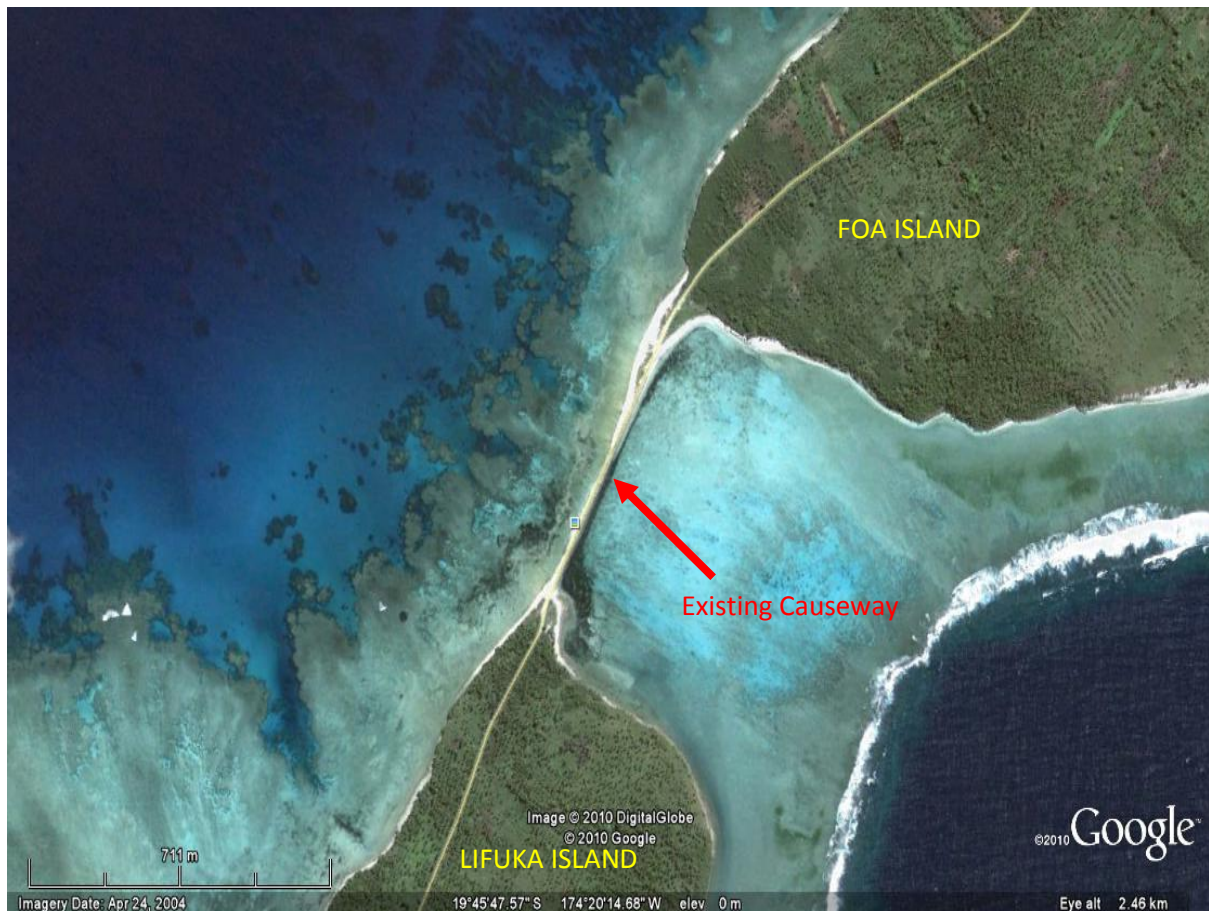
Figure 2b: Study area (close up).

The study area is situated at the Ha'apai Group, at a shallow channel between the islands of Foa and Lifuka. See figure 2a & 2b below.

The Ha'apai Group resembles a chain of barrier islands. The existing causeway is built on a reef flat of a barrier reef system that extends both north and south along the eastern coastline, as fringing reef then become barrier reefs where channels exist. The fringing reefs of the eastern coastlines face the dominant southeasterly wind and waves it generated, making it the main source for sand on beaches along the eastern coastlines of the two islands, Foa and Lifuka.

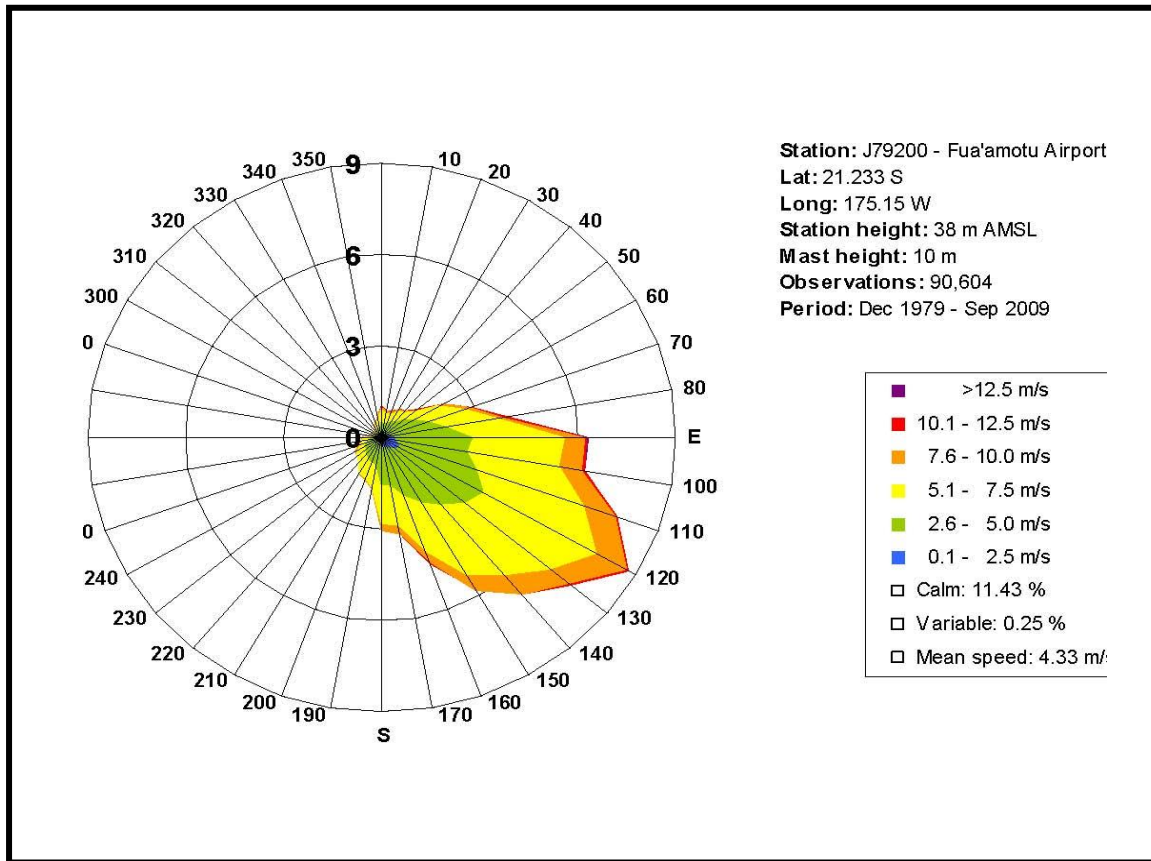
Figure 3: Wind Speed by return period. Source: NIWA, New Zealand

The prevailing winds in Tonga consist mainly of the southeasterly winds, but cyclones pass through the area, generally from the northeast. Under ambient condition the wind speed is between 2.6/s and 7.5m/s (Figure 3). In extreme wind condition the wind has been recorded to reach 26.3m/s from the northeast direction in previous cyclones.

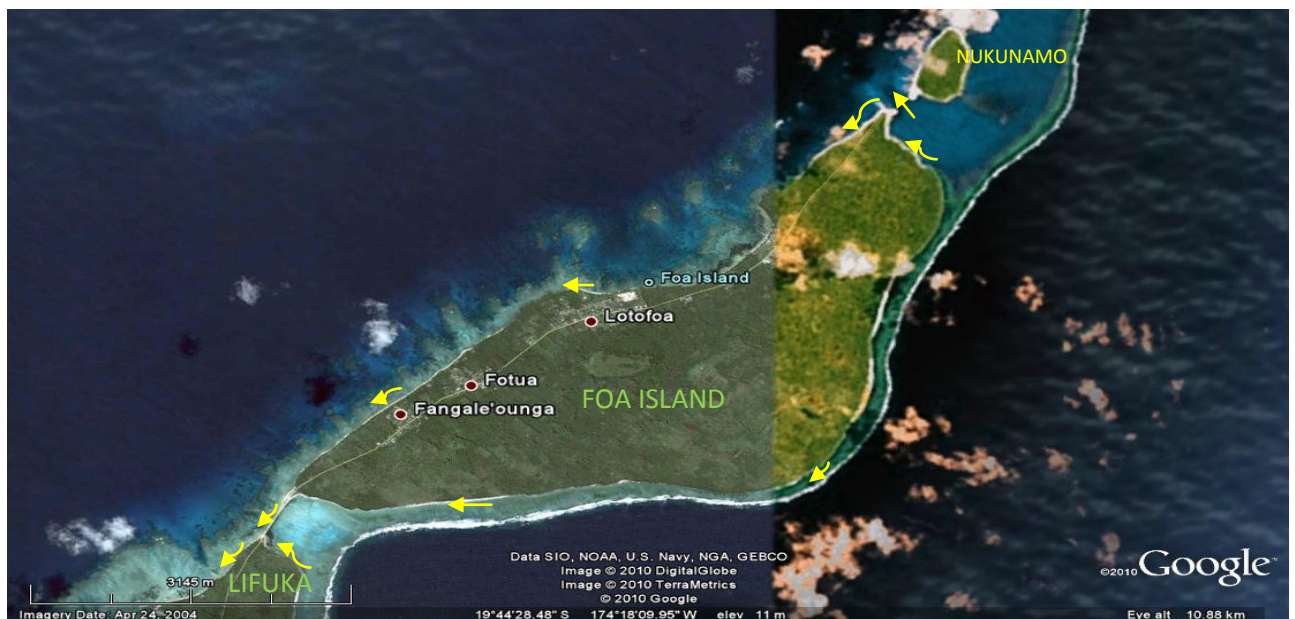
Figure 5: Current pattern determined for along Foa, the Foa-Nukunamo and Lifuka-Foa channels.

Examination of the coastal morphologies and processes acting on the coastlines of Foa and Lifuka suggested a delicate balance between east facing beaches and those on the western side. The eastern coastlines of Foa and Lifuka face the dominant SE wind direction and waves it generated. Current determinations along the coasts of the two islands of Foa and Lifuka suggest strongly that the beaches on the western coastlines are being fed from sediment derived at the eastern coastline (Figures 5 & 6). Observations of littoral current acting in the channel areas (Nukunamo-Foa; Lifuka- Uoleva), showed a dominant east to west flow at both low and high tides.

The above pattern suggests that the channels act as a link in balancing sediment generated at the eastern coastline and the beaches on the western coastline. Refer to Appendix C for GPS locations of sites for current determinations.

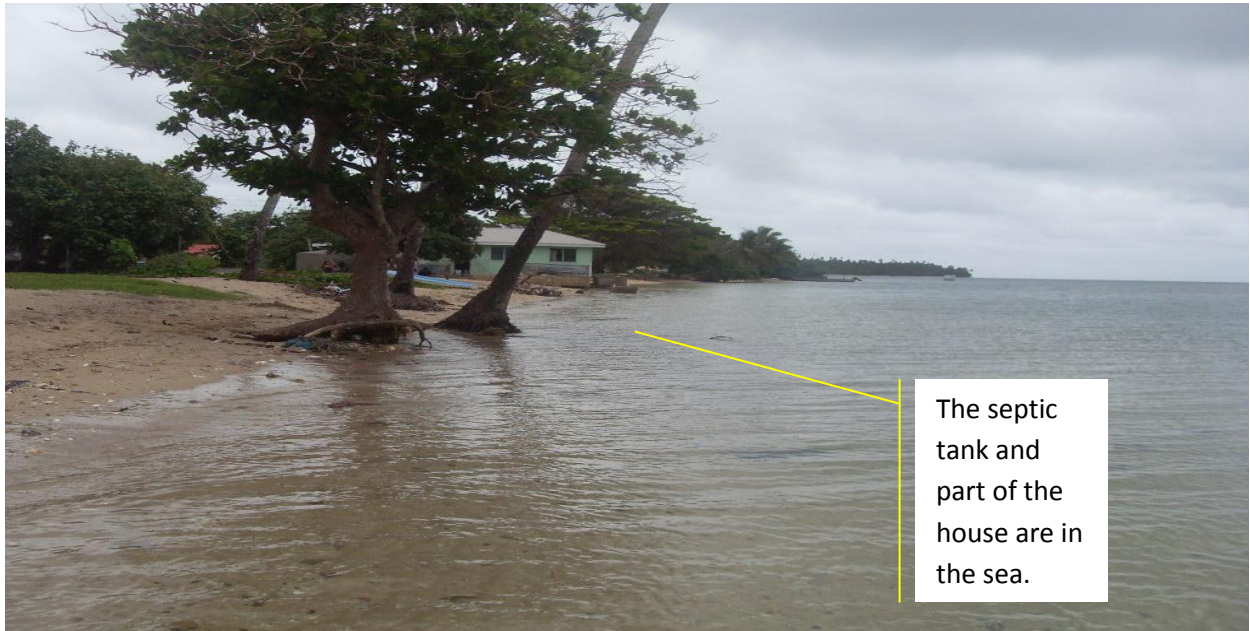
The western coastlines of Foa and Lifuka islands are showing sign of severe coastal erosion (Figure 7 & 8) in some areas. On Lifuka, coastal erosion and sea water transgression is ruining the coastline of the village of Hihifo, while Foa Island is experiencing thinning of sand on its western beaches and totally removed in some areas towards the southern end of the island near the causeway (Figure 8).

Figure 7: Coastal erosion at village of Hihifo, Lifuka Island.

The cause for coastal erosion is depicted from the current regime determined on the coastlines of the two islands. Current determination in channels of Foa-Nukunamo and Lifuka-Uoleva are east-west at both high and low tides suggesting that same applied to Foa-Lifuka channel prior to the construction of the Causeway. It is therefore concluded that prior to the causeway, the system was in equilibrium and the sand of Foa and Lifuka were supplied and driven by an anticlockwise current regime. The building of the causeway between the two islands joined the two processes together, leading to Lifuka's sand to be piled up at the Foa end of the causeway and Foa's sand lost to Lifuka along the western side of the Causeway, during NW winds. The longer route created a lag in sand supply (state of disequilibrium) resulting in accelerated coastal erosion on the two western coastlines of Foa and Lifuka (Figure 7 & 8).

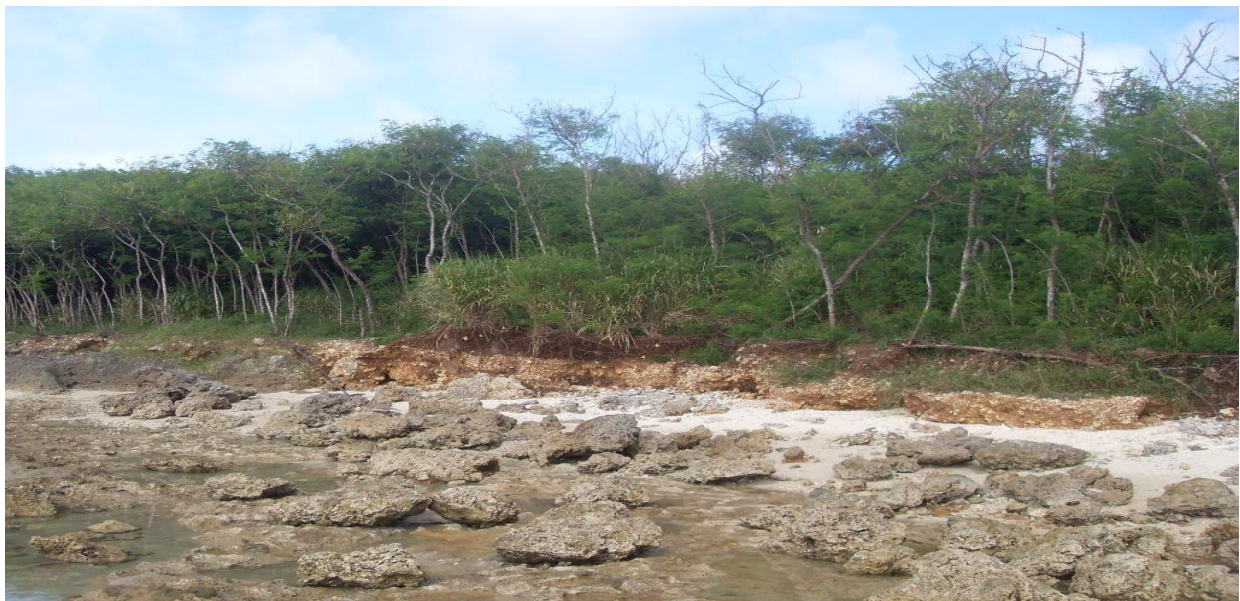
Figure 8: Severe coastal erosion at southwestern end of Foa Island, near the Causeway.

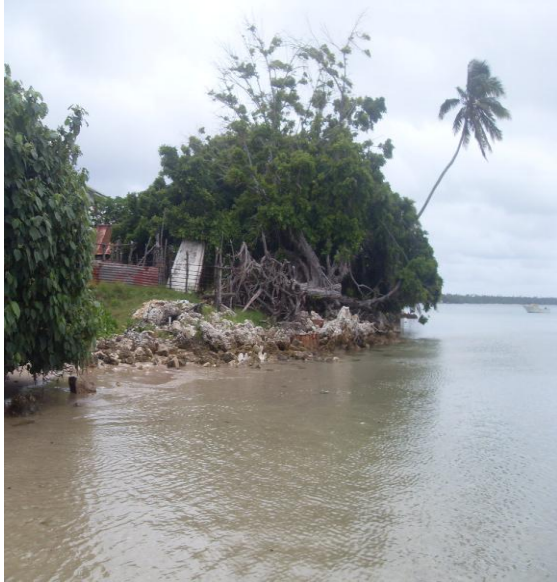
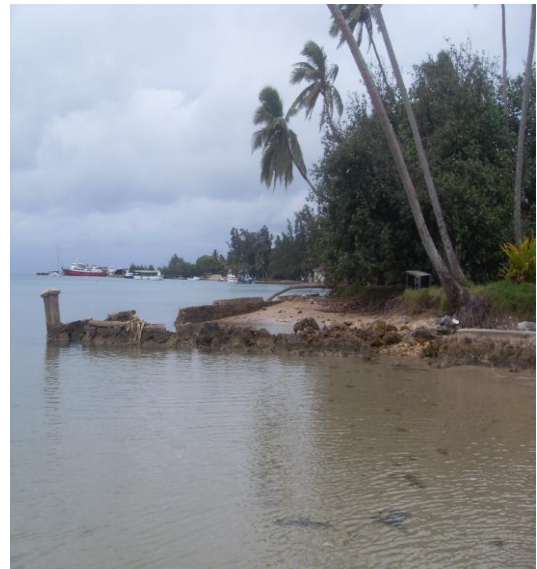
Photos showing coastal erosion at the western coastline of Lifuka island.

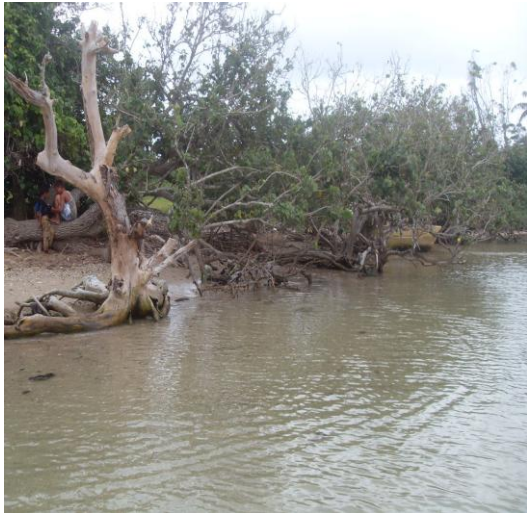
A failed foreshore structure built south of the Governor's Residence. The sea is seen to by-pass the Structure.

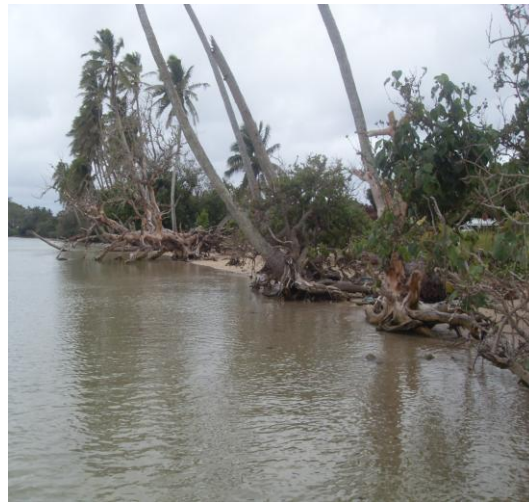
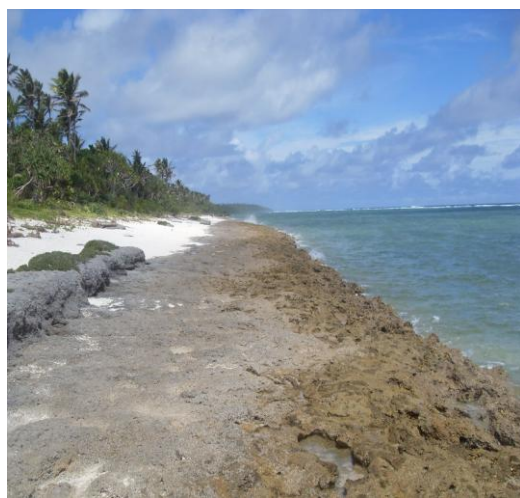
Hihifo village. Coastal erosion is widespread.

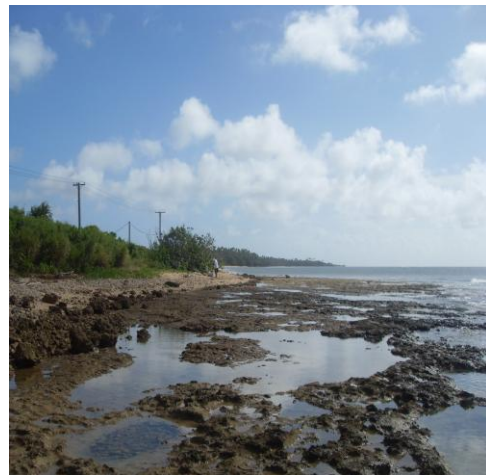
Beach erosion, east coast of Foa island.

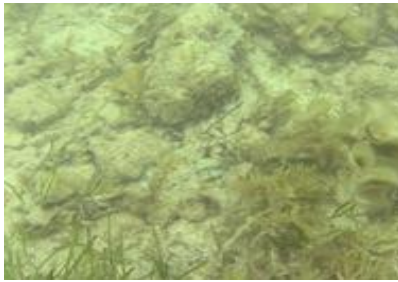
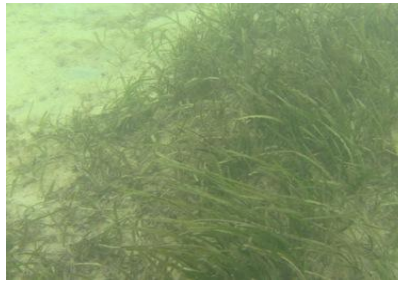
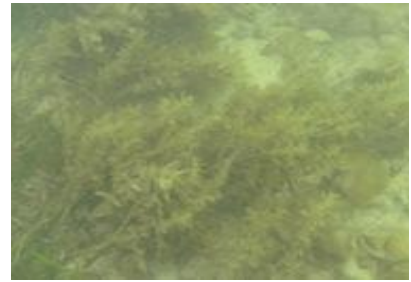
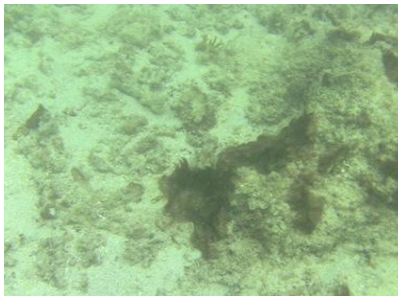
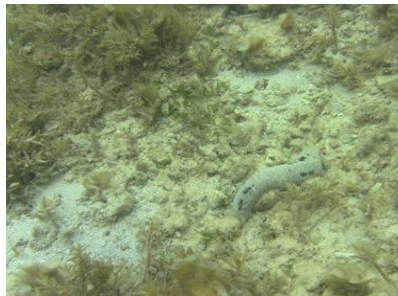
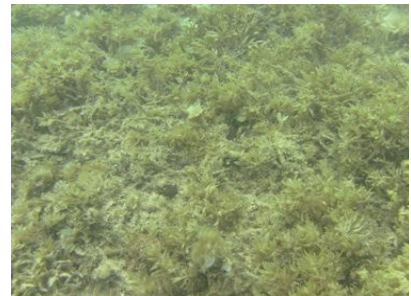
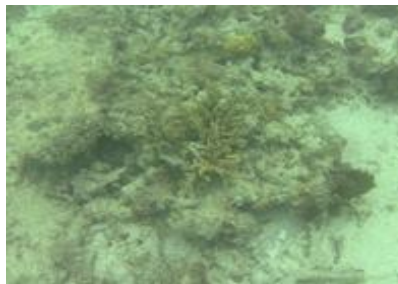
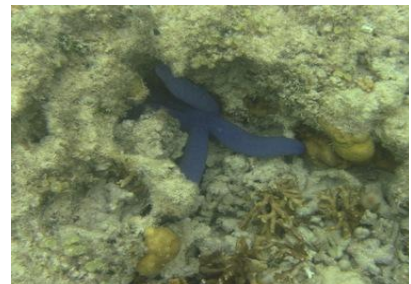
Plate 9 – 17 Indicate typical habitat of the western side of Foa Causeway

The coral on the western side looked degraded and mostly dead (Appendix E, Sites 4,5,6). The area is dominated by brown seaweed (*Sargassum sp.*) which is totally absent in the eastern side. The seagrass was found to increase towards edge of reef, scattered around the middle area and more abundant again near the causeway.

There appears to be a buildup of sediment on the western side of the Causeway which is probably due to frequent maintenance works carried out on the causeway. Dead coral and rubbles were extensive. Sea weeds that are indicative of high sedimentation were also prevalent in this area. Lack of ocean mixing due to barrier provided by the causeway allows for fine sediment to accumulate in the area and acts to suffocate coral reefs, sessile and slow moving marine organisms (brachiopod and Mollusca). Marine organisms were noted to lack in the area which is likely due to lack of ocean mixing and nutrients necessary for the survival of marine organisms and coral on this side.

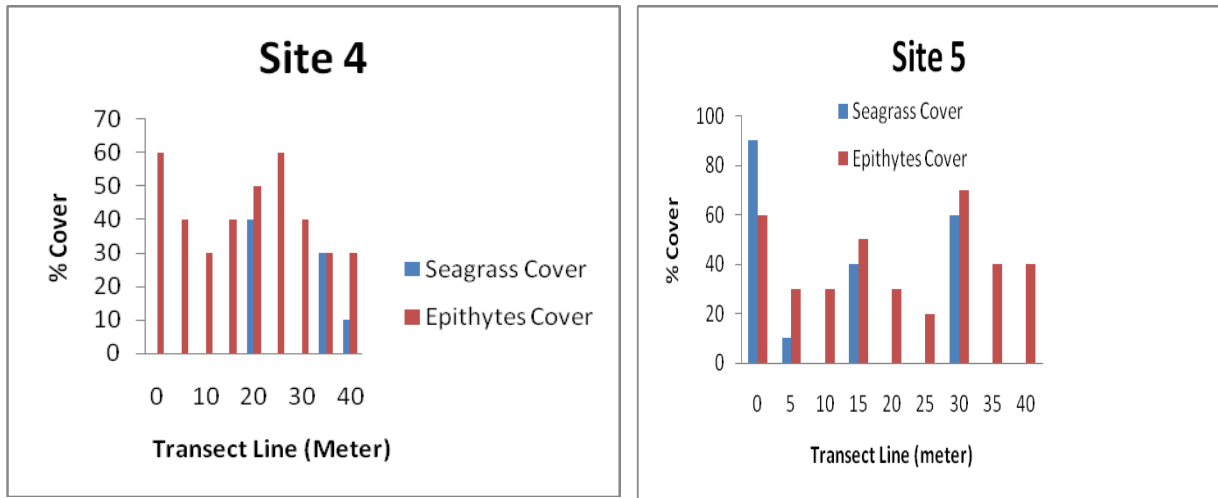
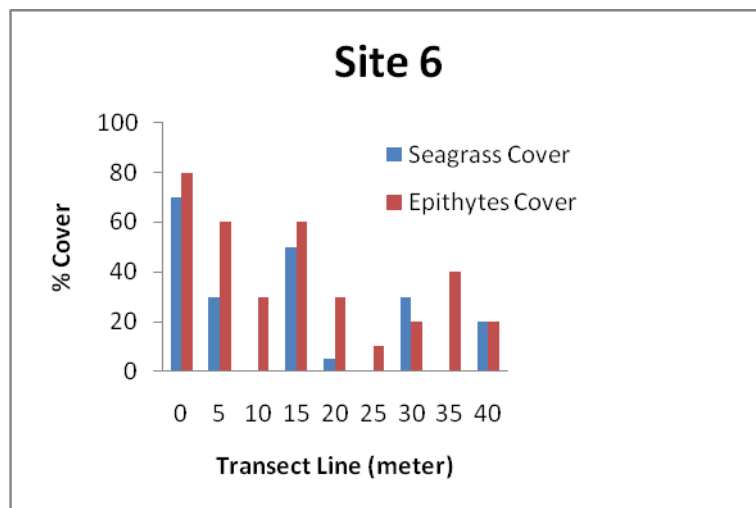
The epiphyte coverage is more prevalent on this side than the eastern side of the causeway (Figure 2). The epiphytes cover seaweeds, seagrasses and even rubbles and the pavement. Branching Coral (*Acropora* sp) was found in areas towards the edge of the reef but very scarce.

Figure 2: Percentage cover of seagrasses and epiphytes at the Western side areas of the Causeway

The epiphyte coverage is more prevalent on this side than the eastern side of the causeway (Figure 2). Epiphytes were found to cover seaweeds, seagrasses and even rubbles and substrates. Branching Coral (*Acropora sp*) was found in areas towards the edge of the reef but very scarce.
