EVALUATION OF THE IMPACTS OF HARBOUR ENGINEERING

ANIBARE BAY REPUBLIC OF NAURU (RON)

SOPAC Technical Report 316

This report presents the preliminary results of a coastal engineering, and environmental evaluation, of design parameters, for a fishing boat harbour facility at Anibare Bay, Republic of Nauru.

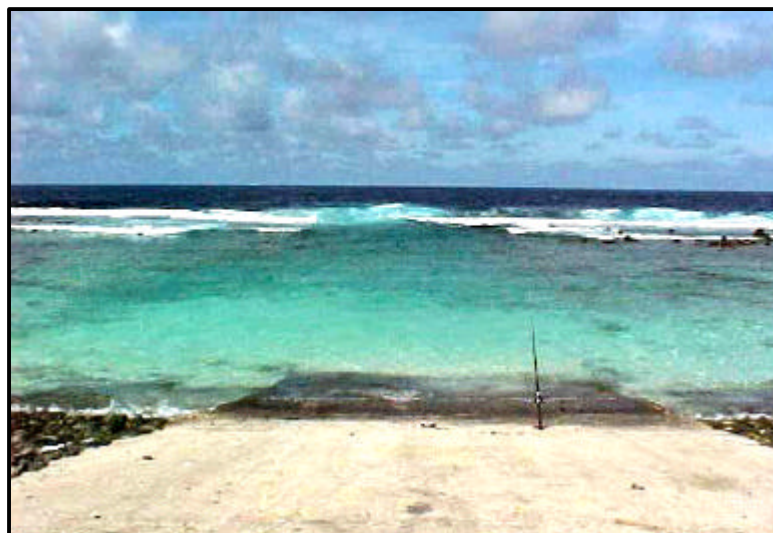
Figure 16. Anibare Channel before harbour construction. Note the concrete boat ramp in the foreground and the proximity of surf on the reef crest in the background.

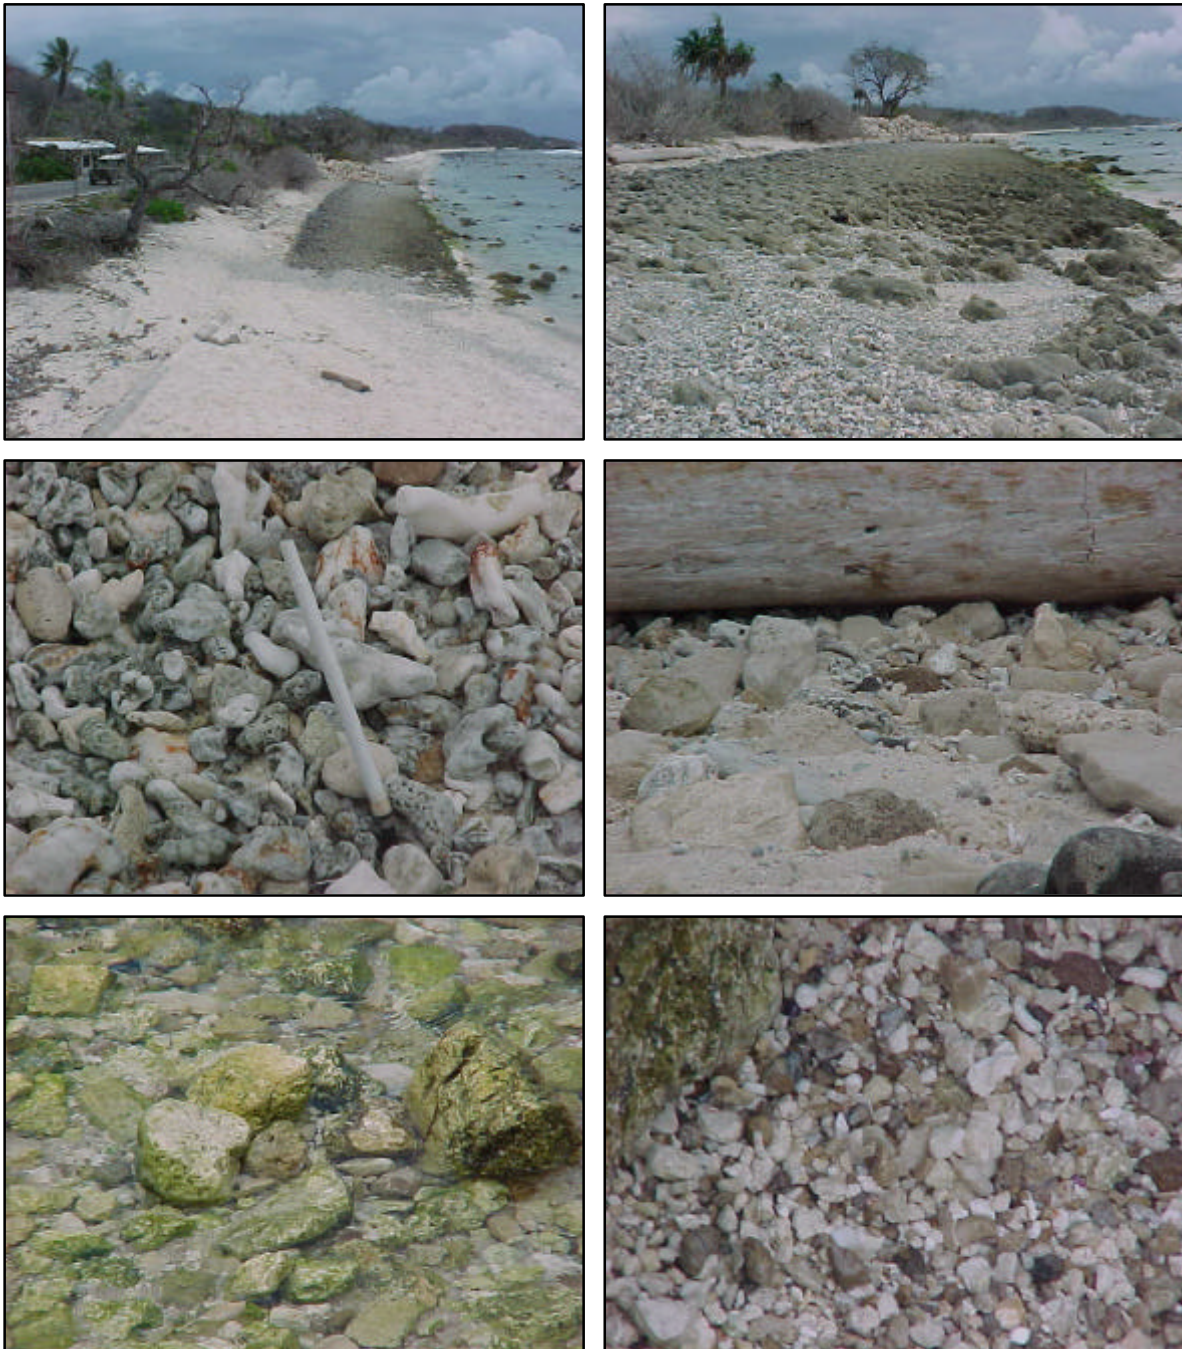
Figure 18. Beach physiography (top photos) and sedimentology (middle and lower photos) at the development site. Note the coarse sub-rounded and well washed Mollusca and coral gravels on the lower beach in the middle left and top right photos; and the sub-angular boulders with sand on the mid-beach, in the middle right photo. The lower left photo shows filamentous green algae on angular boulders; while the lower right photo shows sub-rounded, medium gravel deposited between rip-rap boulders pockets on the lower beach at the site.

- ✓ Molluscs, foraminifera tests, and Echinoderm tests comprise most of the remaining 25 % of the sand fragments;
- ✓ the upper beach has a thicker sand accumulation, about 0.75 m, which is usually thicker during the early half of the year (Figure 16);
- ✓ small coconut trees and coastal shrubs line the coastal areas (Figure 15);
- ✓ shorefront vegetation are largely small shrubs and are currently being affected by severe erosion (Figures 15);
- ✓ the erosion scarp at the problem coastline is between 0.80 m and 1.75 m high (Figures 11-12 and 17);
