SCALING UP PACIFIC ADAPTATION (SUPA)

SNAPSHOT 2021:
**Coastal Protection Measures,
Tonga**

ASSESSING IMPACT AT INTERVENTION LEVEL

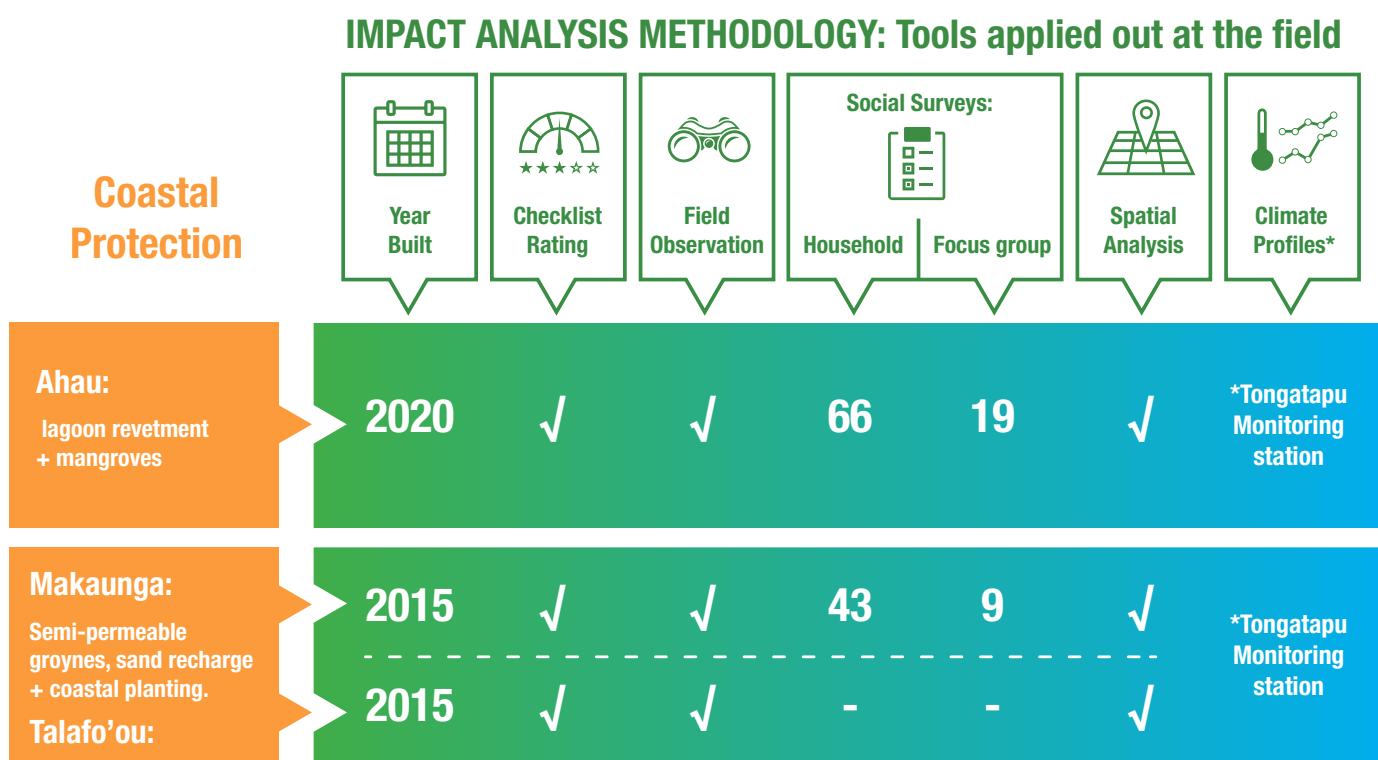
Figure 6. Overview of applied tools: field observation, surveys, interviews, mapping with additional data layer from the nearest climate monitoring station.

Field observations of groynes indicated the good condition of structures with some elements showing general signs of deterioration that require attention. Most of the groynes were placed below the high-water mark by about 1-2metres and obstructs the sand from the up-drift side of the groyne but allows sand to bypass atop of the groynes during high tide.

The signs of coastal erosion noted along Makaunga was likely to occur during strong wind and stormy weather in recent past. However, signs of coastal erosion appear to decrease towards the Lighthouse. Field observations suggest that groyne structure is not protecting the Makaunga coastline like it does for the northern part of Talafo’ou where sand is supplied from the Lighthouse end. This maybe due to the interactions between the southerly longshore current and northerly tidal current as observed in the past with local knowledge.

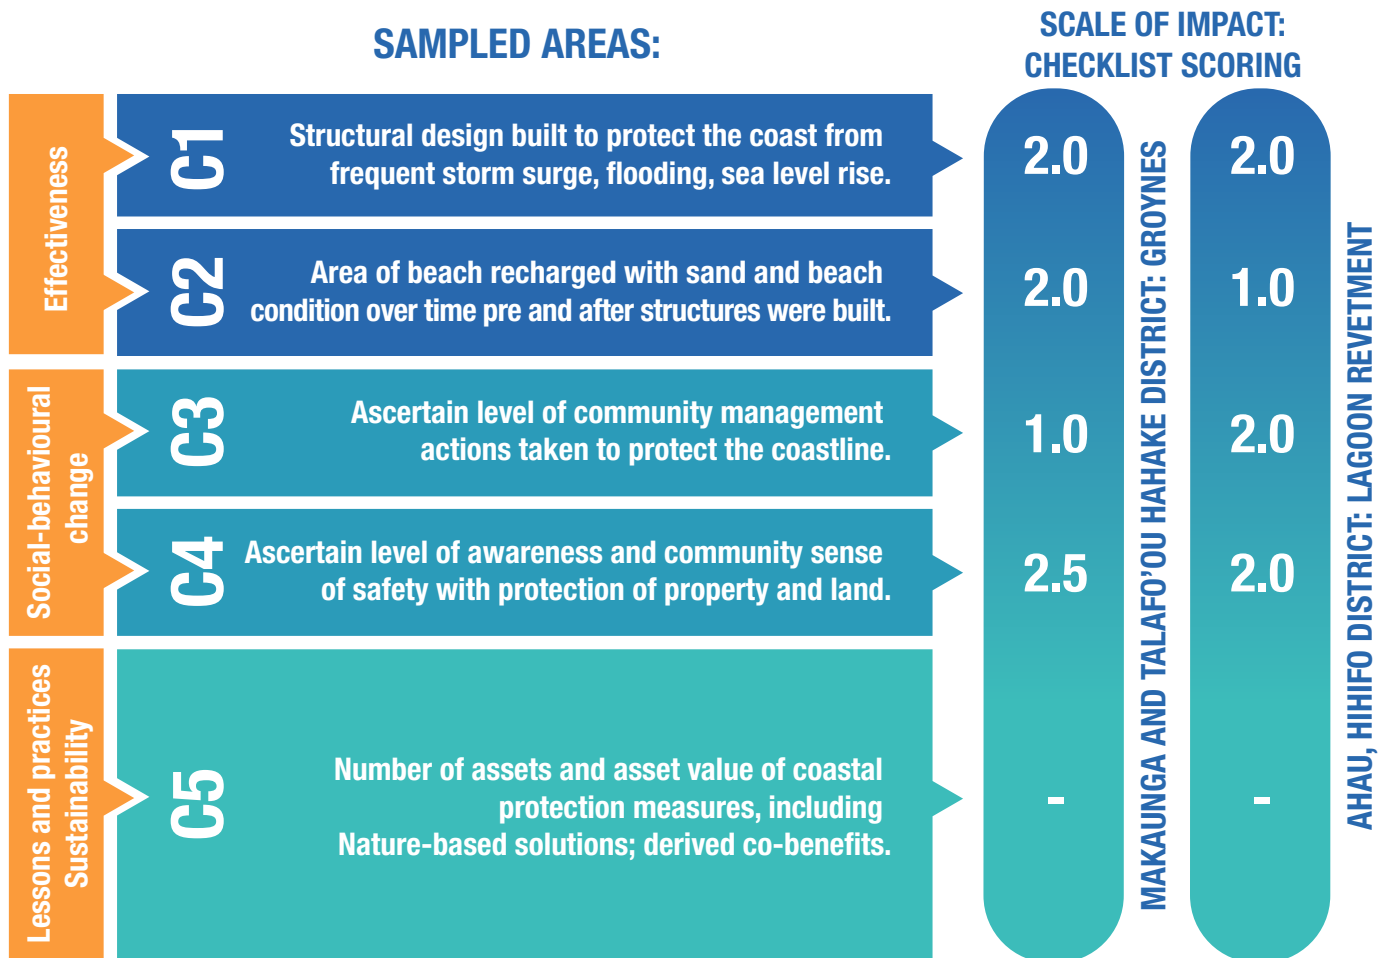
Figure 8. Summary of Indicator Results for trialled coastal protection(C) measures in Tonga.

**STATEMENT OF THE OVERALL MEAN IMPACT OF THE INTERVENTIONS:
MEDIUM IMPACT @ HAHAKE AND HIHIFO**

Checklist for a range of characteristics rated during field observation of the groyne structures along Hahake protecting the Makaunga and Talafo'ou coastline sums up scores. Figure 8 details the tally of scores for each indicator aligned to criteria set for measuring the impact of intervention onsite i.e. lagoon revetment along Ahau village in Hihifo and groynes adjacent to Makaunga and Talafo'ou villages. Overall, average impact rating was medium.

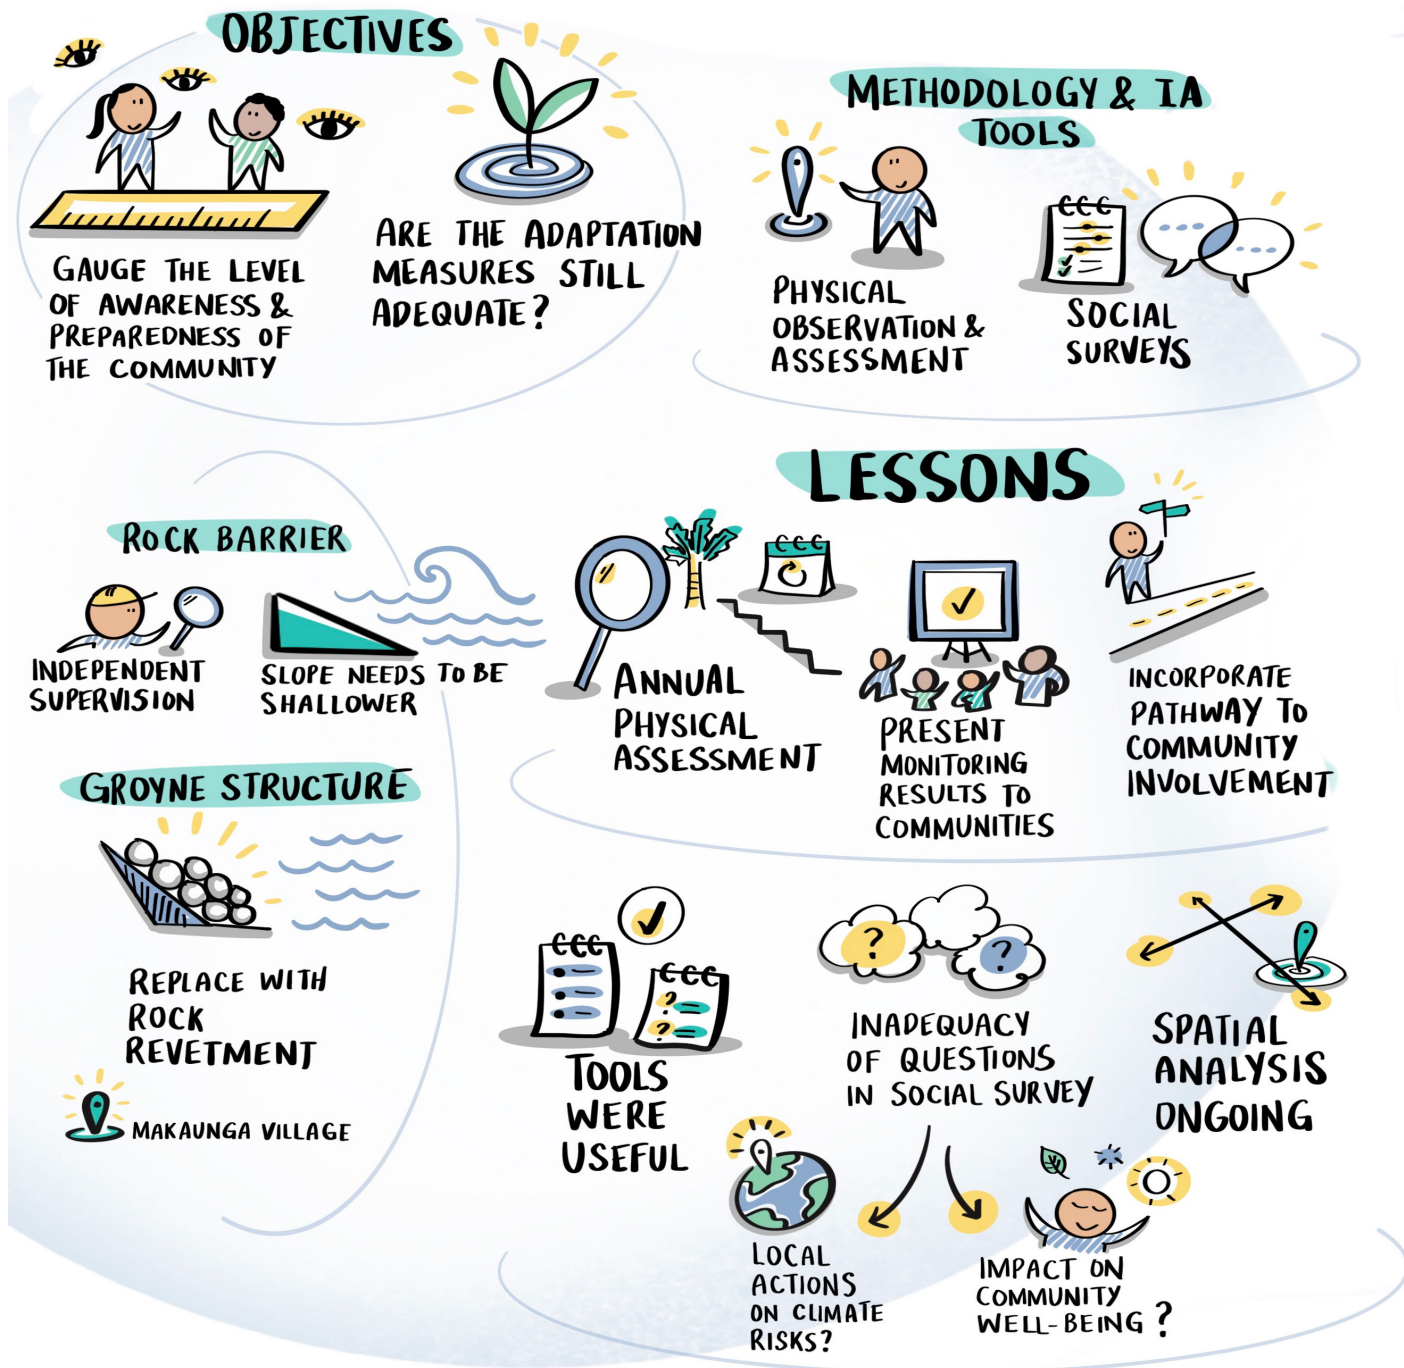
Figure 9. Impact assessment of coastal protection measures, Tongatapu.

Most of the people from the two communities accept that the two projects are protecting their lives and properties. However, defects from poor engineering needs to be addressed for the Ahau protection. The Makaunga Groyne structure may also need a new design/structure because sand is not accumulating. Coastal erosion is happening at this coastline.

Groyne structure- May need to be replaced with a rick revetment, especially the portion towards Makaunga village. Require adherent to detail of modern engineering and to be well supervised.
