Tree Stocktaking Assessment Report

**Tree Stocktaking, Replacement, Maintenance and
Monitoring of Tagabe River Catchment, Vanuatu.**

November 2024

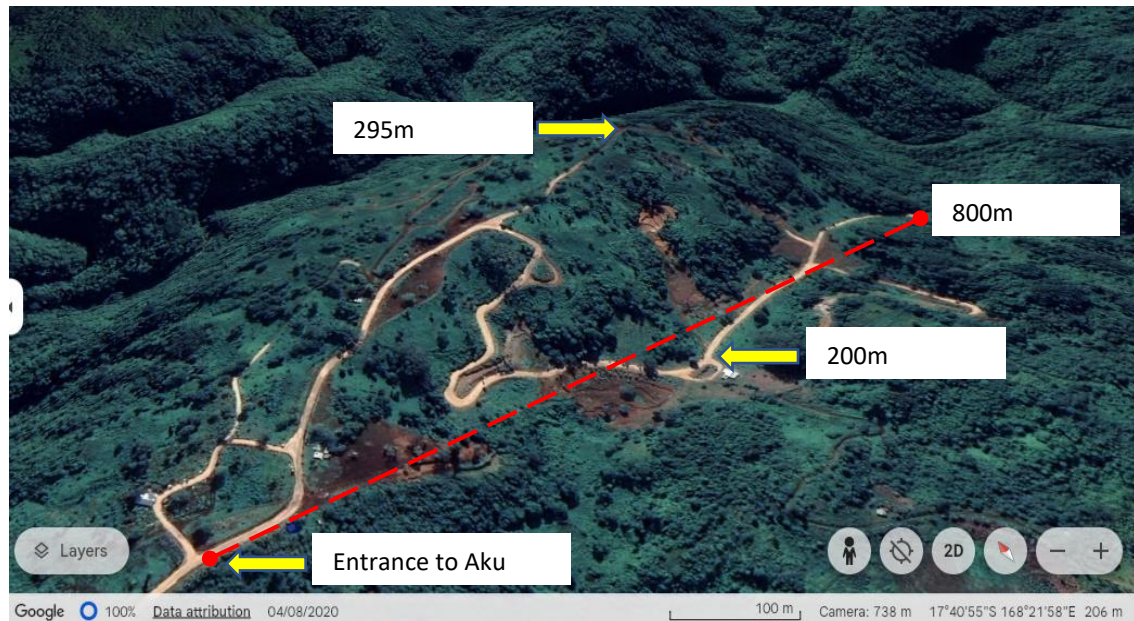
Figure 1. Topographic imagery of Aku Farm (August 2020). (Source: Google Map)

This assessment is focused on Aku Farm. A satellite map of the site is provided below with Figure 1 displaying the 33 ha property, with the highest elevation of 295m above sea level and the lowest elevation at 200m above sea level.
