Survey of the Regional Distribution and Status of Asbestos-Contaminated Construction Material and Best Practice Options for its Management in Pacific Island Countries

Report for the Federated States of Micronesia

**Prepared for the Secretariat of the Pacific Regional
Environment Programme (SPREP)**

May 2015

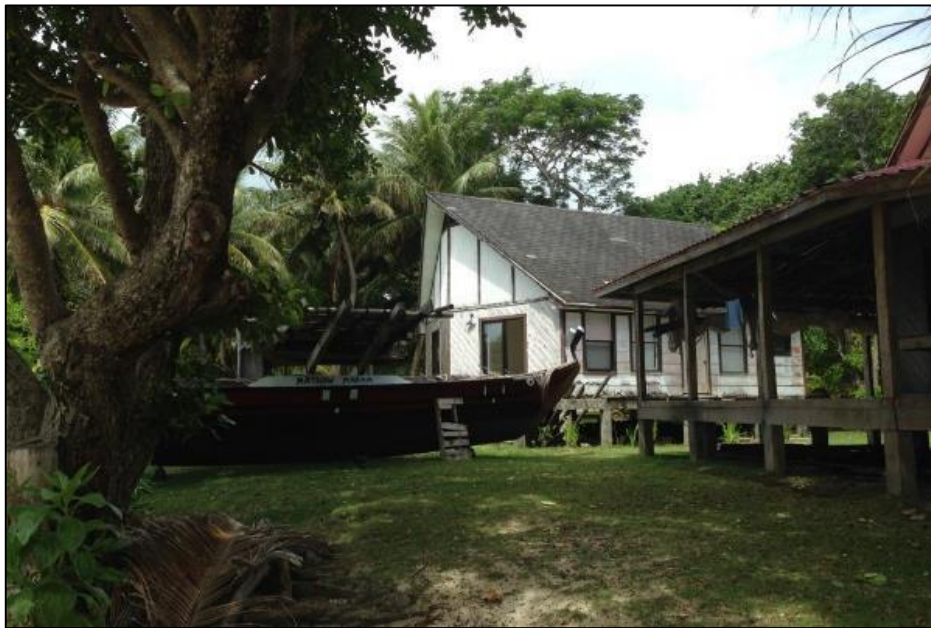
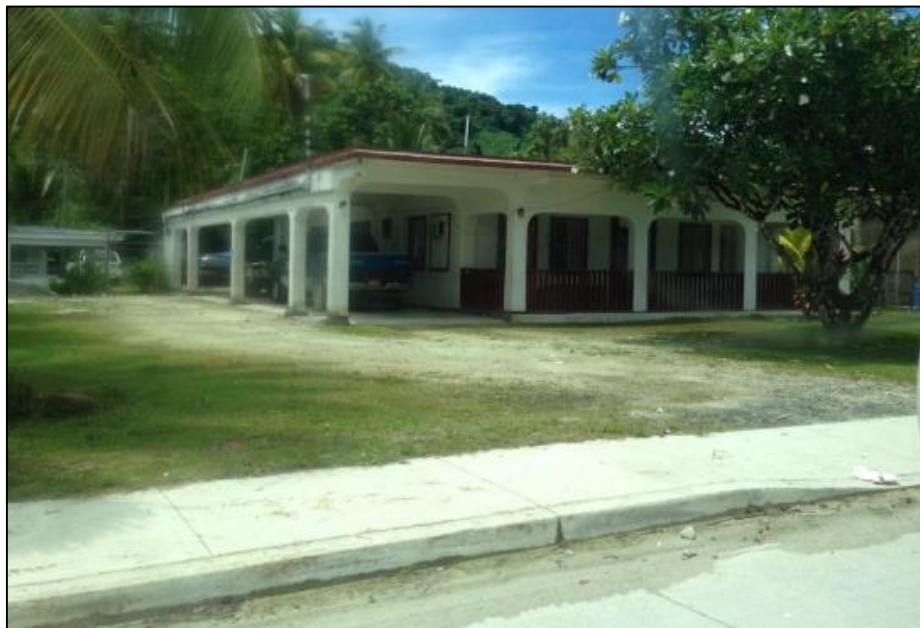
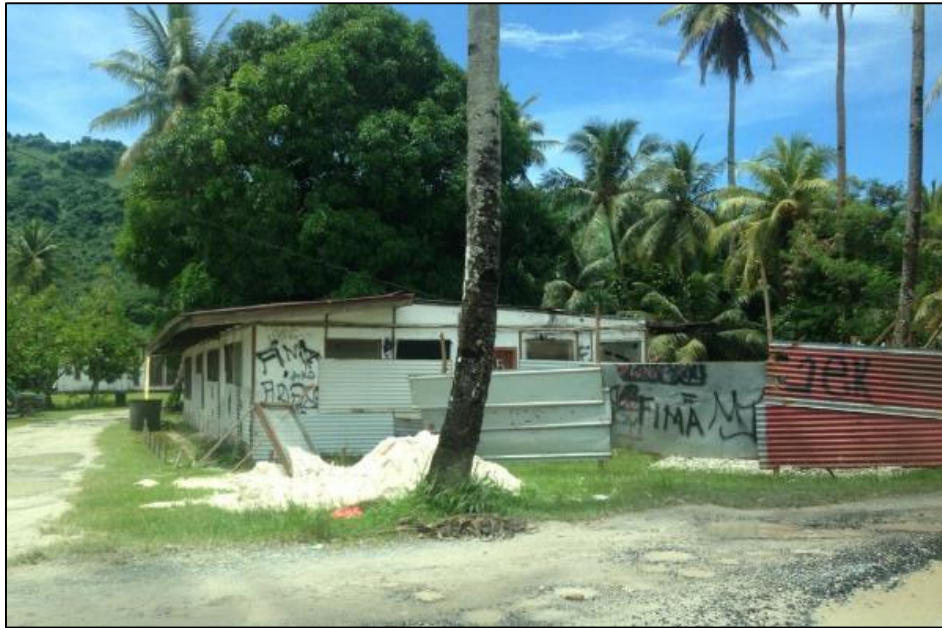
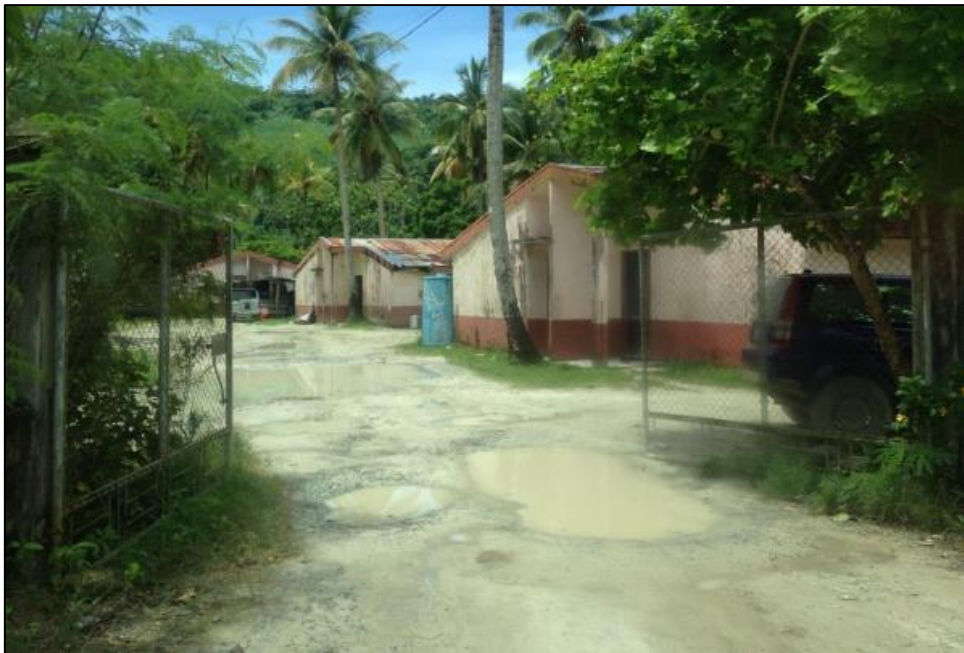
Photos 1 - 4: typical structures in FSM

Residential dwellings observed throughout the FSM were constructed mainly using plywood or fibre board, concrete blocks and corrugated iron however there are still a number of traditional houses made of natural materials.
