Survey of the Regional Distribution and Status of Asbestos-Contaminated Construction Material and Waste - Best Practice Options for its Management in Pacific Island Countries

Report for Niue

**Prepared for the Secretariat of the Pacific Regional
Environment Programme (SPREP)**

July 2015

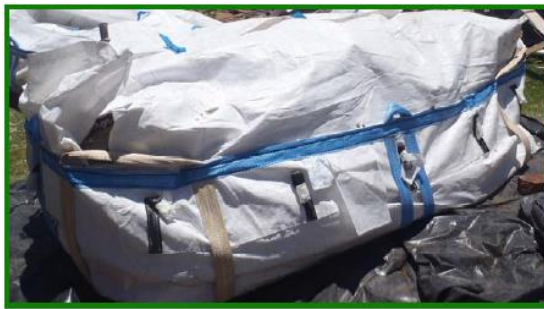
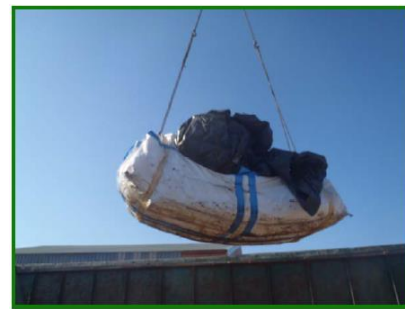
Photos 33 and 34: Asbags in use

Asbags are fabric bags in various sizes with lifting strops – see photos below. There are special ones for roofing sizes.

- d) Lay down black plastic sheeting to the floor of each room, remove all ceiling linings and place all rubbish into suitable containers for disposal (plastic lined bins or fabric bags such as "Asbags" – see Photos 33 and 34 below) for correct removal & disposal. All ceiling material will need to be treated as asbestos-contaminated as debris and fibres fall from the roofing with roof movement and wear.

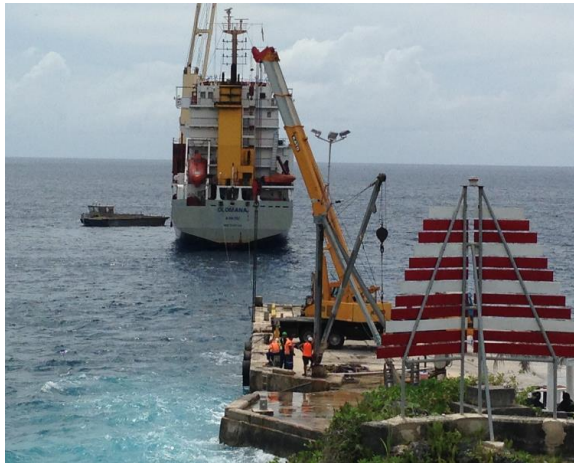
Photo 35: Niue Wharf Cargo Transfers

Loading of containers is via a barge at the wharf in Niue and the barge delivers the containers to the ship – see Photo 35 below.
