Survey of the Regional Distribution and Status of Asbestos-Contaminated Construction Material and Best Practice Options for its Management in Pacific Island Countries

Report for the Independent State of Samoa

**Prepared for the Secretariat of the Pacific Regional
Environment Programme (SPREP)**

May 2015

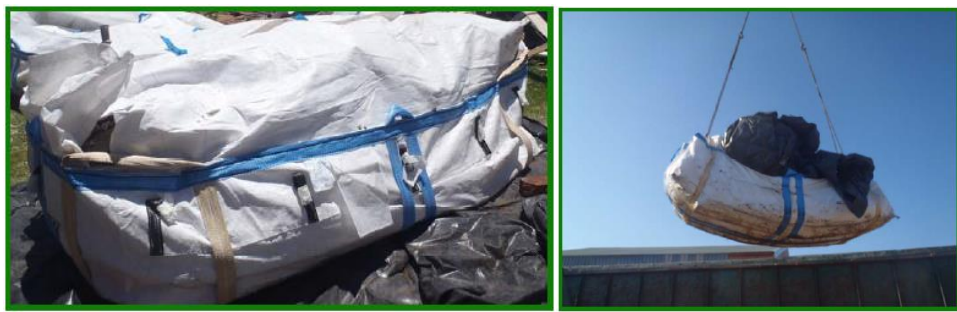
Photos 11 & 12: Asbags in use

Asbags are fabric bags in various sizes with lifting strops – see photos below. There are special ones for roofing sizes.
