# **Survey of the Regional Distribution and Status of Asbestos-Contaminated Construction and Waste Material and Best Practice Options for its Management in Pacific Island Countries**

## **Report for the Republic of Vanuatu**

**Prepared for the Secretariat of the Pacific Regional  
Environment Programme (SPREP)**

**May 2015**

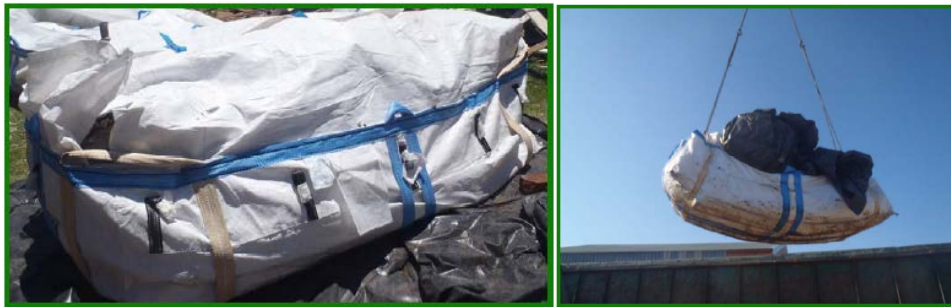
**Photos 17 and 18: Asbags in Use**

Asbags are fabric bags in various sizes with lifting strops – see Photos 10 and 11 below. There are special ones for roofing sizes.

- d) Lay down black plastic sheeting to the floor of each room, remove all ceiling linings and place all rubbish into suitable containers for disposal (plastic lined bins or fabric bags such as "Asbags" – see Photos 17&18 below) for correct removal & disposal. All ceiling material will need to be treated as asbestos-contaminated as debris and fibres fall from the roofing with roof movement and wear.
