SAND AND AGGREGATE RESOURCES VAIUSU BAY, APIA, WESTERN SAMOA

Robert Smith
SOPAC Secretariat

September 1995

SOPAC Technical Report 223

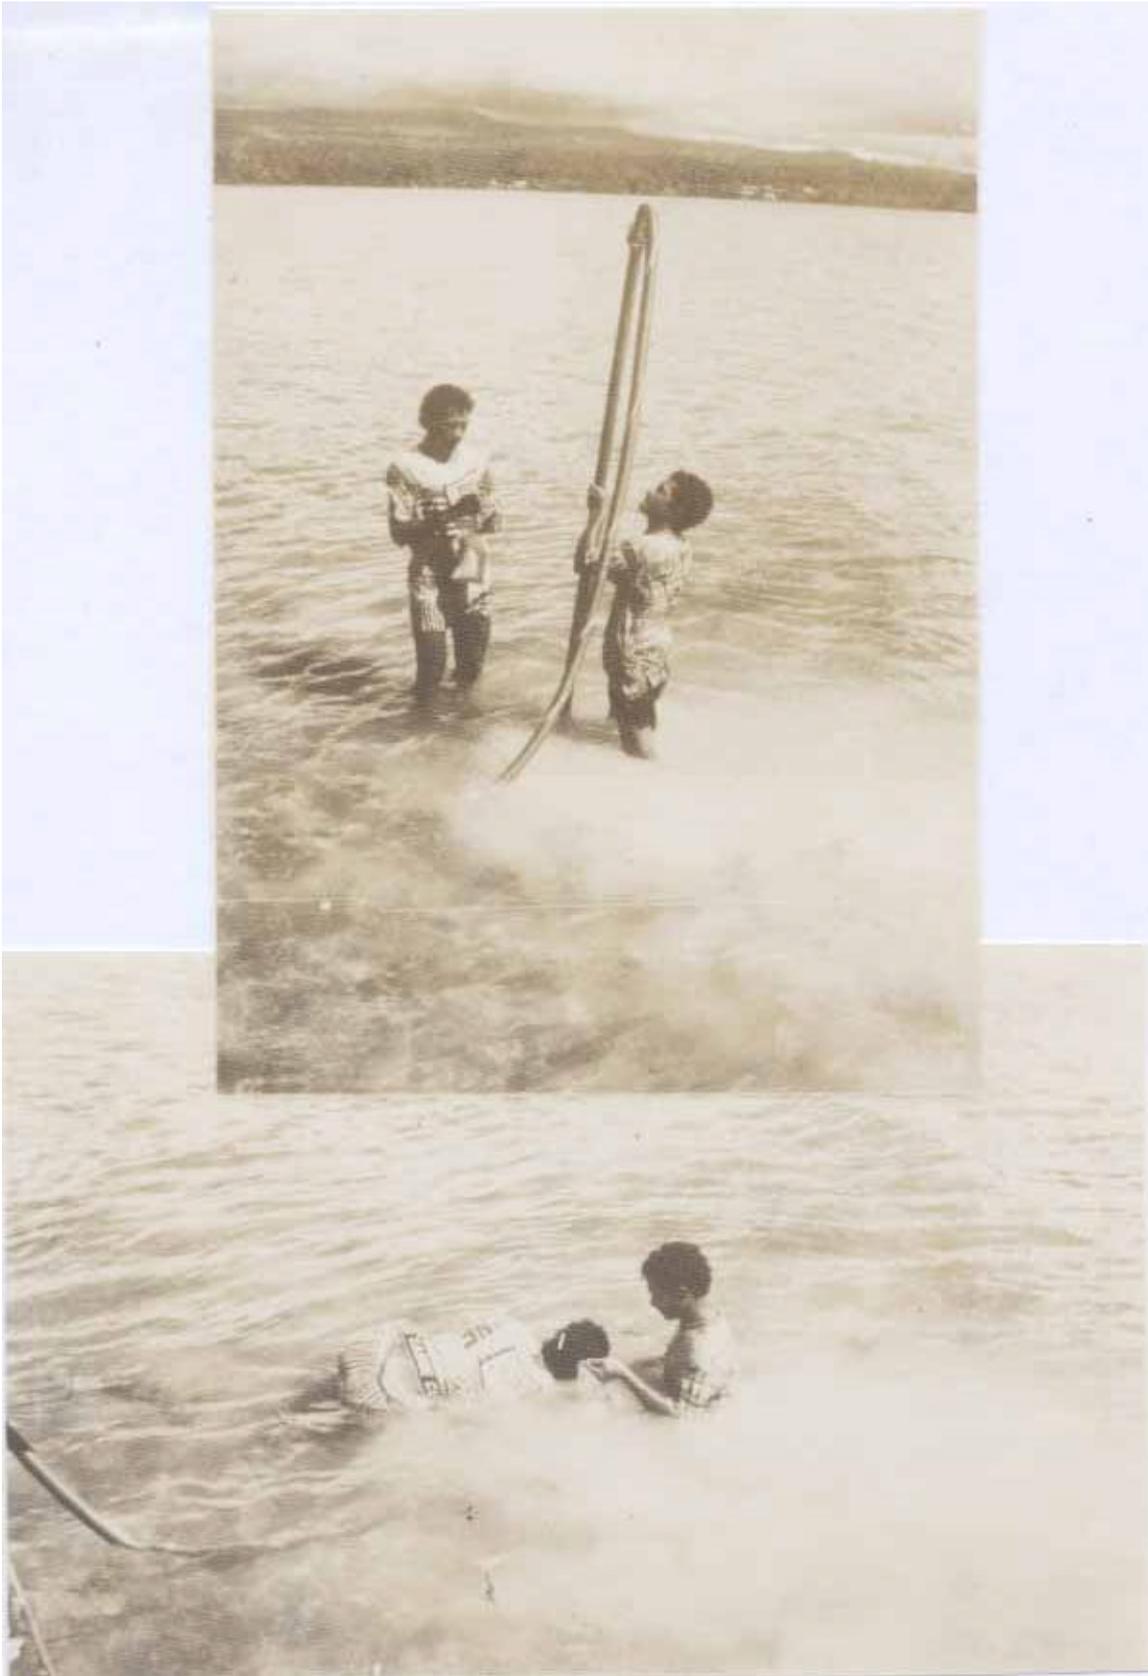
Figure 2. Jetprobing in Vaiusu Bay.

This diver controlled system to drill into the seafloor consisted of a 3 meter-long galvanised 2" ID pipe with a 1" ID jet nozzle connected to a diesel water pump (Figure 2).

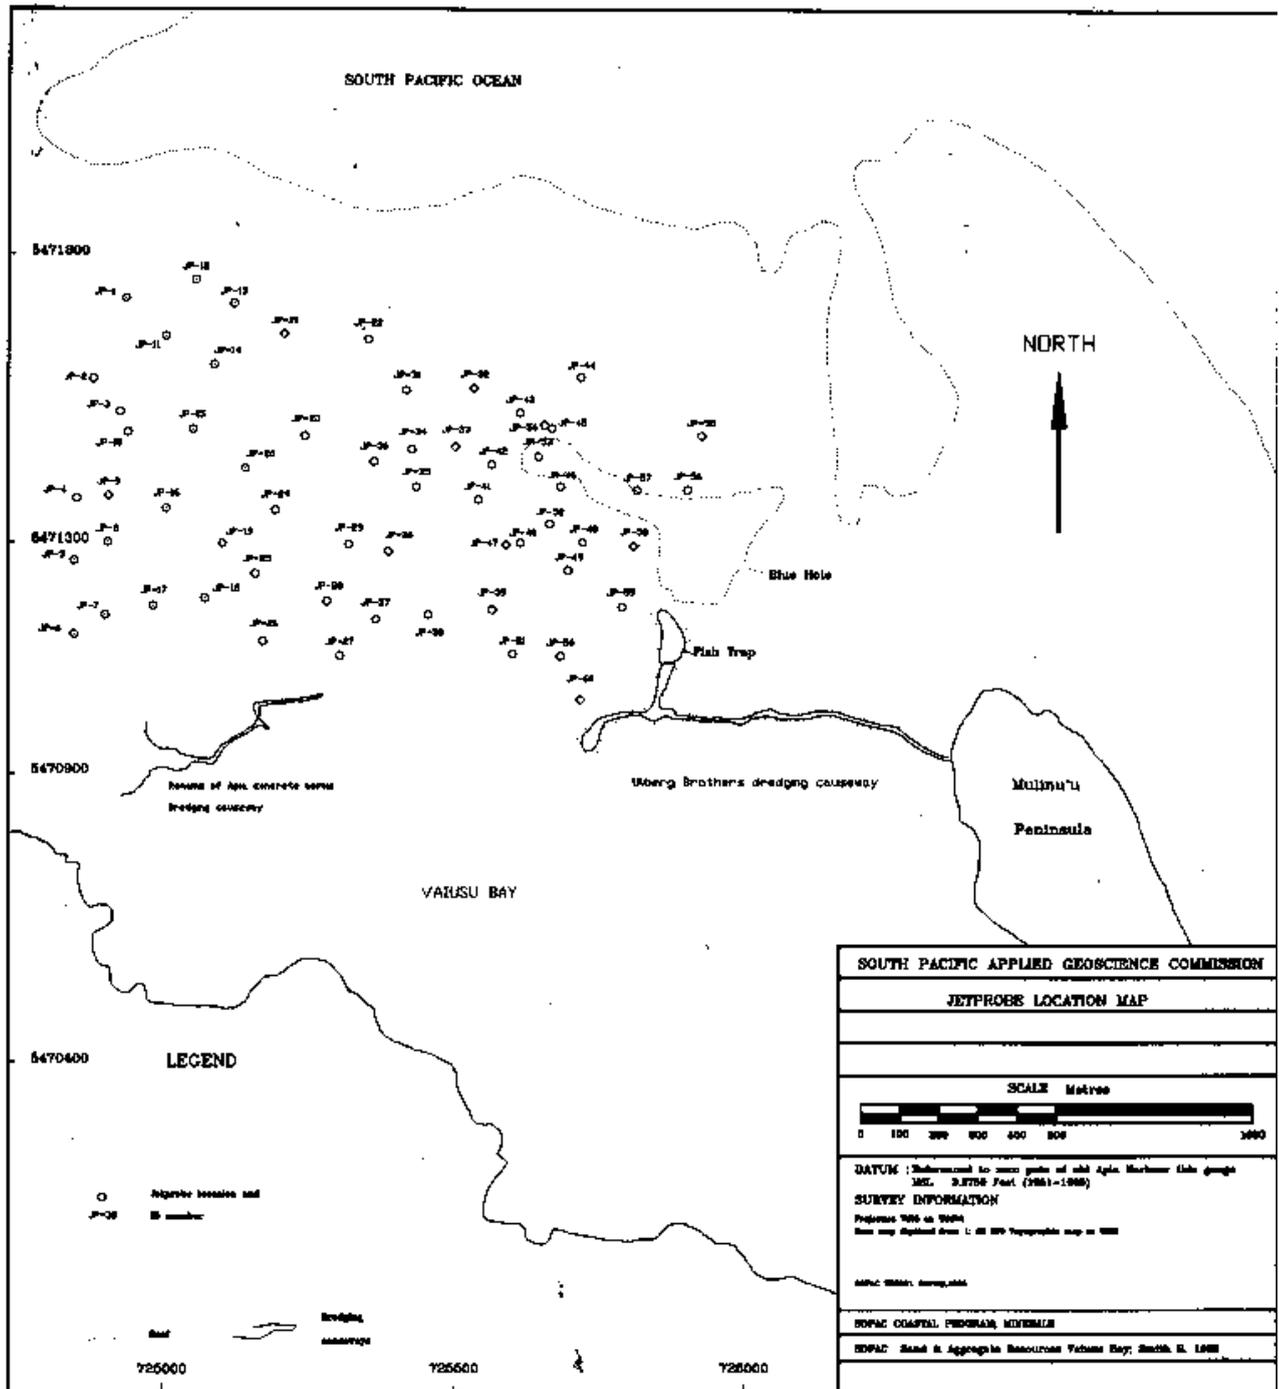
Figure 3. Jetprobe locations Vaiusu Bay.

During this survey 60 jetprobe holes were drilled into the lagoon floor in the area surveyed (Figure 3) to confirm sediment thickness, obtain samples for grain size analysis, and determine sediment distribution and composition. The sample return was dependent on the nature of the substrate drilled. In loose to semi-consolidated sands there was a large sample return that could be collected in the return flow of water at the top of the hole. In semi-consolidated gravels with high porosity and permeability, as in a coral and rubble detritus deposit, the sample return was small. In addition ten surface sample were taken. A log of all sampling is in Appendix 2.

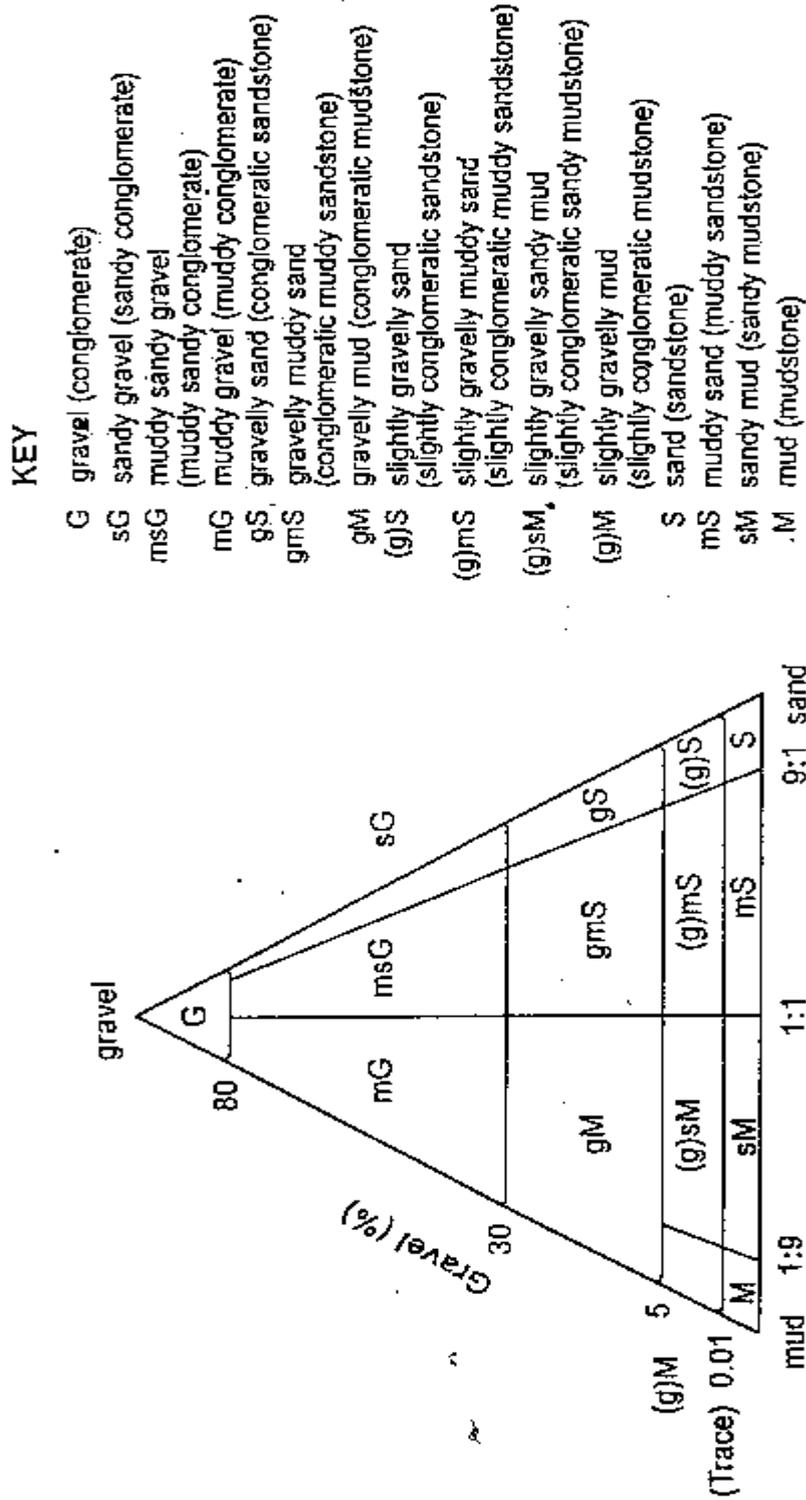
Figure 4. Textural sediment classification from Folk.

Table 1. Grain size classification as used in this report. Textural classification of the sediments (Figure 4) is based on Folk (1968).

Following Folk's textural classification for sediments (Figure 4), the samples plotted in three categories, gravelly sand, sandy gravel and gravel. Based on this, the distribution of gravel, sand, and mud is shown in Figure 12, 13, 14 respectively.

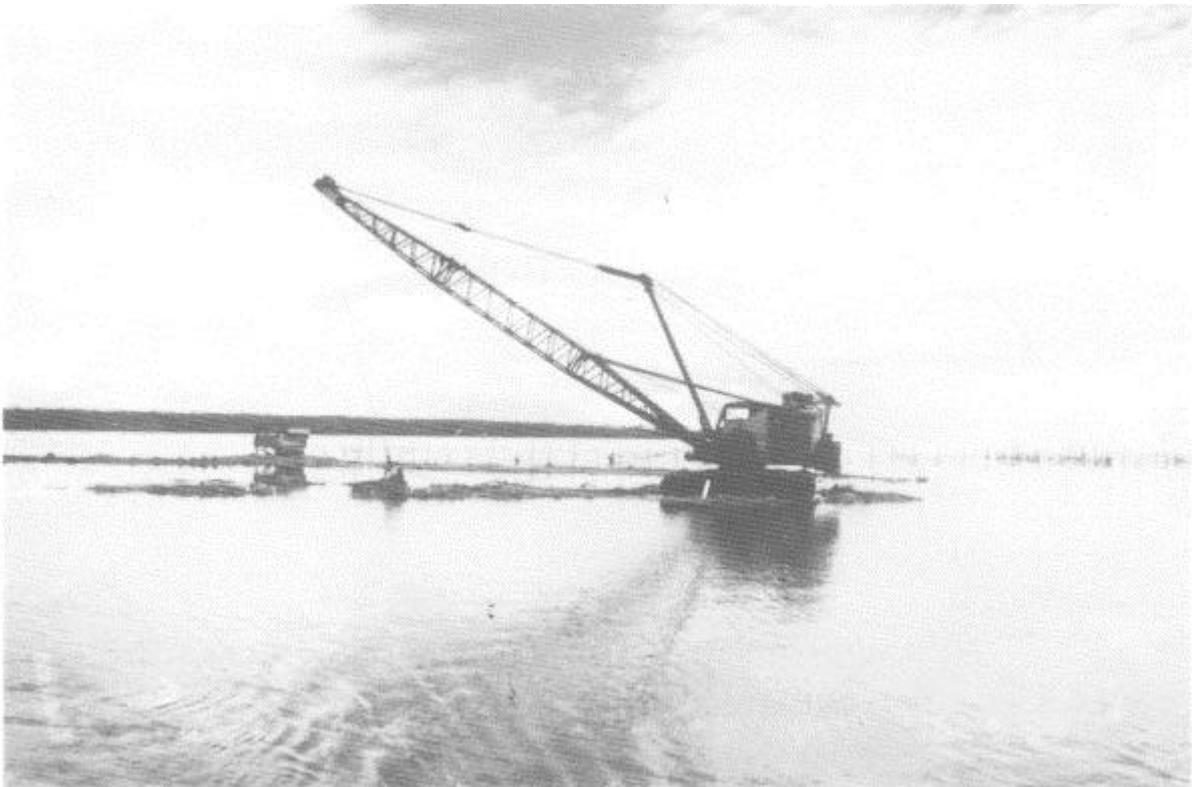
Figure 5. Dredging in Vaiusu Bay. Note fishtrap behind dredge.

The current method employed at present for aggregate extraction from the lagoon areas of Vaiusu Bay by operating draglines from dredge causeways constructed from the shoreline into the lagoon (Figure 5). The location of the current extraction sites and active causeways are shown in Figure 6.

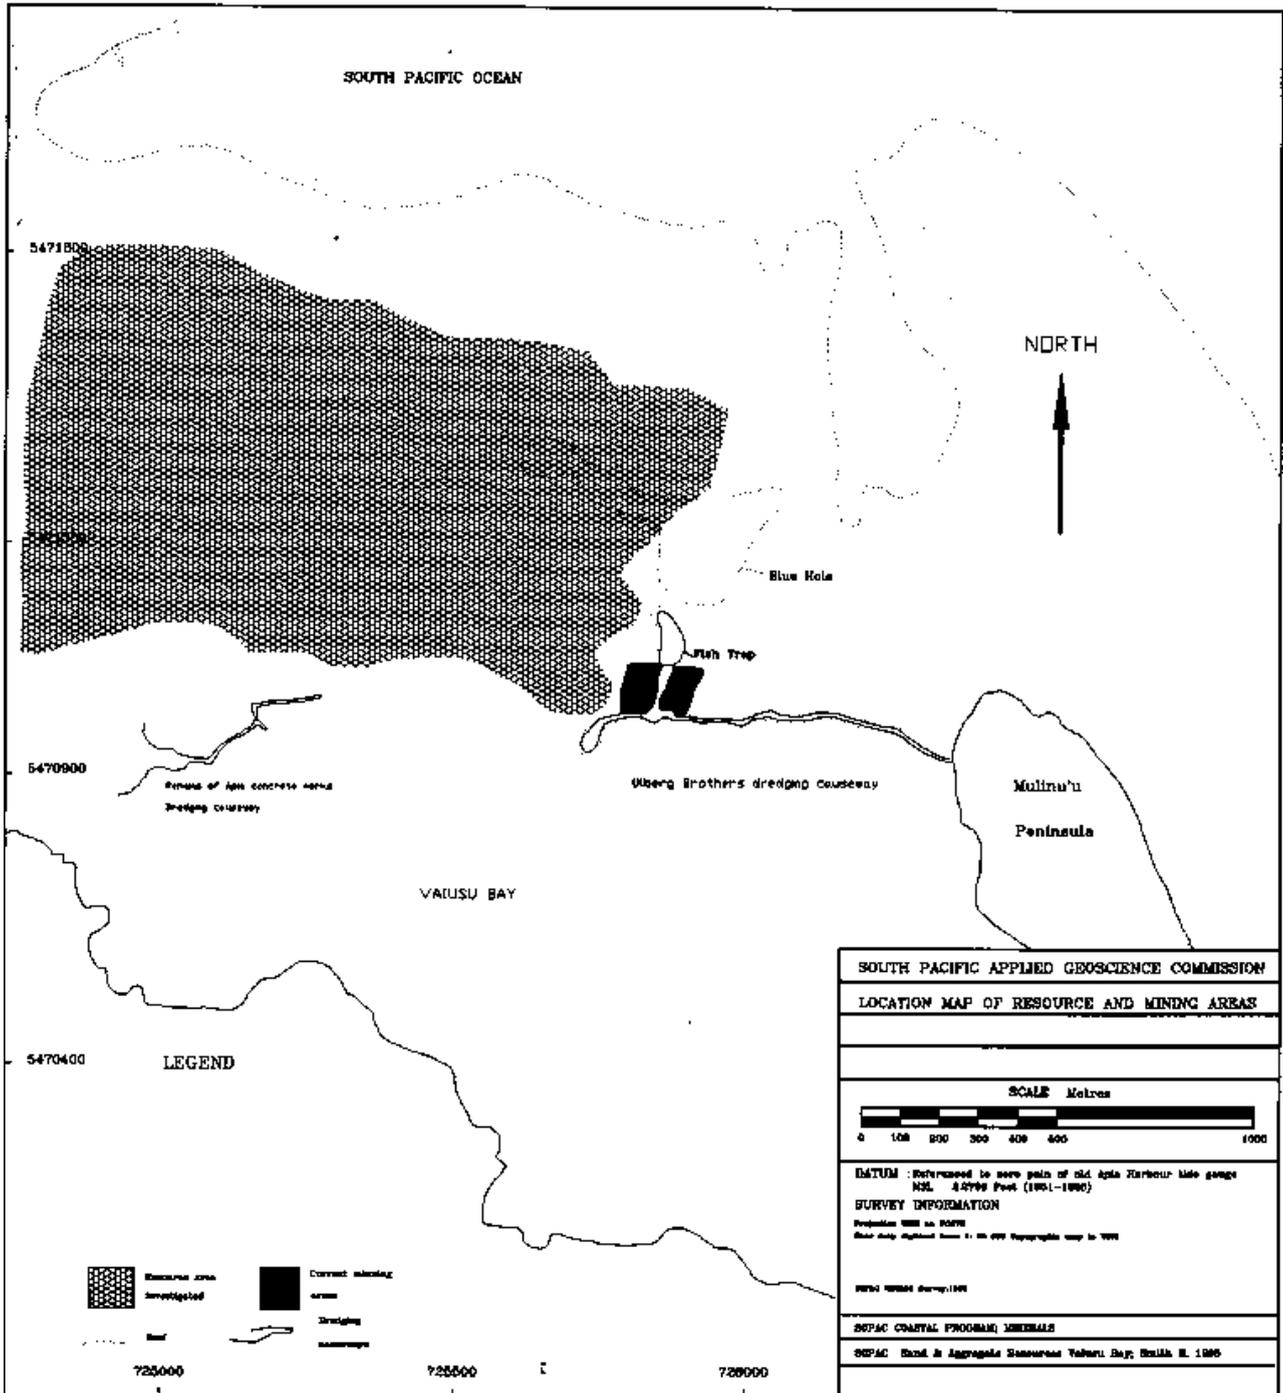
Figure 6. Location of the current extraction sites and active causeways.

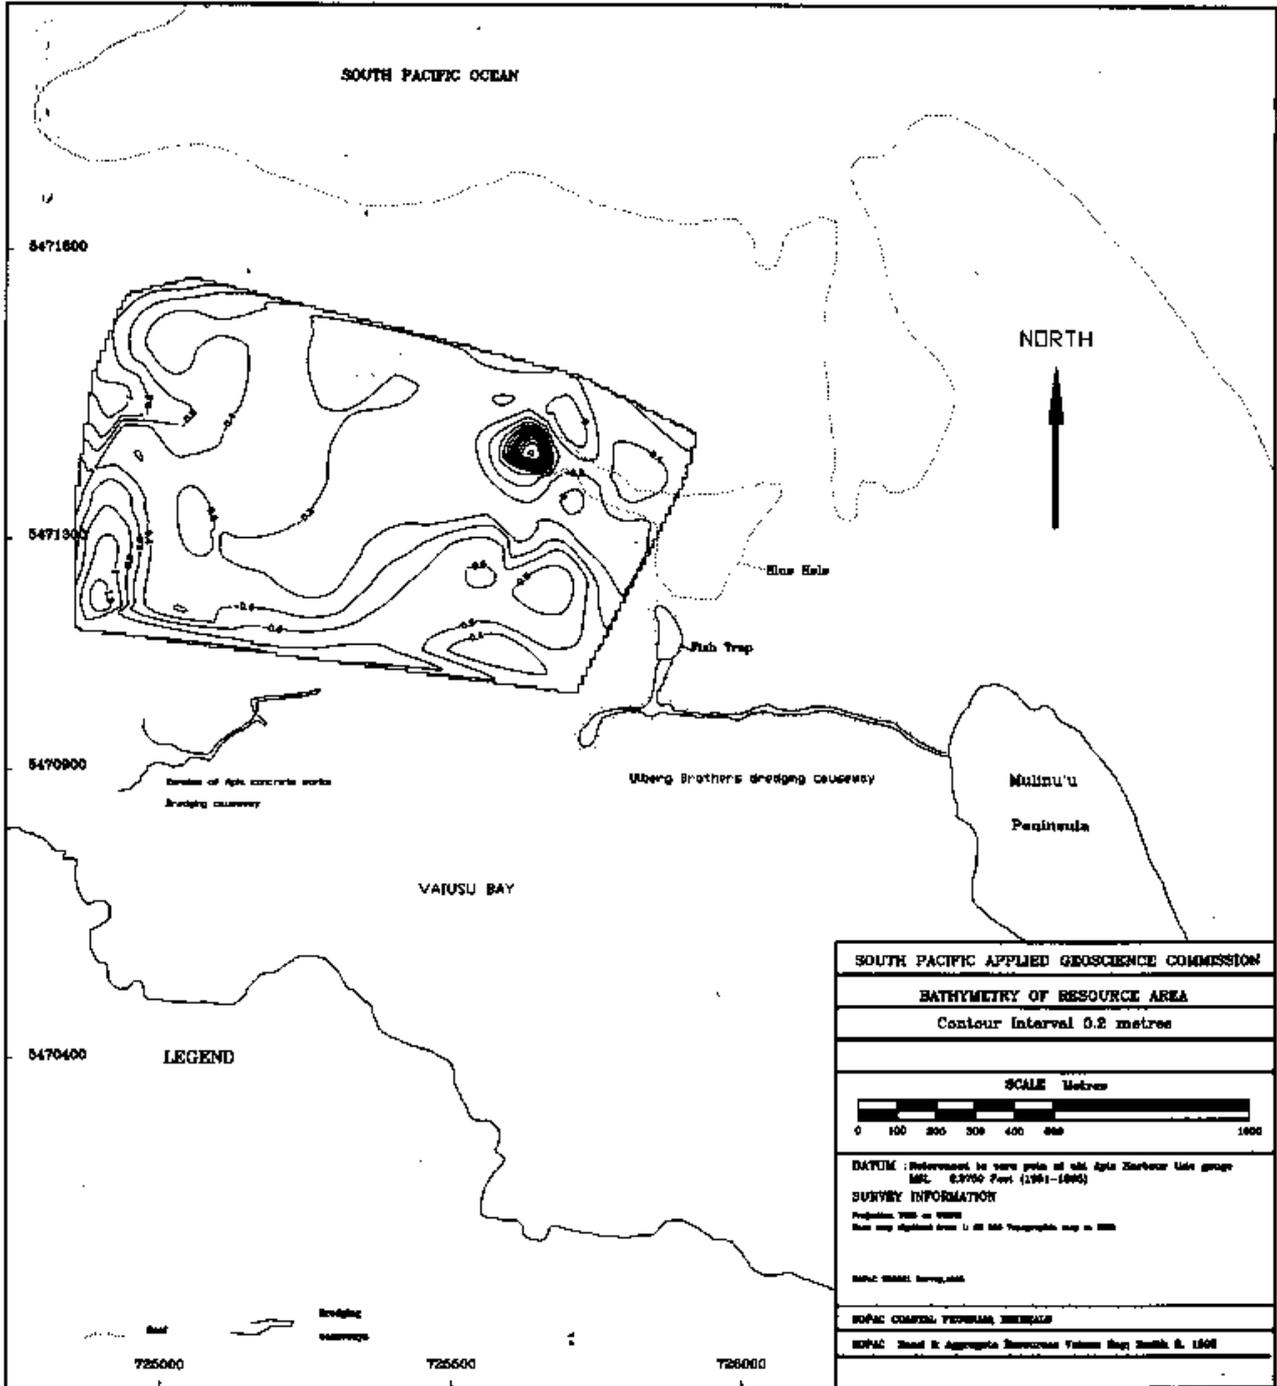
Figure 7. Bathymetry Vaiusu Bay.

Bathymetric soundings in this area are from the 60 jetprobe stations. Detailed profiling was prevented with the loss of the transducer on the coral reef. The area surveyed was characteristically shallow and of low relief with much of the area exposed at low tide. Figure 7 is the bathymetry shown with a contour interval of 0.25 metres.

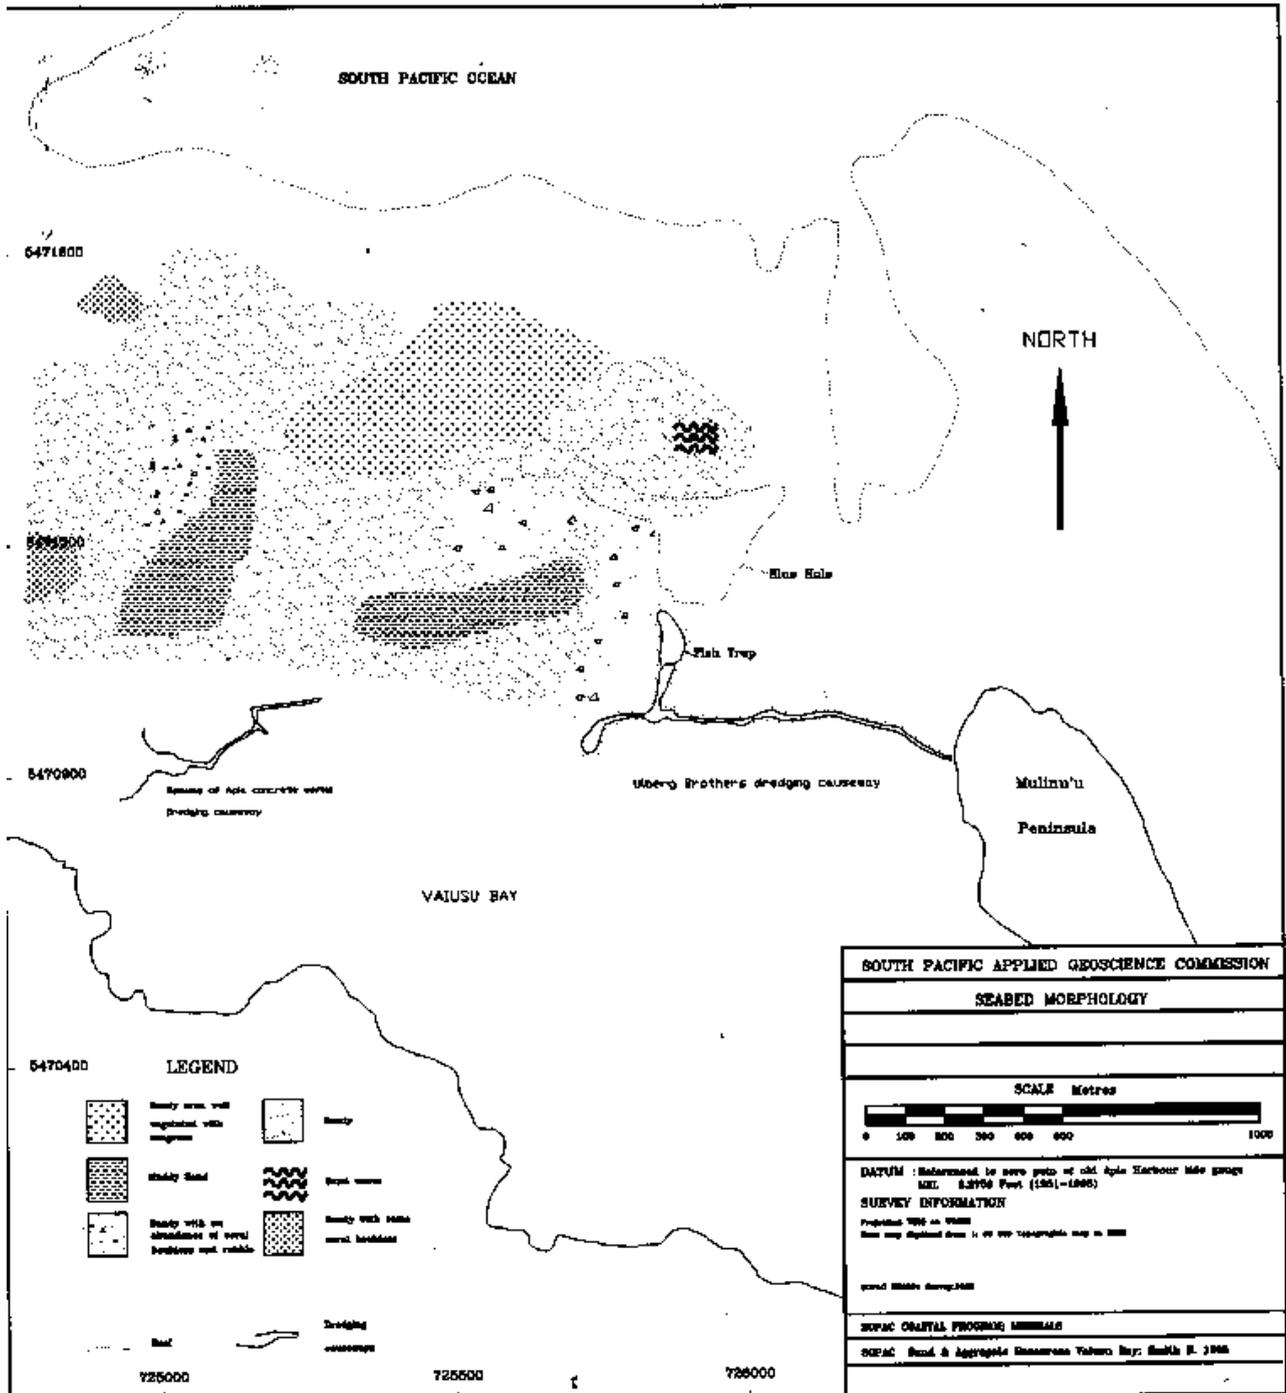
Figure 8. Seabed morphology interpreted from the jetprobe locations.

Figure 8 is an inventory of the different seabed morphological units interpreted from the jetprobe locations. In general the area is devoid of any significant coral growth and beds of seagrass. An area lying north of the current dredging site and close to the reef crest was the only area where seagrass was noted to be abundant. Of the total area shown in Figure 8 (1.6 million m²) the area still under seagrass represents only 13 % coverage.

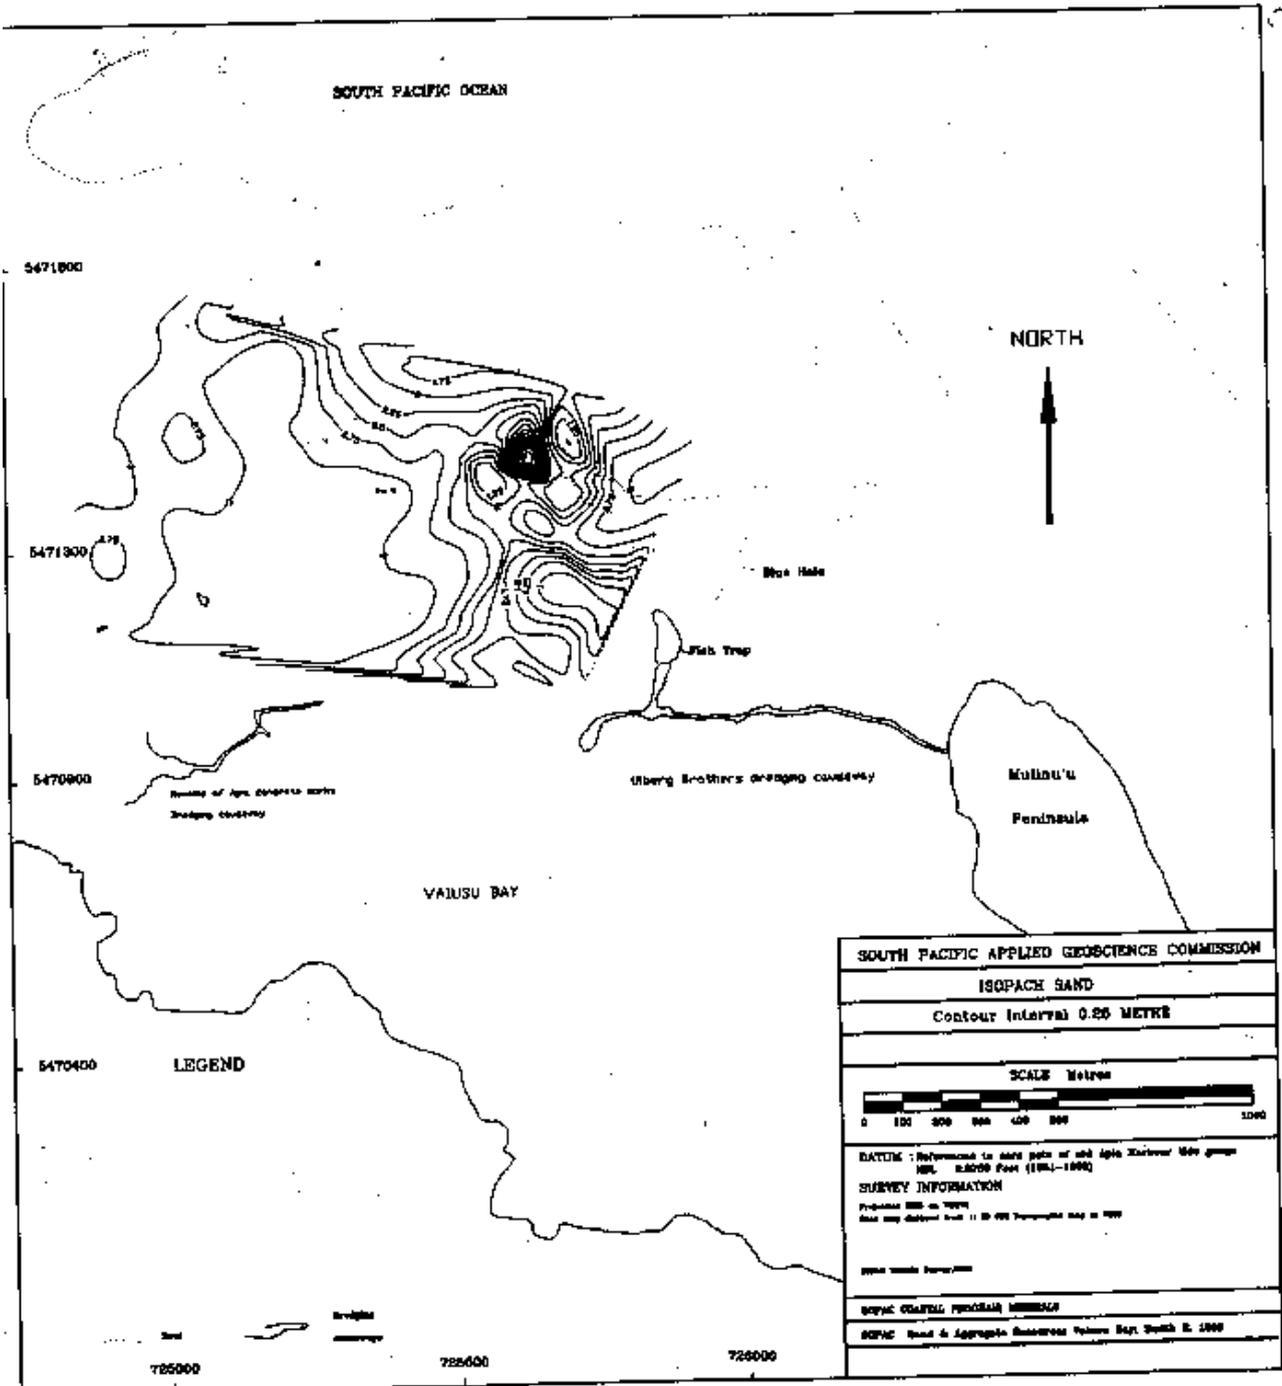
Figure 9. Isopach of sediment in resource area.

From the jetprobe locations and depth of penetration data combined with the bathymetry data an isopach, a map of sediment thickness was generated to calculate the resource volume (Figure 9). For a water depth range between 0 and 3.0 metres there is a potential resource volume of 3 million m³ available. This is a conservative figure based on proven thickness of sediment from the jetprobe data. In 1987 a borehole northwest of the area surveyed penetrated 17 meters of coral sands (JICA1987) terminating before reaching bedrock. In Figure 10, based on the jetprobing results is a map illustrating “buried reef pavement” , areas where a hard impermeable substrate interpreted to be reef pavement covered by a layer of sand between 0.5 and 2 metres thick. These areas were identified during the jetprobing, when the probe penetrated through the top sand layer and reached a resistive substrate. Due to the substrate’s impermeability the jetprobe bounced as a result of the hydraulic action of the water jet.

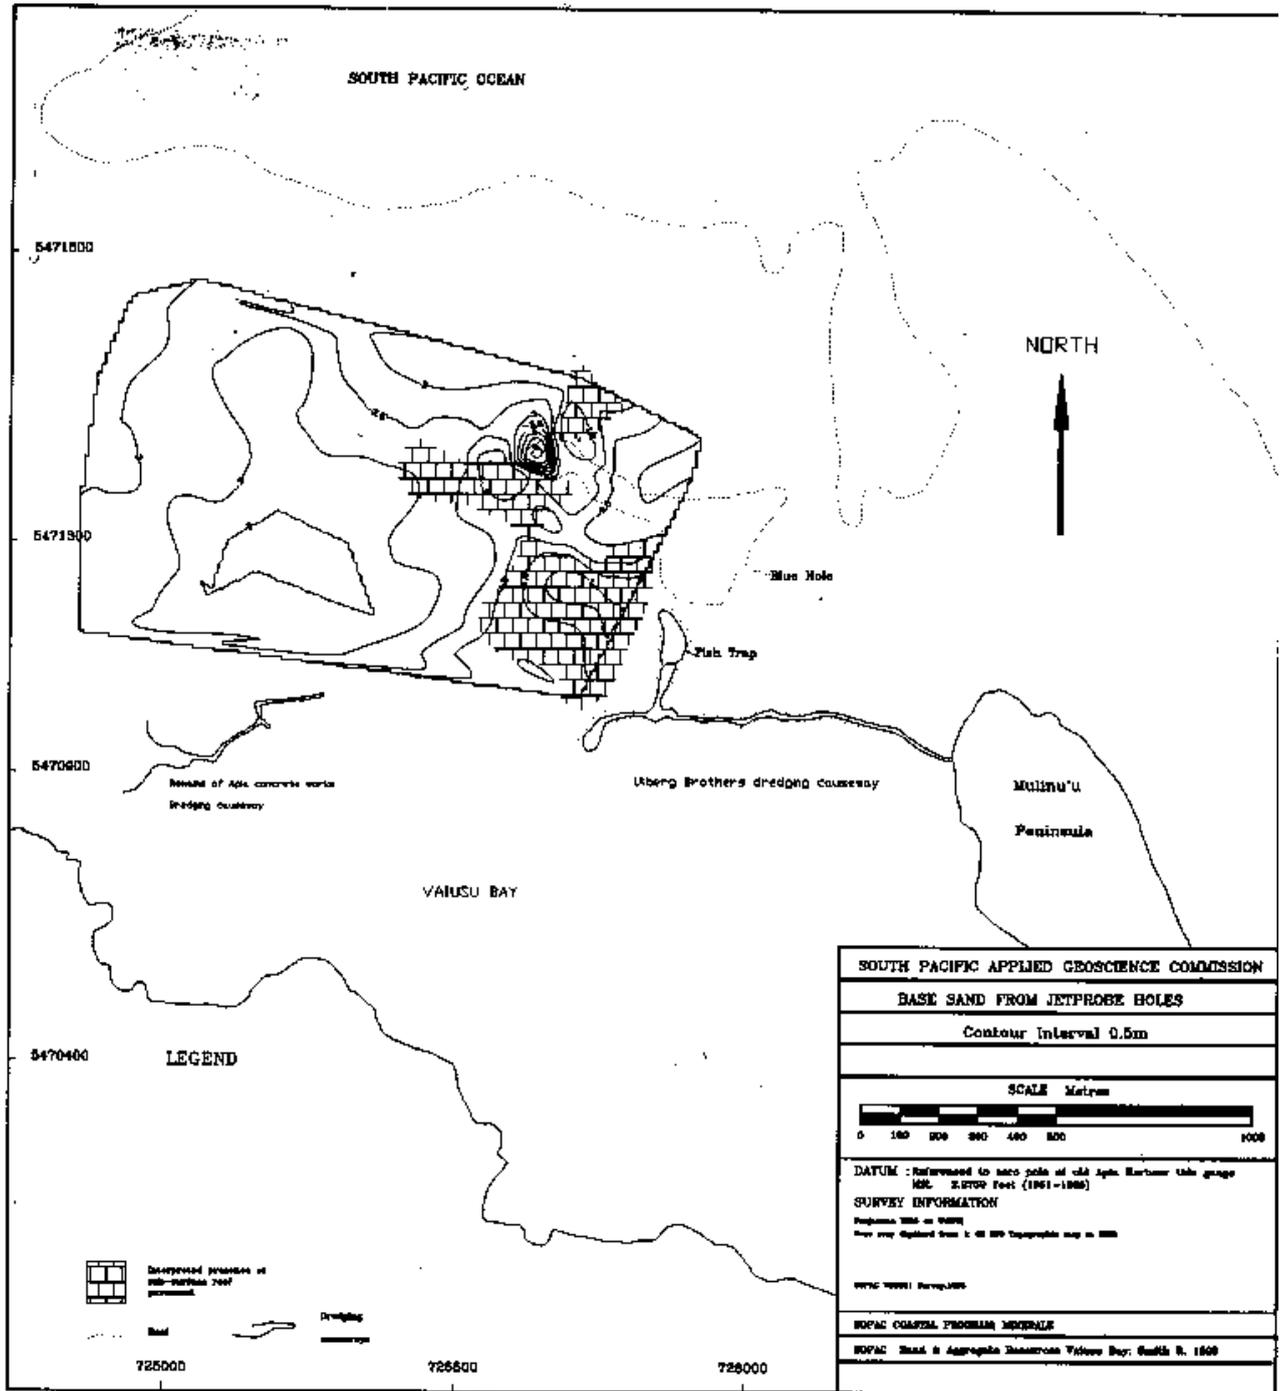
Figure 10. Base of sand from jetprobe data in resource area.

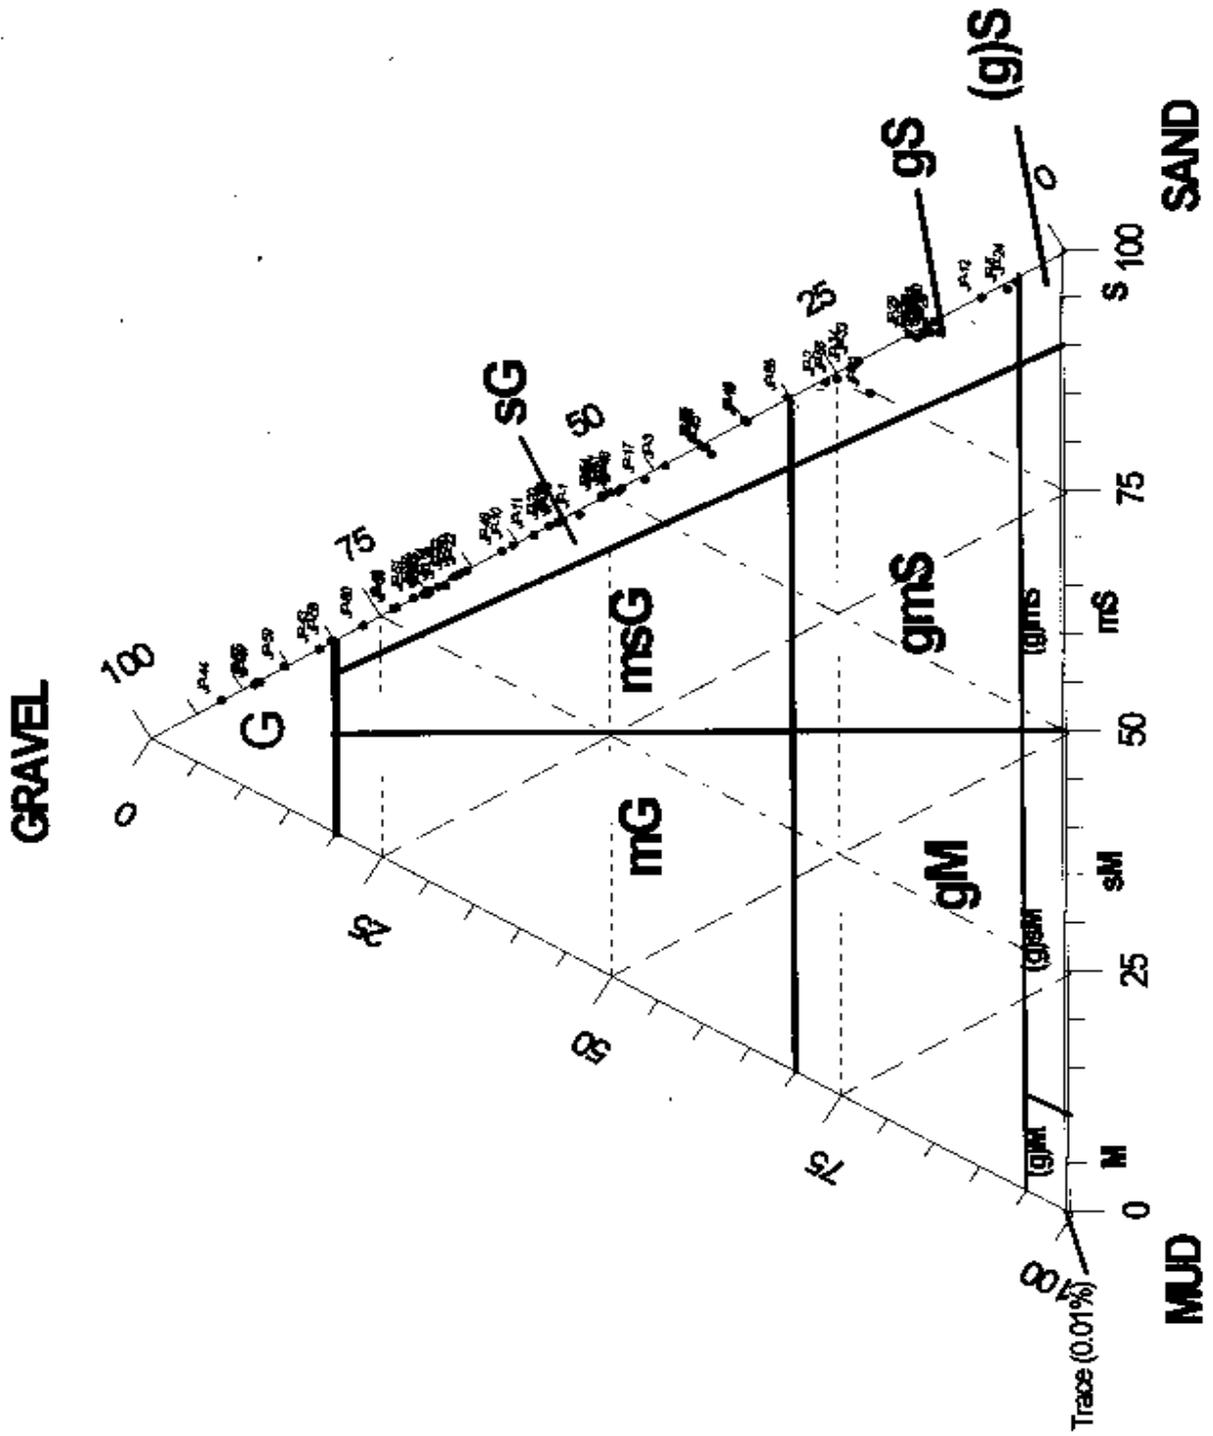
Figure 11. Textural nature of jetprobe samples based on Folks classification.

Dry sieve data analysis data of the jetprobe samples were used to compile a ternary plot of sample texture based on three end components, gravel fraction, sand, and mud (Figure 11).

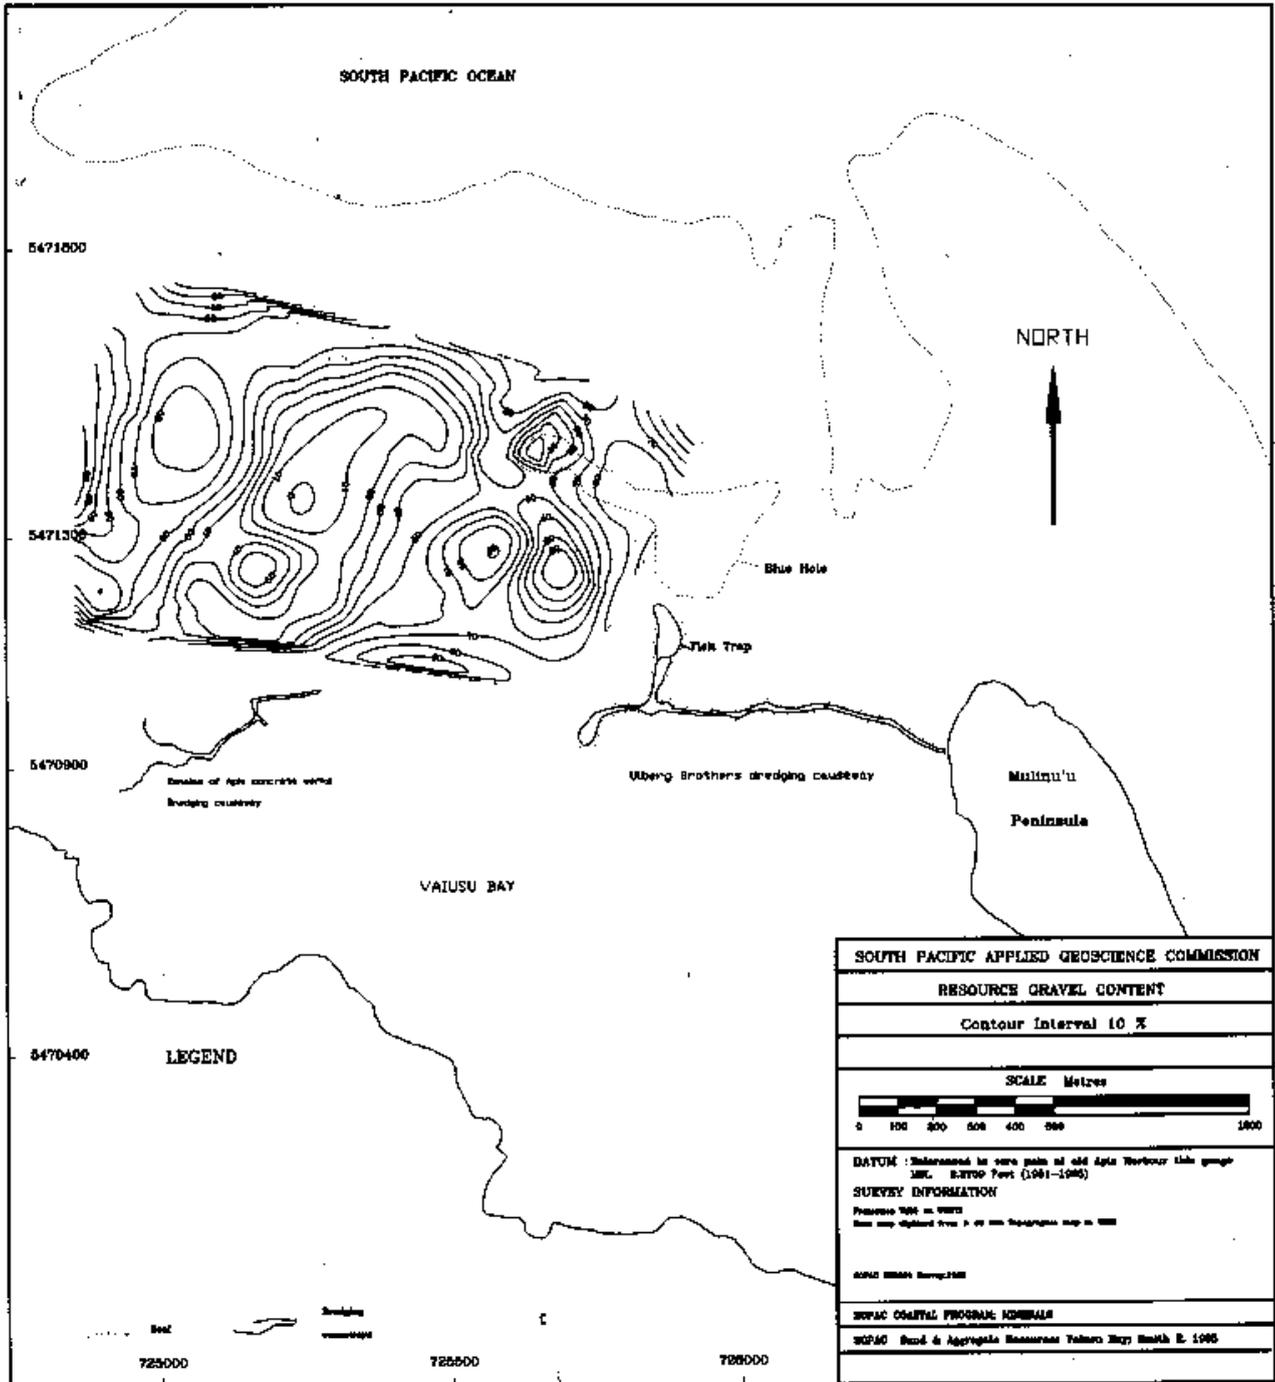
Figure 12. Resource gravel content.

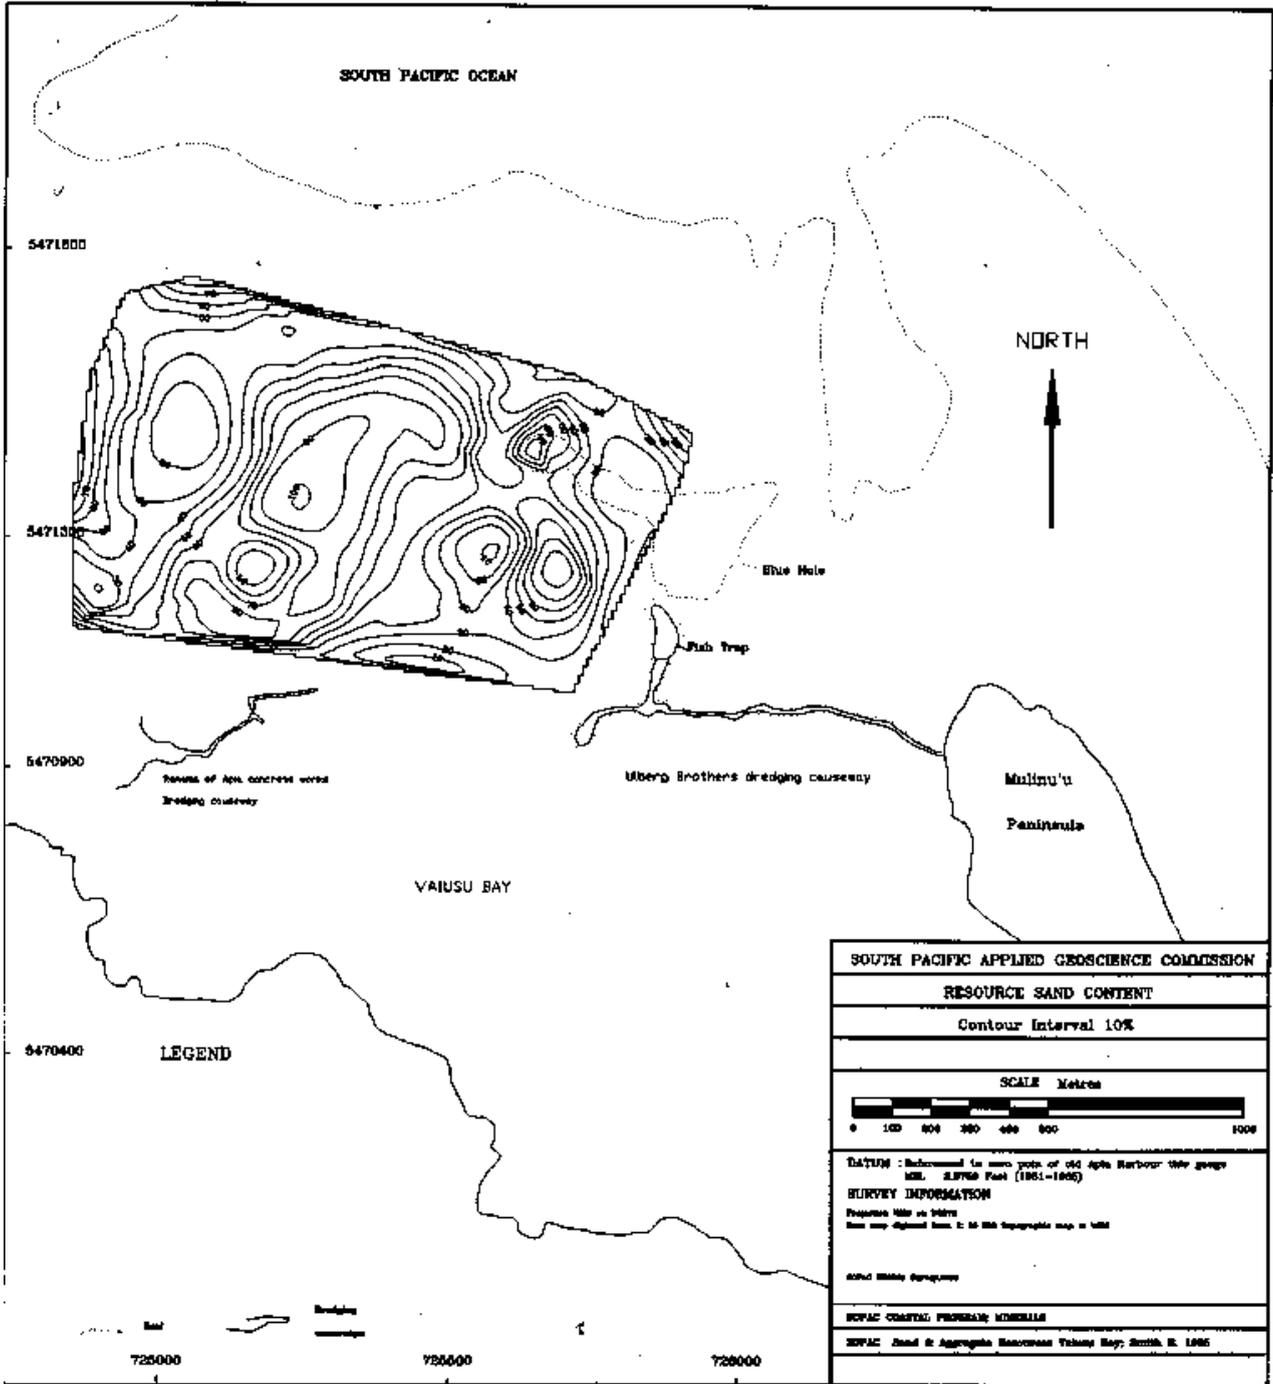
Figure 13. Resource sand content.

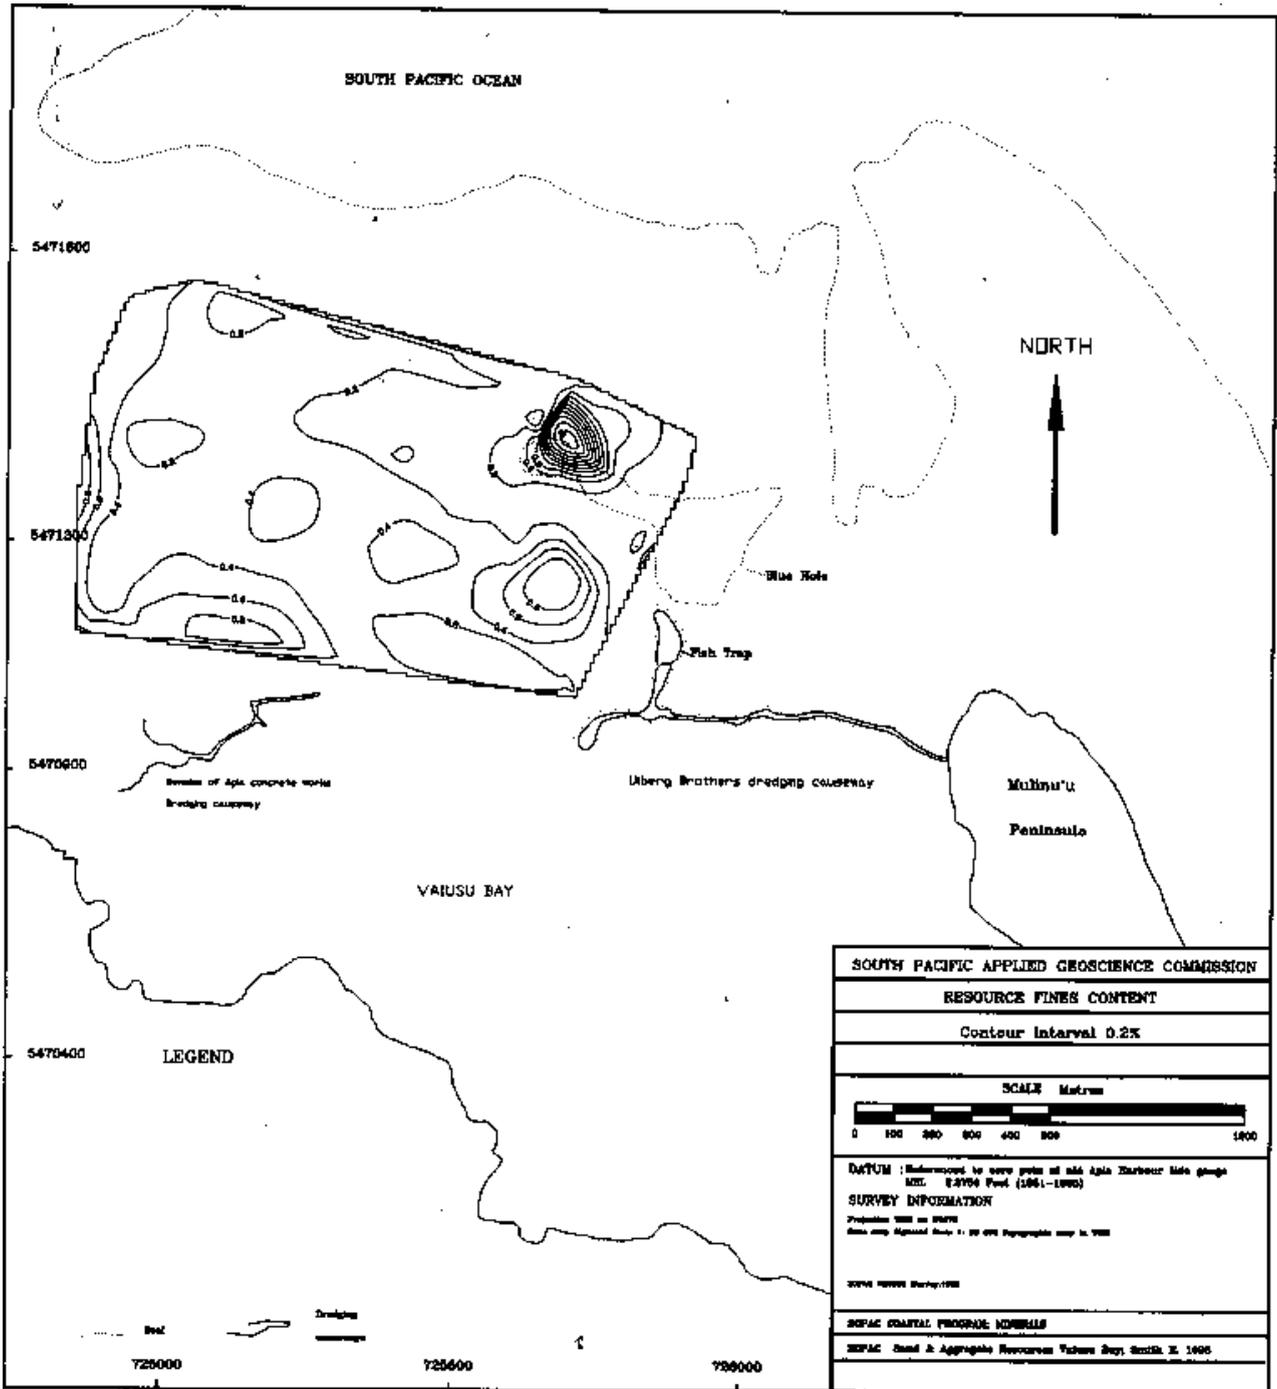
Figure 14. Resource fines content.
