SAND AND AGGREGATE RESOURCES VAIUSU BAY, APIA, WESTERN SAMOA

Robert Smith
SOPAC Secretariat

September 1995

SOPAC Technical Report 223

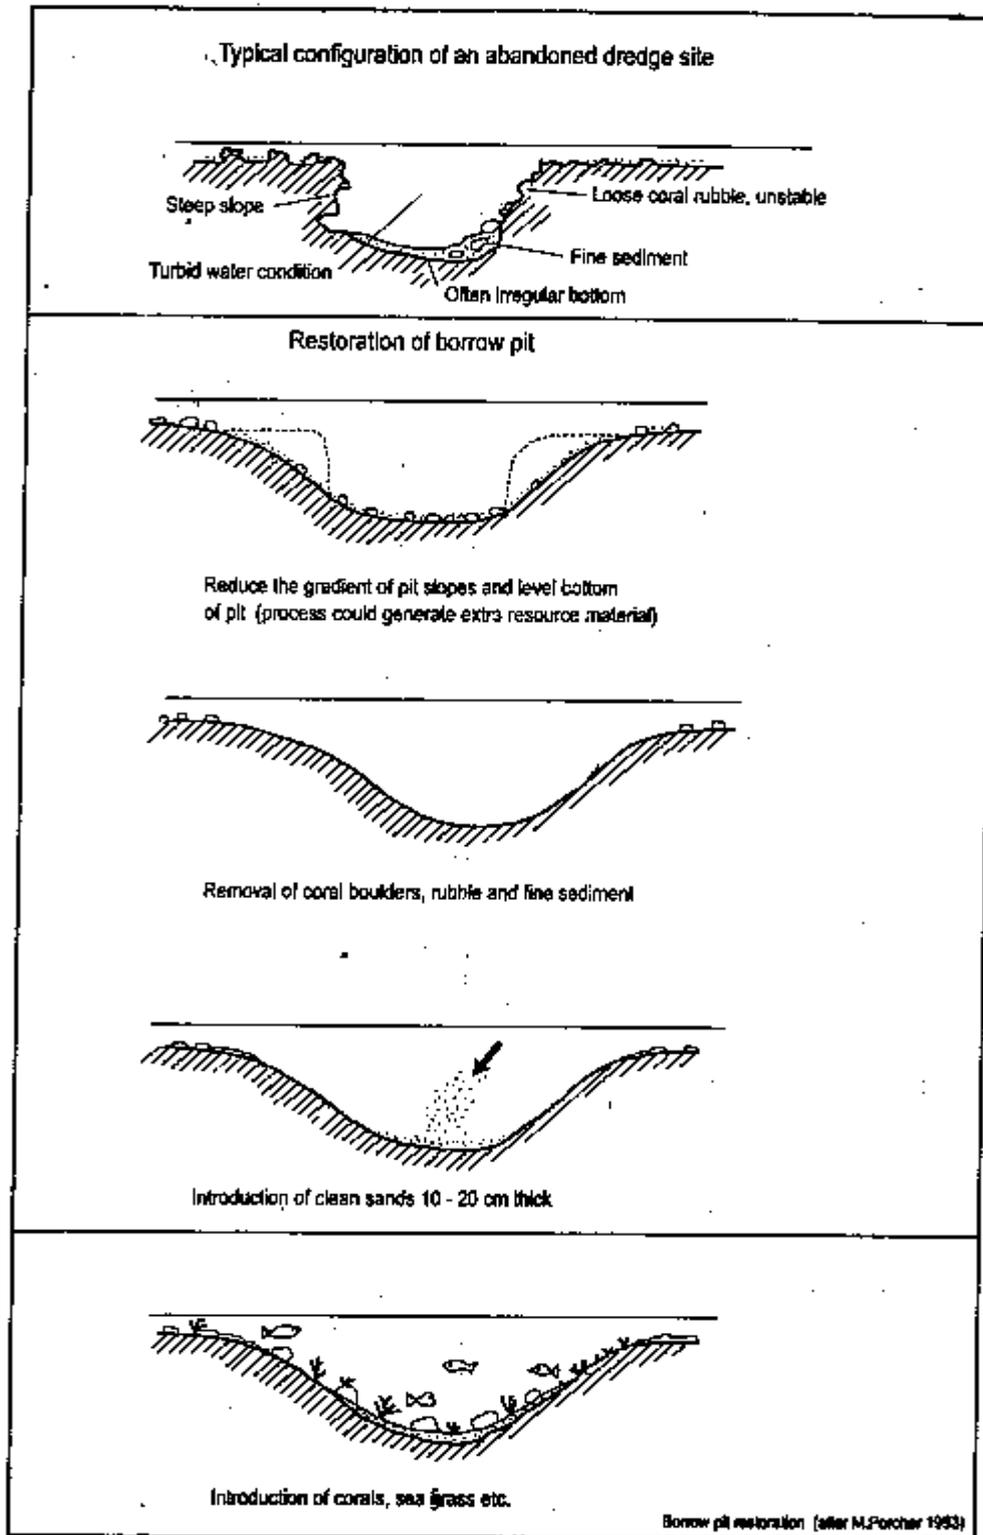
Figure 15. A cartoon illustrating a technique of dredge site reclamation.

Figure 15 is an illustrative cartoon depicting a sequence to rehabilitate a mined area (Porcher M 1993). Rehabilitation of old workings is desirable not only for health reasons, encouraging new coral growth and recolonization of sea grassbeds it can impact in a positive manner on coastline stability, water circulation but is also aesthetically pleasing.
