## ENVIRONMENTAL CASE STUDIES

SOUTH PACIFIC REGIONAL ENVIRONMENT PROGRAMME (SPREP)

THE EFFECTS OF MINING ON THE ENVIRONMENT OF HIGH ISLANDS: A CASE STUDY OF NICKEL MINING IN NEW CALEDONIA

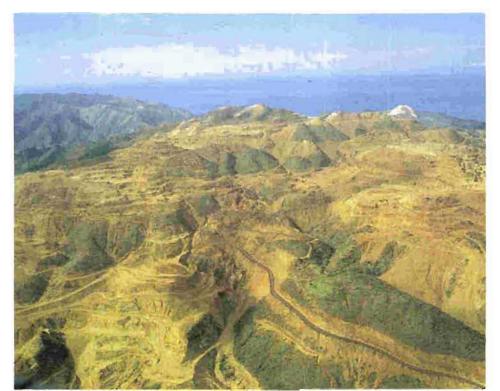
Extraction benches, access roads and dumped waste materials in THIO Plateau mine.

In 1943 and 1954/55, exploitation was confined to the summit ridges where maximum ore concentrations were more easily reached. Subsequently, the whole central portion of the mountain masses was cut off from 400 m above sea level upwards. Extraction proceeds in horizontal cuts forming giant benches 5 to 8 m wide which reproduce in relief the pattern carved out of the ore-bearing layers, as can be seen on the Panguna copper mine at Bougainville (Papua New Guinea), and enable the ore to be easily loaded and trucked away.

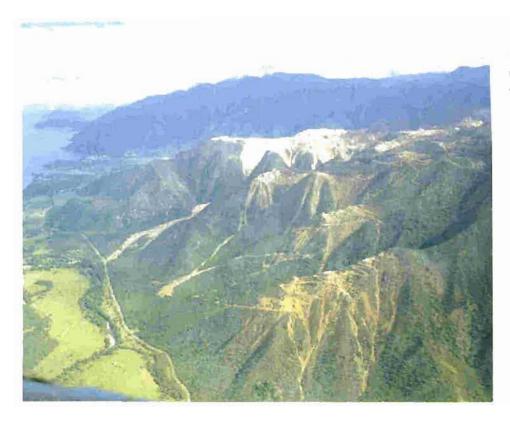
The Dothio river valley and the Carrieres mine.

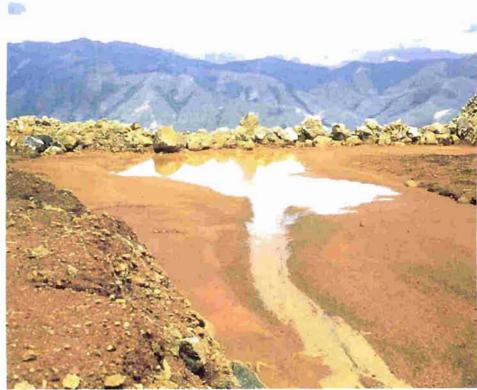
A protective dam of boulders traps the finer materials on a spoil-dump.

Building of rock dams and settling ponds below the mining zones also aims to intercept these materials as they are being carried downstream. An example can be found in the works carried out by the Nickel Company (SLN), which operates the Plateau mines in the Thio area, on the lower portion of the Ouanamourou, a right-bank tributary of the Dothio, to reduce the amount of material meansported beyond the Wellington waterfall. Dikes were made by bulldozer to channel the coarser materials and a diversion dam built to trap the finer ones.
