Impacts of Oil Palm Activities in the Kokoda and Popondetta Catchments

An Initial Environmental Examination

February-March 2006

Report for CELCOR and Ahora/Kakandetta Peoples Foundation

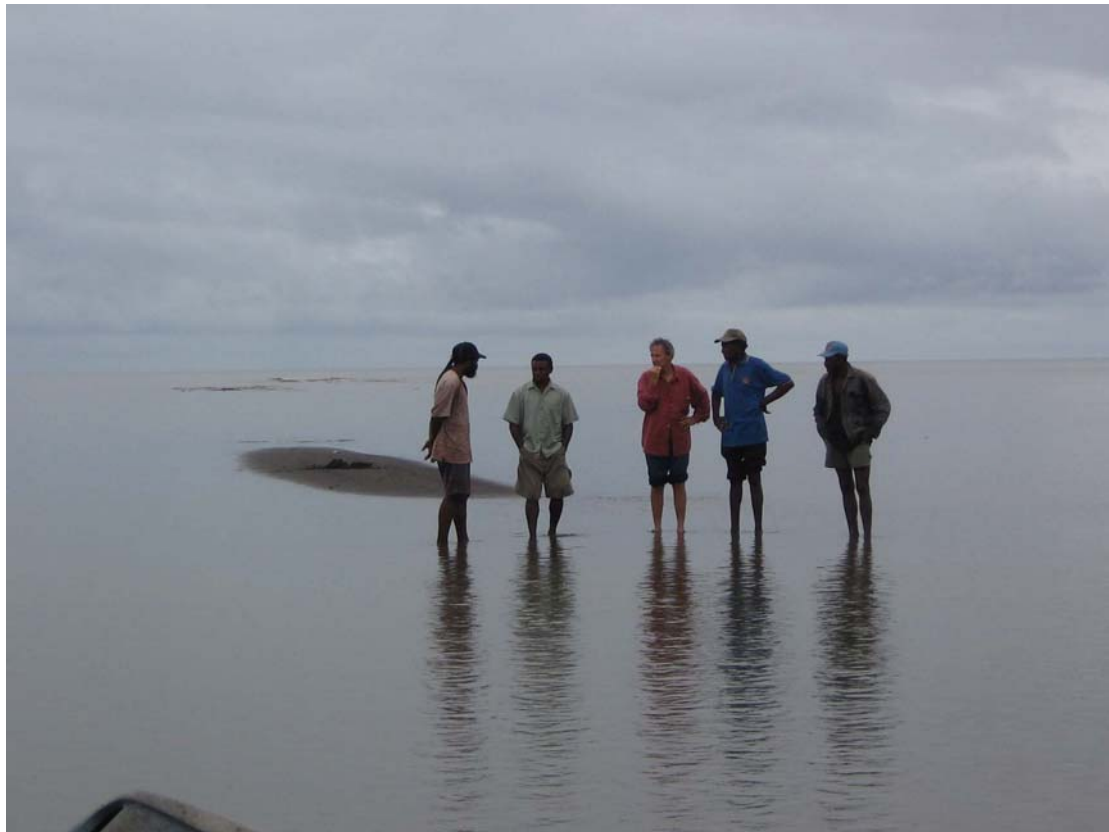
Sedimentation in Bauroda Lagoon – Ninianda Bay

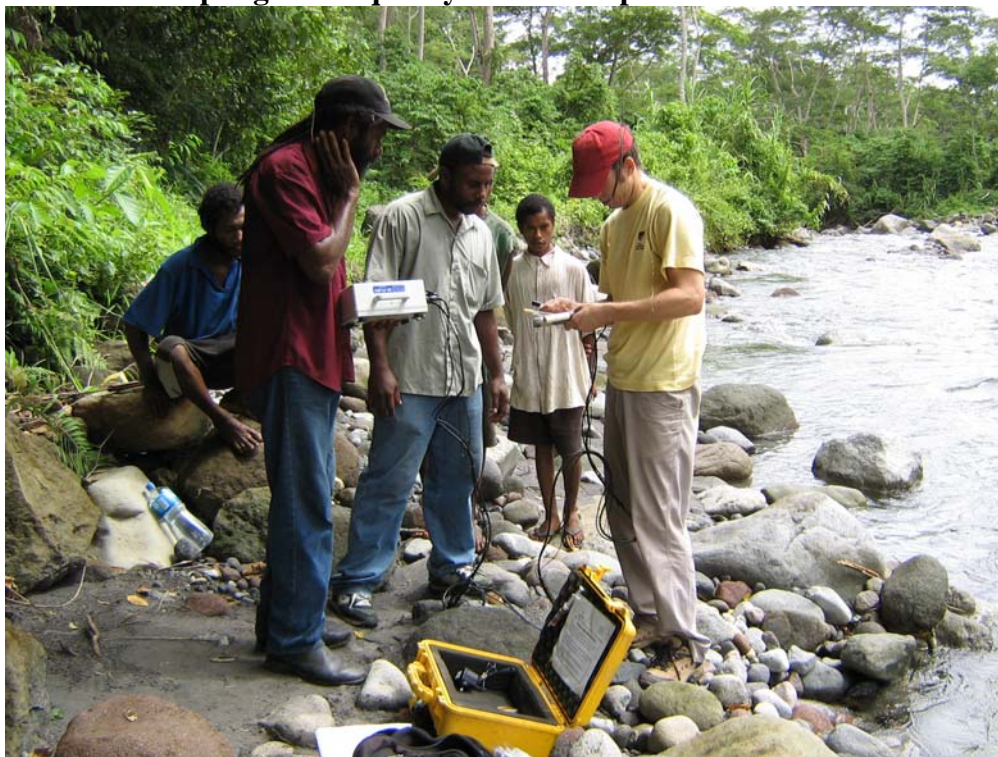
Plate 1: Sampling water quality with multi-parameter monitor.

The instrumentation used was a TPS 90-FL multi-parameter monitor. The parameters measured included; dissolved oxygen, conductivity, pH, temperature and TDS. EnviroEquip calibrated all probes prior to the 2-week period of sampling. Conductivity and pH were calibrated daily as recommended by the operating procedures of the 90-FL.

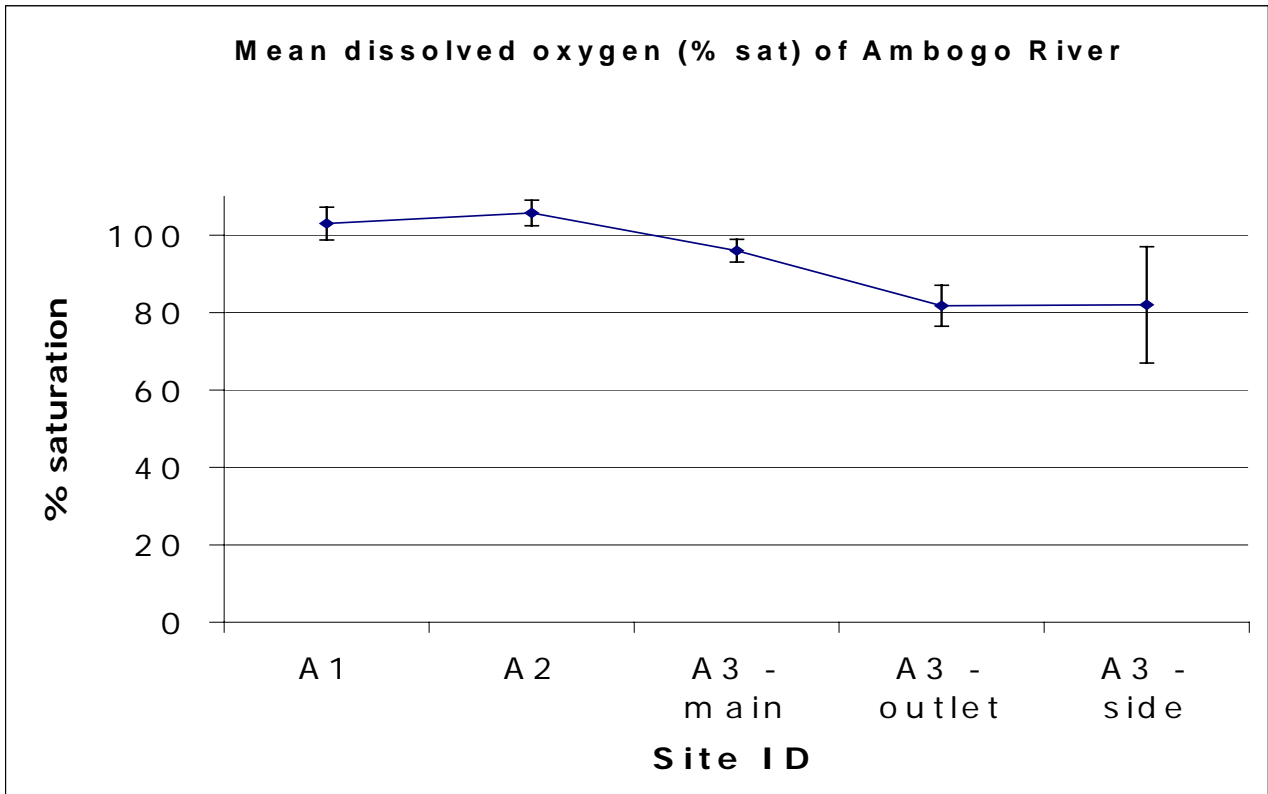
Figure 1: Mean dissolved oxygen (% sat.) of Ambogo River 1/3/06-4/3/06

The overnight sampling displayed an increasing trend of TDS throughout the night, however this result may have been due to the probe being constantly immersed into the river and building up the salinity reading.

The POME discharged into the Ambogo River resulted in a depression of the dissolved oxygen levels within the effluent plume. The oil and grease content was recorded to be 6ppm, which after dilution within the creek and by heavy rainfall on the holding ponds, suggests the POME at discharge may exceed the 50ppm recommended by the Malaysian POME environmental standards. Further sampling during the dry season and directly from the discharge point would be required to confirm these results.

The effluent plume was observed on each of the 4 sampling days between 10 am – 1 pm. **The consistently depressed dissolved oxygen levels recorded during the overnight sampling suggests the release of POME from the mill's discharge point was continuous throughout the sampling period.** Persistent reductions in dissolved oxygen can result in fish and invertebrate death or immobilisation and loss of river biota. The impact of this plume on the downstream ecological system requires further study. This evidence supports the PNG's Department of Environment and Conservation's (2005) statement that "the zero discharge system would be inefficient during wet season and peak production at the mill".

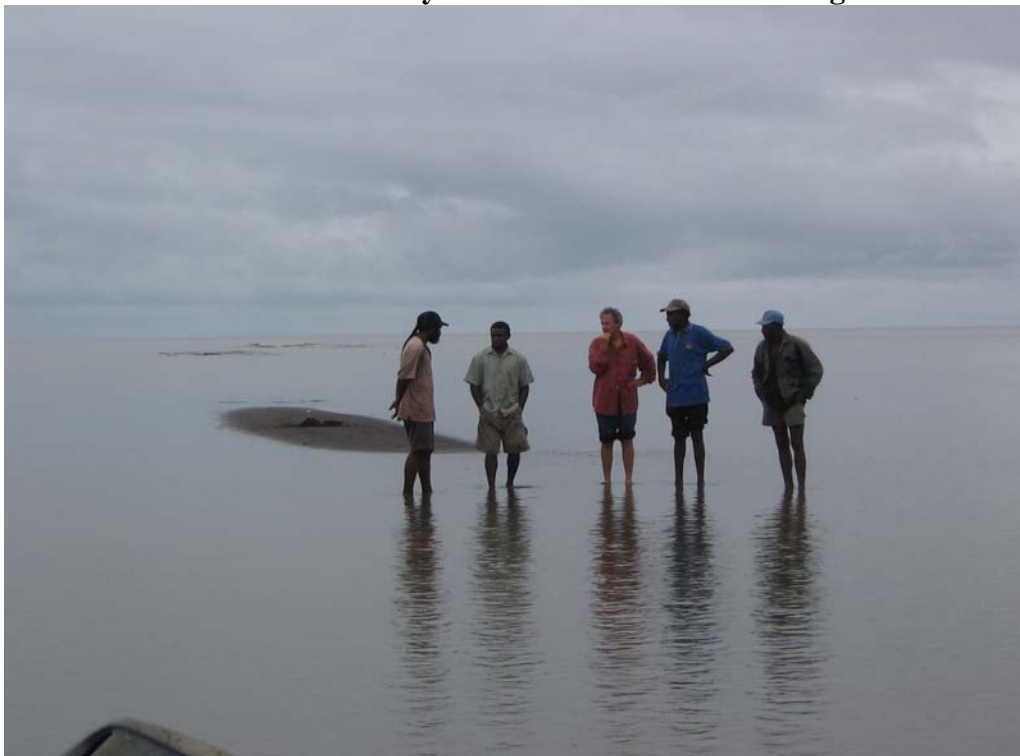
Plate 3: Ninianda Bay sedimentation - Bauroda Lagoon

A site visit was undertaken to Ninianda Bay (Barouda Lagoon) in response to community representatives stating the bay had undergone high levels of sedimentation since the introduction of oil palm. A comparison of the photo in Plate 3 taken in the middle of Ninianda Bay (6/3/06) to Map 3, supports the community's evidence that widespread sedimentation had occurred between the shoreline and the mangrove island in Ninianda Bay. The water level from the shore of the bay to the island did not exceed 1m in depth. At the site visit there was no sighting of the pre-existing fringing reef and deep water between the shoreline and the mangrove island. Sediments showed little evidence of benthic colonisation.

Increased sediment loads have been recorded throughout regions that have undergone large-scale agricultural activities (LaFranchi, 1999). Evidence of extreme levels of sedimentation was observed in the regions downstream of the Popondetta catchment. The comparison of maps that were created in 1975 with the current height of the sea floor suggested that siltation is up to 10m in depth. The University of PNG has proposed a research project on sedimentation on West New Britain. This research will test the hypothesis that oil palm plantations cause dramatic sediment deposition into adjacent streams, rivers and estuaries.
