**COASTAL MORPHOLOGY, SHORELINE STABILITY,  
AND NEARSHORE MINERAL RESOURCES  
OF UPOLU, WESTERN SAMOA**

March 1991

CCOP/SOPAC Technical Report 90

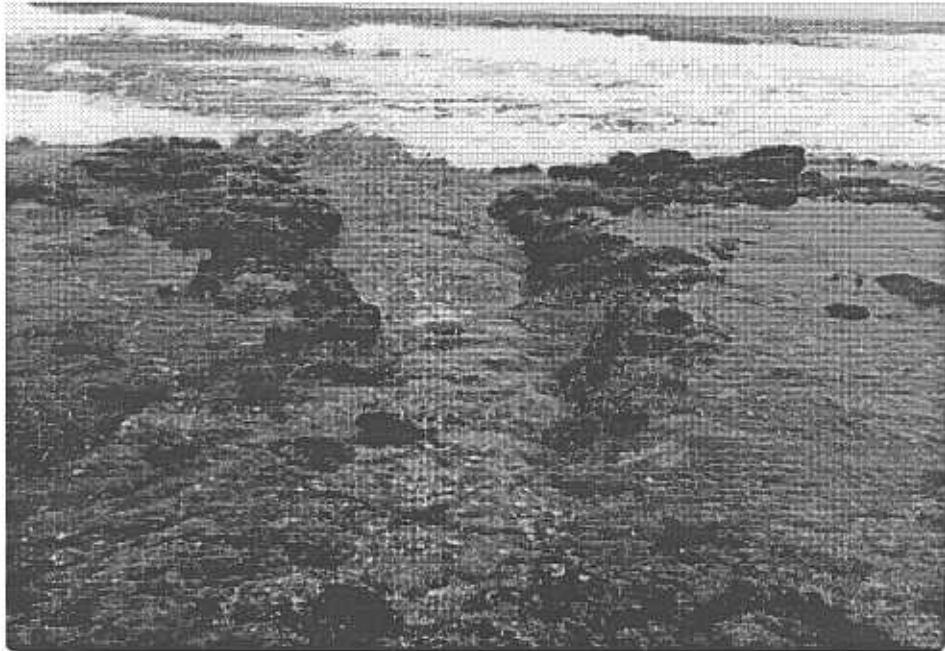
Figure 5. Photographs illustrating various features of the reef environment. Top: a) Small surge channel, approximately 1 m wide, near the reef crest. Coralline algae and compact coral colonies are the dominant biota. View to the north, near Matautu Point, Falefa, N. Upolu. Bottom: b) Reef rubble composed mostly of broken coral fragments, landward of the reef crest, Matautu Pt. Watch in lower center for scale.

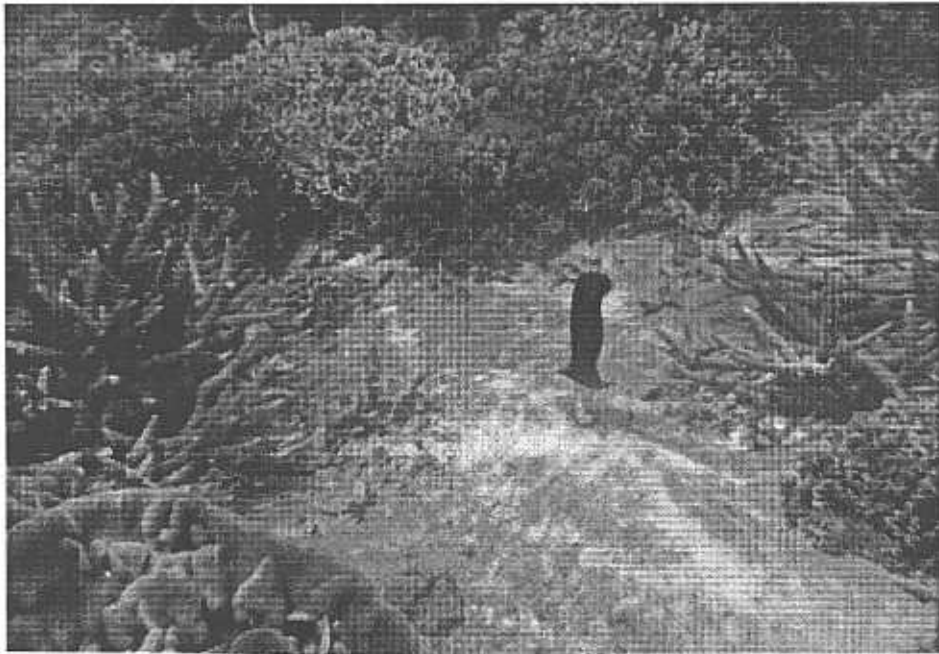
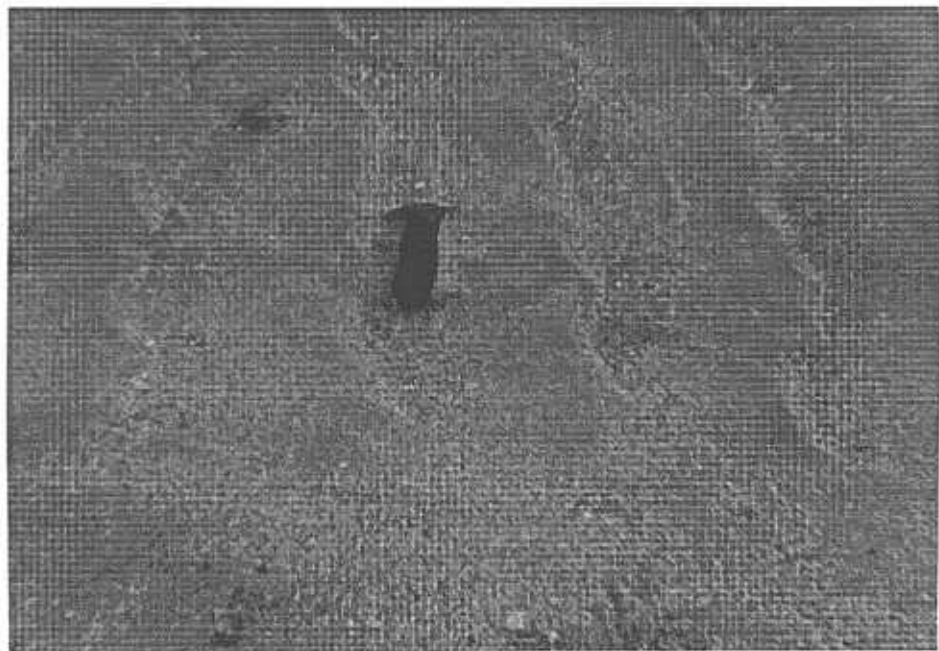
Figure 5. Top: c) Underwater photograph of coral colonies (*Acropora sp.* and others) from a shallow reef flat moat, Saleilua, S. Upolu. Knife inbedded in carbonate sand in center of photograph. Bottom: d) Underwater photograph of rippled sand bottom, inner reef flat, Saleilua. Knife for scale.

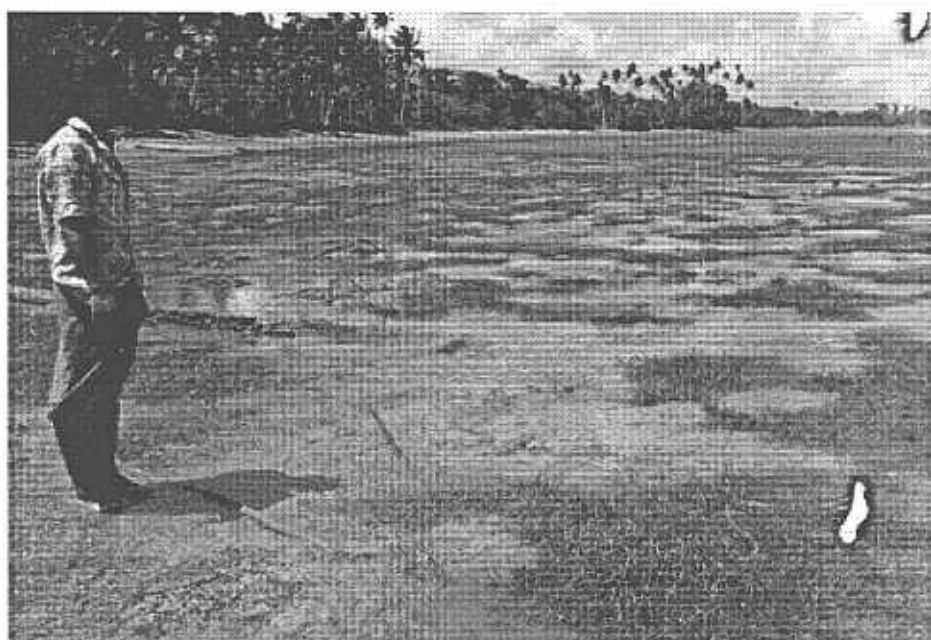
Figure 5. Top: e) Seagrass (*Halophila ovata* ?) from reef flat near Matautu Pt. Watch for scale.  
Bottom: f) Seagrass beds (*Syringodium isoetifolium* ?) of the inner reef flat near Tafitoala, S. Upolu.

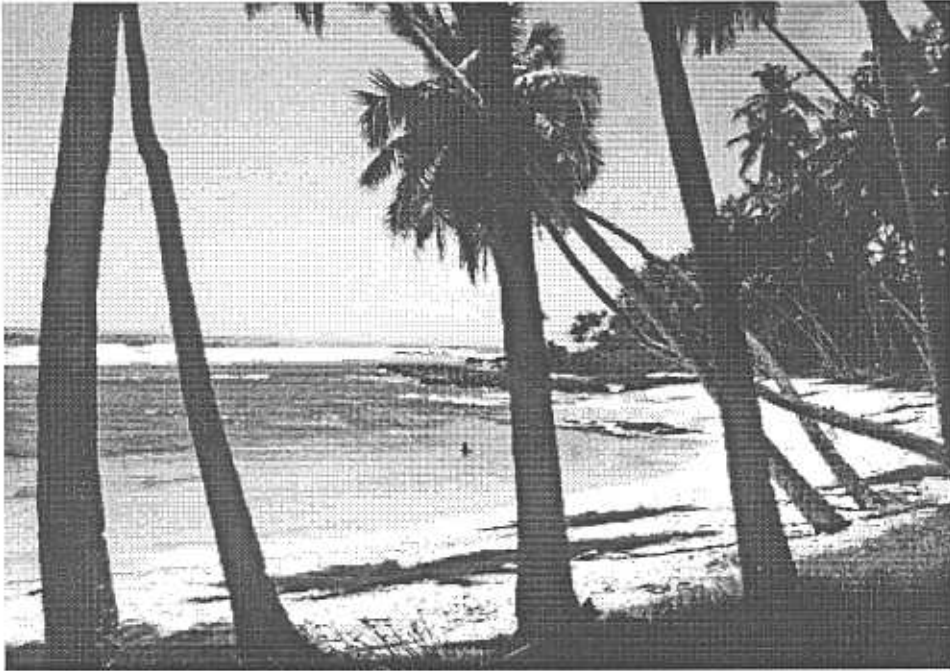
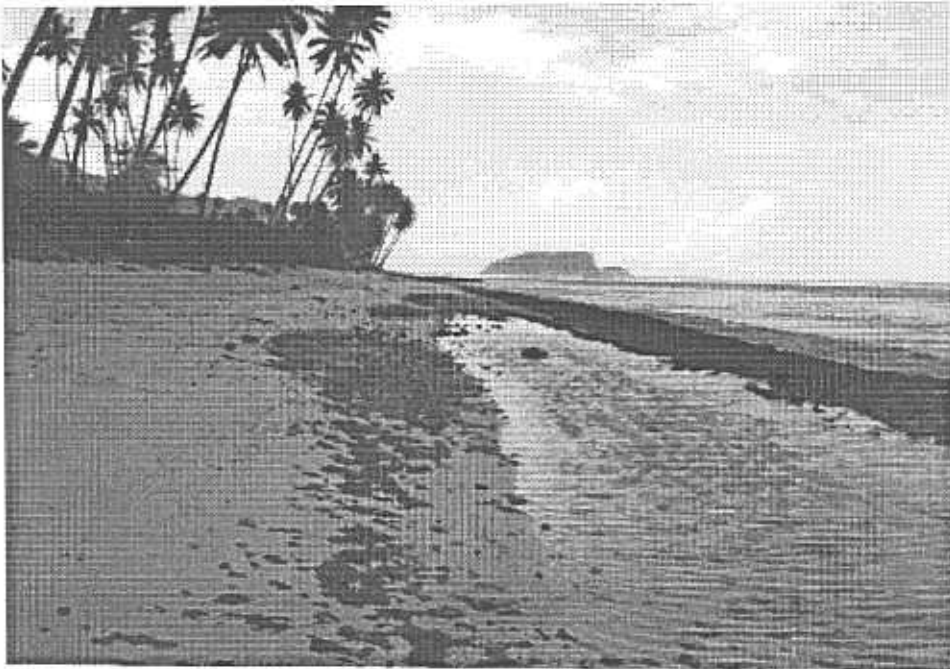
Figure 10. Top: a) Photograph of a pocket beach of carbonate sand bounded by outcrops of Lefaga basalts, southeast of Matautu, Lefaga (Return to Paradise Beach). View to northwest. Bottom: b) Photograph of carbonate sand beach with prominent beachrock exposures (centre and centre-right). The beachrock demarks a former shoreline position which is slightly oblique to the present shoreline indicating some realignment has taken place. Photograph taken near Saleapaga, Lepa. View to east.

The beaches usually occur either as (semi-) continuous stretches of coast or as discrete pocket beaches bounded by rock headlands (Figure 10a). Pocket beaches are the most common type on Upolu. The longest continuous beach on Upolu is the beach fronting the Vaie'e Peninsula barrier spit in the Safata District (~4 km).

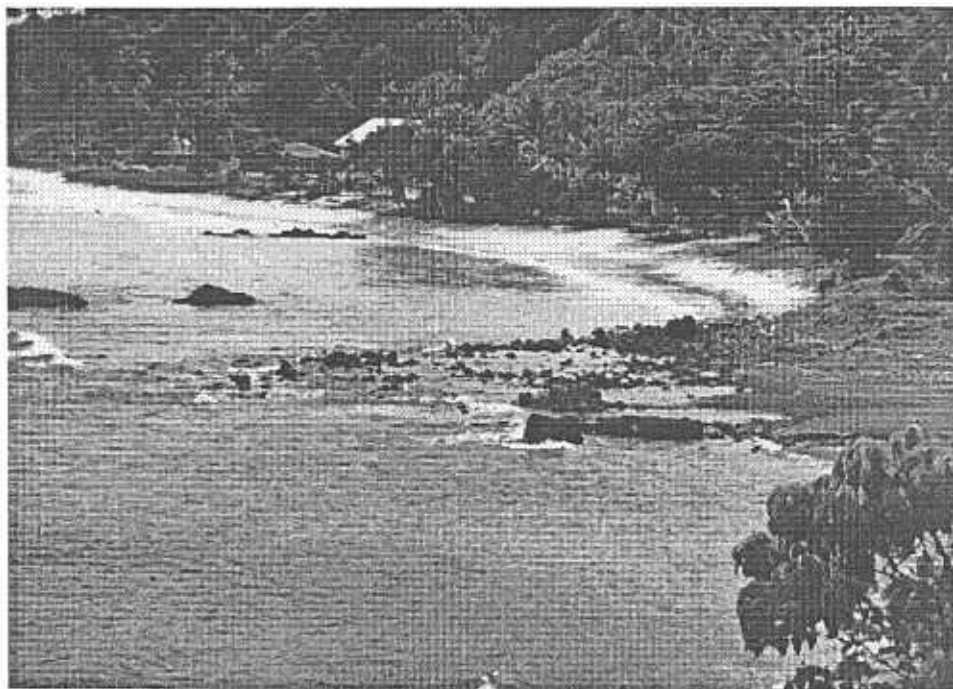
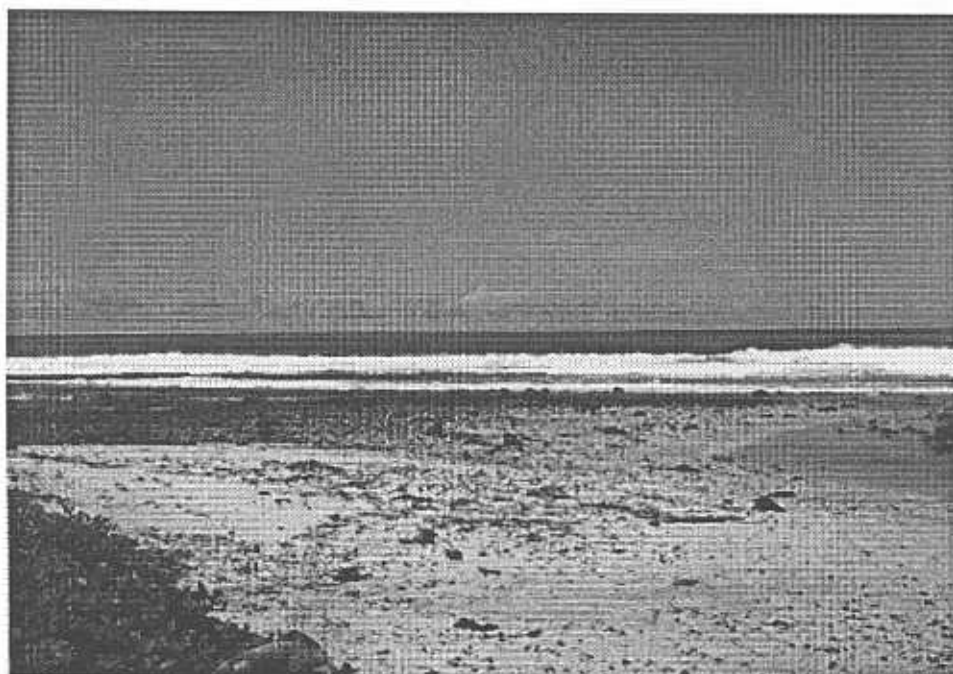
Figure 14. Top: a) Photograph of flood delta composed of terrigenous sediments (volcanics) at the mouth of an unnamed stream, Vavau, Lepa. Presumably the initial flood delta was much larger - the overlying sands having been winnowed away leaving behind a gravel base. View to west. Bottom: b) Photograph of volcanic-gravel flood delta base overlain by carbonate sands. Mouth of Sinoi Stream, Lepa. View to south.

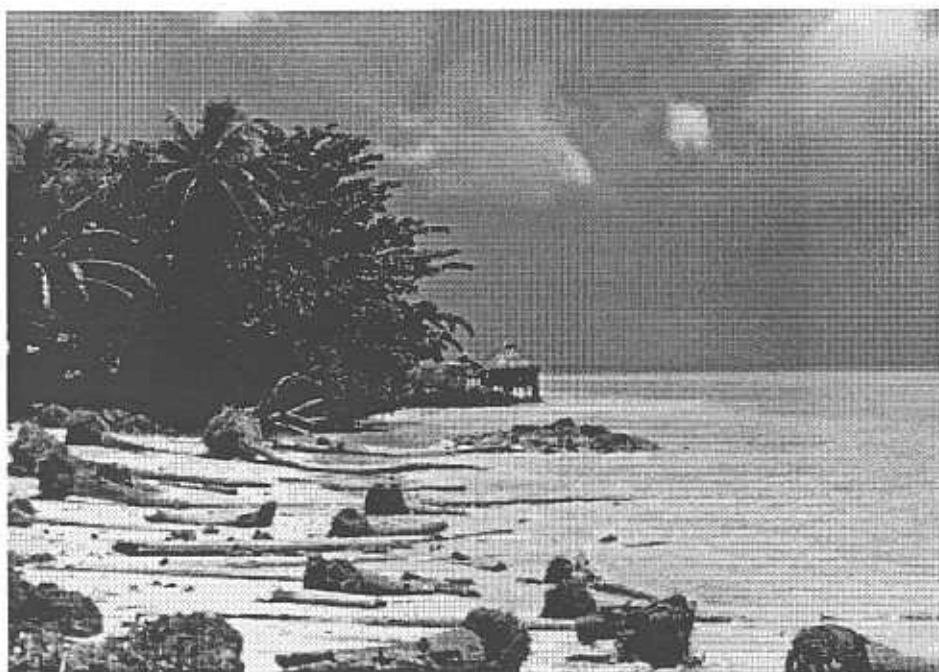
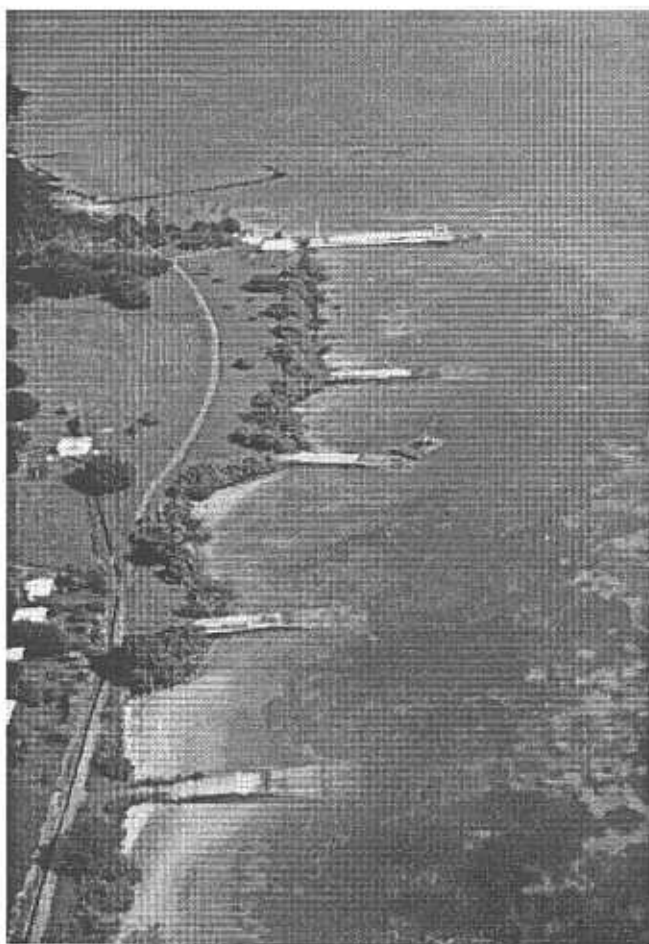
Figure AI/1. Top: a) Shoreline near Lalovi, Mulifanua showing eroded coconut palms on shore, basalt boulders (foreground) used in revetment to protect coast road, and reclaimed land with fale in centre. View to south. Bottom: b) Oblique aerial photograph near Toloa showing groins and dragline. Note the general lack of sediment on the beach; the groin at the bottom has trapped some carbonate sand on its eastern side indicating transport to the west. The darker areas on the reef flat is covered by marine flora. View to west.

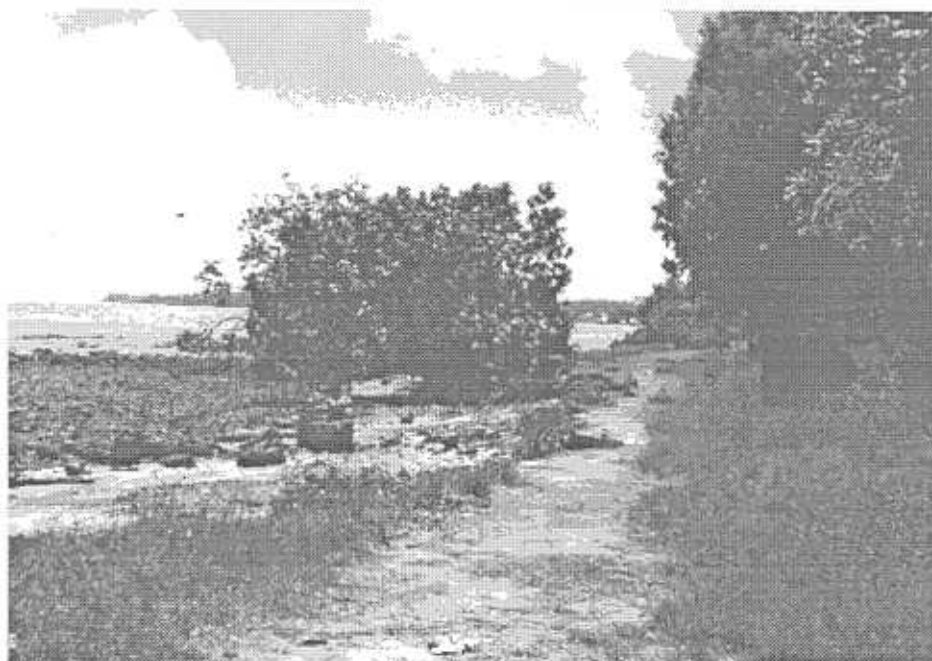
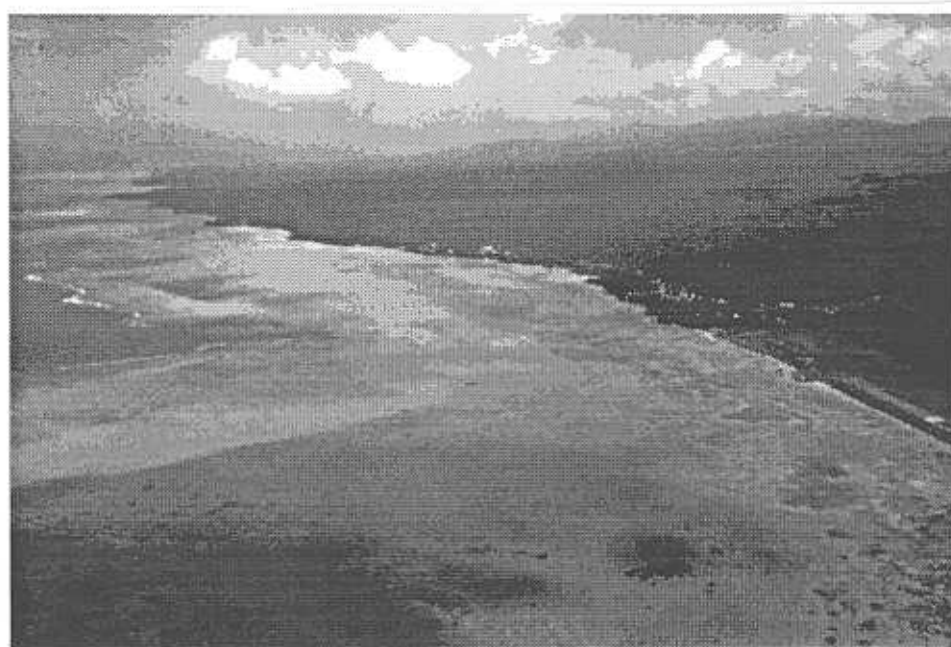
Figure AI/2. Top: a) Remnant of coastal road near Vailu'utai School, Nofoali'i. The new coastal road was diverted inland; without shore protection structures the old road has eroded away. View to east. Bottom: b) Oblique aerial photograph of large sand body on the reef near Faleolo Airport. Former dredge sites are visible in the lower right. View to east.

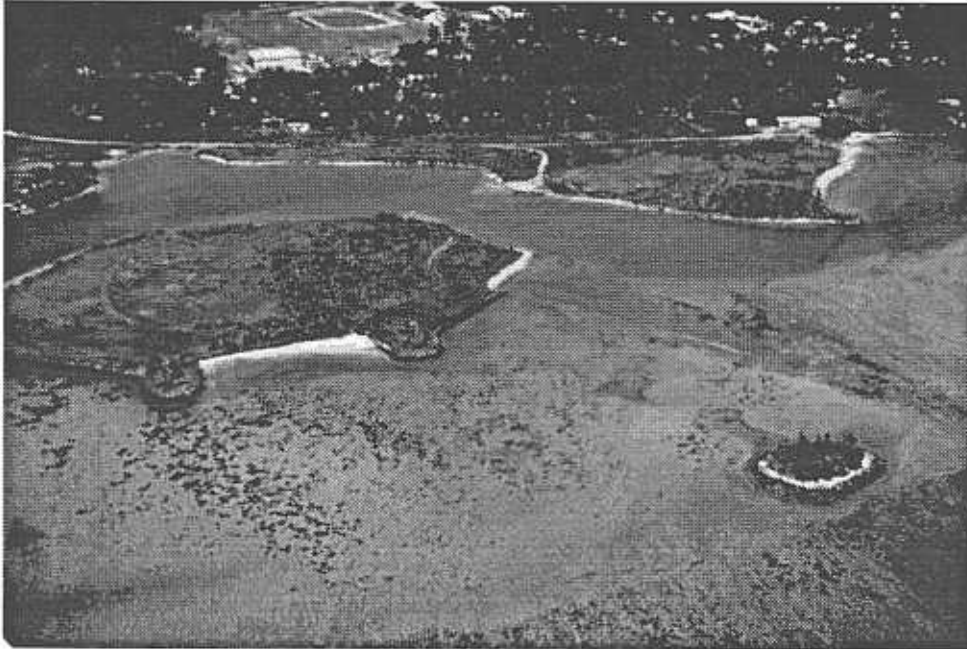
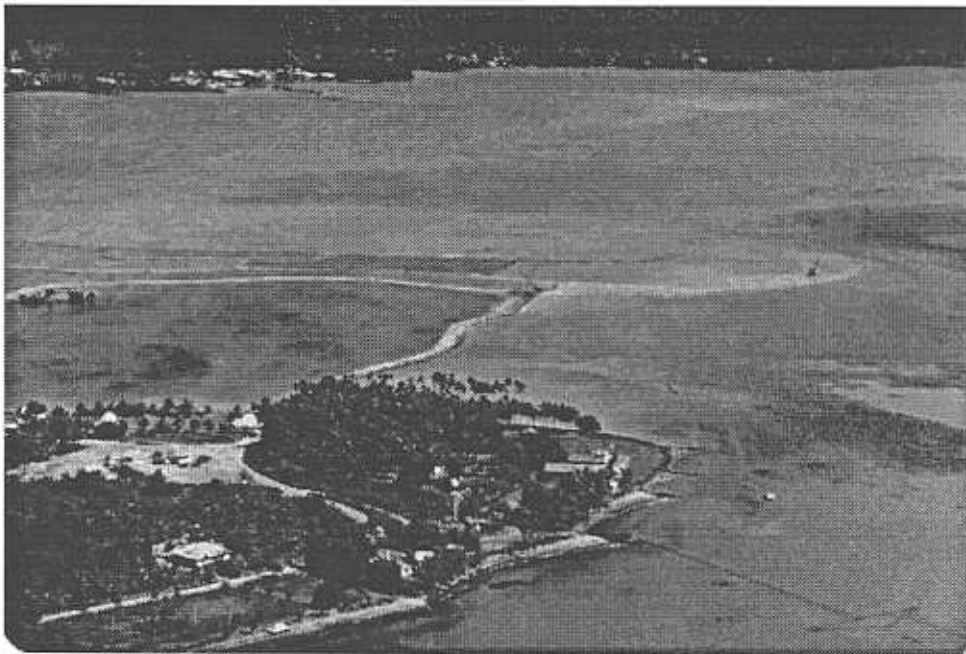
Figure AI/3. Top: a) Oblique aerial photograph of the Royal Samoan Hotel site showing the reef flat borrow pits and reclaimed land (island). The beach in the centre of the island indicates westward longshore drift as evidenced by sand buildup on the western (right) seawall. View to south. Bottom: b) Distal end of Mulinu'u Peninsula showing the nearshore dredging operations, causeways, and rock groins. Sand buildup on the groins indicates westward drift. View to south.

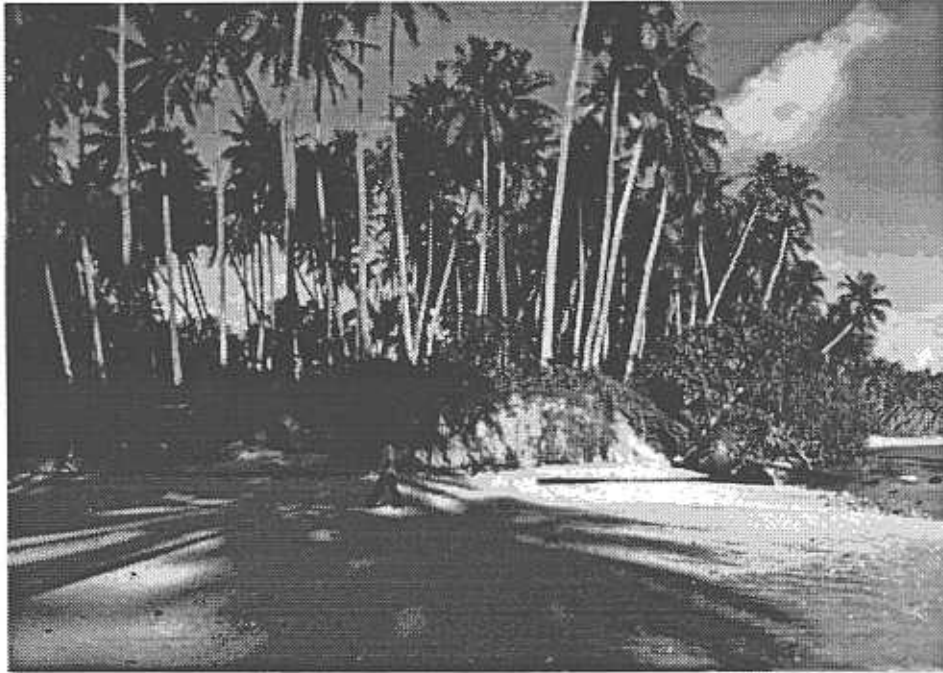
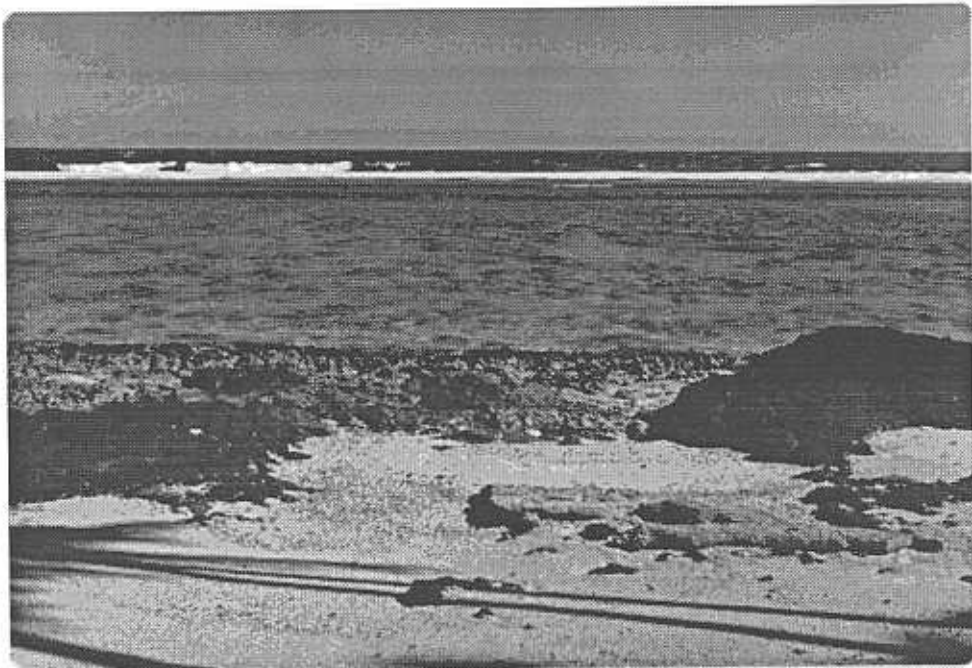
Figure AI/5. Top: a) Mined out beach ridge near Salamumu. View to east. Bottom: b) Narrow fringing reef and carbonate sand beach overlying a basalt terrace. Beachrock is exposed at the shoreline (centre). Near Leniu Point, view to south.

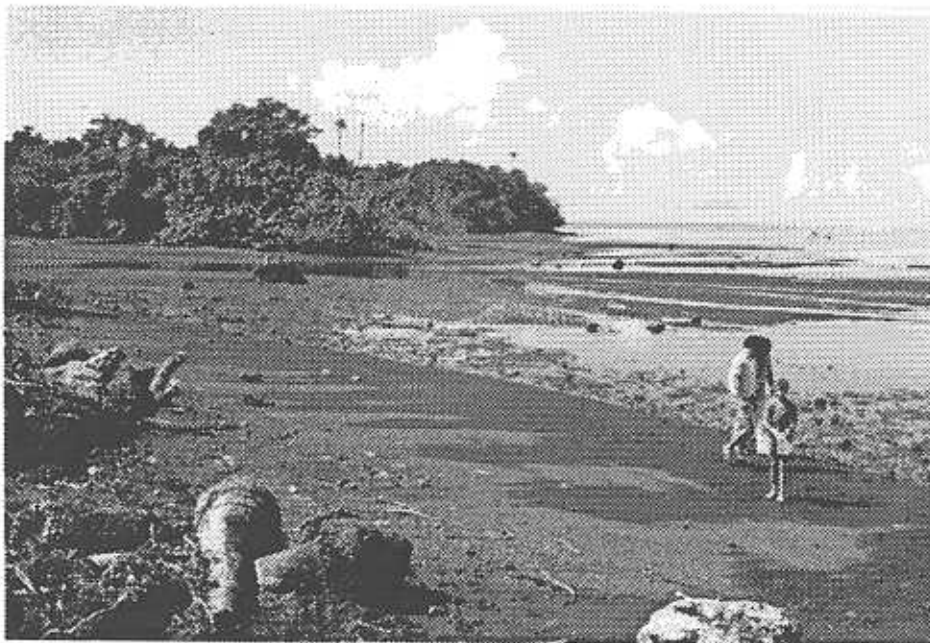
Figure AI/7. Top: a) Landward shoreline of Vaie'e Peninsula showing mangoves and muddy sediment. View to northwest. Bottom: b) Shoreline near Si'umu composed mostly of terrigenous sand; note eroded coconut palms on foreshore. View to east.

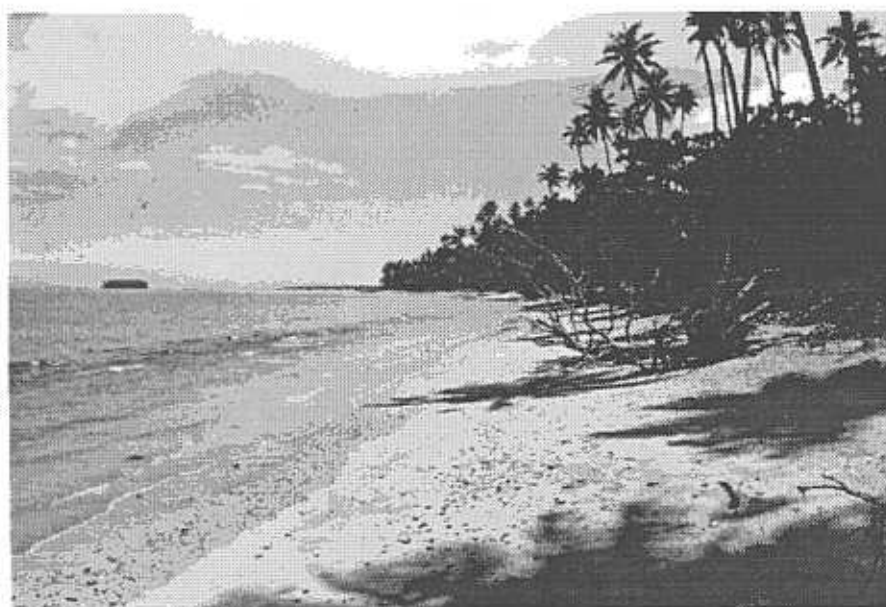
Figure AI/8. Top: a) Mouth of the Fagatoloa River near Salani; note the partially submerged flood-delta on the reef flat (centre). Beach is composed of mixed terrigenous/carbonate sediment. View to east. Bottom: b) Tafatafa Beach showing partially submerged beachrock (left centre) and small erosional backbeach scarp (right centre). View to west.

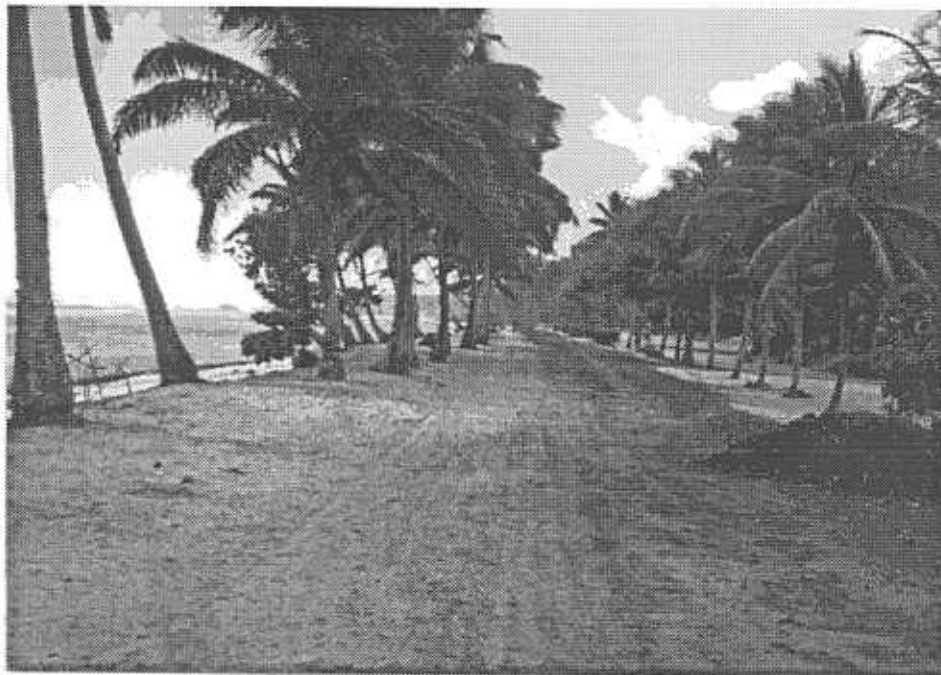
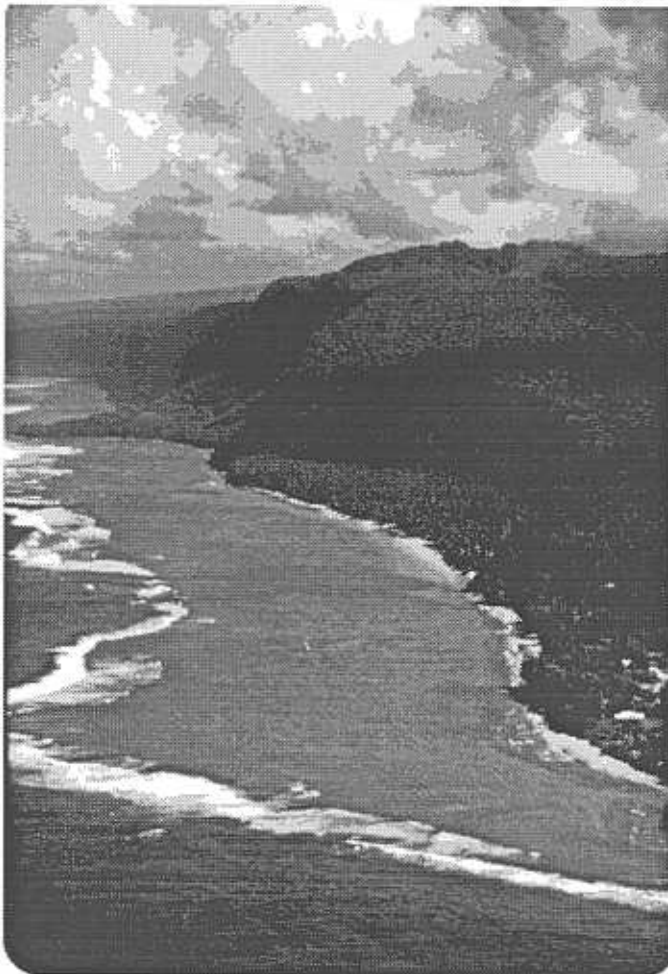
Figure AI/9. Top: a) Coastal road on crest of beach ridge near Saleapaga. The road was recently overwashed by waves during a storm. View to west. Bottom: b) Oblique aerial photograph of the eastern Lepa coastline showing the coastal escarpment, narrow strip of carbonate sand, and fringing reef. The promontory in the centre is Cape Tuiolemu. View to west.

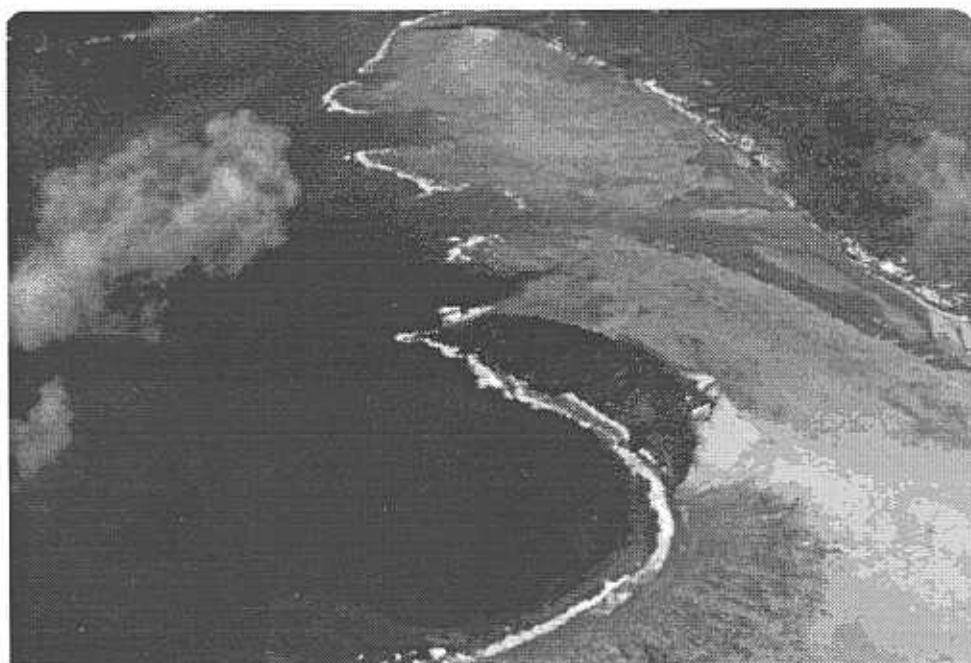
Figure AI/10. Top: a) Low-lying swampy area landward of the beach ridge near Mutiatele. View to west. Bottom: b) Oblique aerial photograph of the Aleipata coastline showing the reef and submarine terrace. View to southwest.
