## **Seagrass Restoration Guidelines for Kiribati**

Compiled by Dr Paul L.A. Erftemeijer (DAMCO Consulting)

For the Secretariat of the Pacific Regional Environment Programme (SPREP)

Perth, 15 March 2020

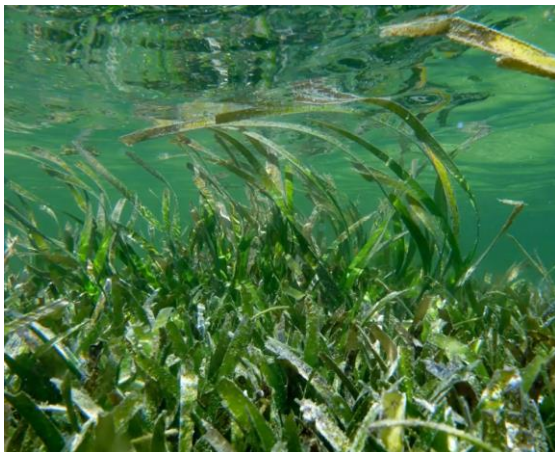
**Figure 4.** Seagrass beds trap fine particles and strip nutrients from the water column.

Due to the complex architecture of the leaf canopy in combination with the dense network of roots and rhizomes, seagrass beds stabilize bottom sediments and serve as effective hydrodynamic barriers reducing wave energy and current velocity, thereby reducing turbidity and coastal erosion. Further, seagrass beds trap large amounts of nutrients and organic matter in the bottom sediment (Figure 4).

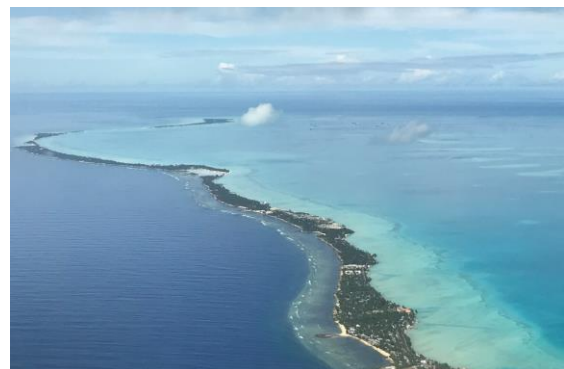
**Figure 5.** Aerial view of South Tarawa, showing a string of islets connected by causeways.

Causeway construction between many of the islets of Tarawa (Figure 5) has changed lagoon hydrology and blocked seasonal migration pathways of some economically important fish species (Brodie et al., 2020). The causeway construction process itself is likely to have caused significant sediment disturbances and turbidity plumes, which can cause significant impacts on seagrasses (Maragos, 1993; Chunting and Howorth, 2003; Erftemeijer and Lewis, 2006).

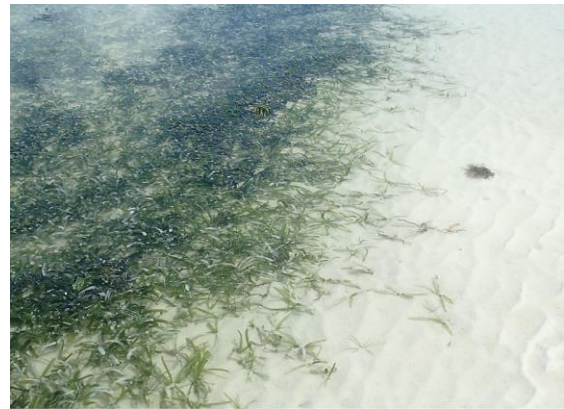
**Figure 6.** Patch expansion through lateral rhizome elongation of a circular seagrass patch at Nanikai.

Given the fact that *Thalassia hemprichii* primarily expands its meadows vegetatively through rhizome elongation (Figure 6) (with only low levels of sexual propagation through seeds), and that this is a slow process (advancing with approximately 0.5 to 1 m per year), there is scope for seagrass restoration / planting to try and speed up that process.

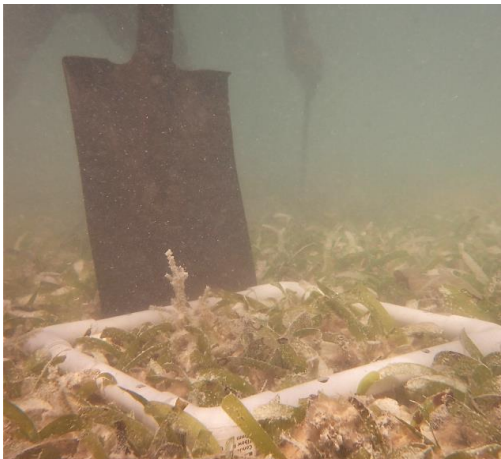
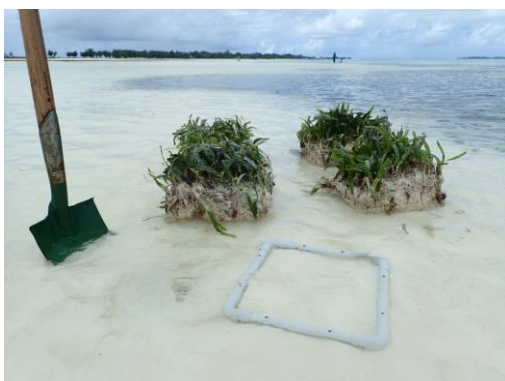
- Excavate square 25x25 cm blocks or 'sods' of seagrass (including roots and soil) from an existing (healthy and relatively dense) donor meadow using a spade or shovel

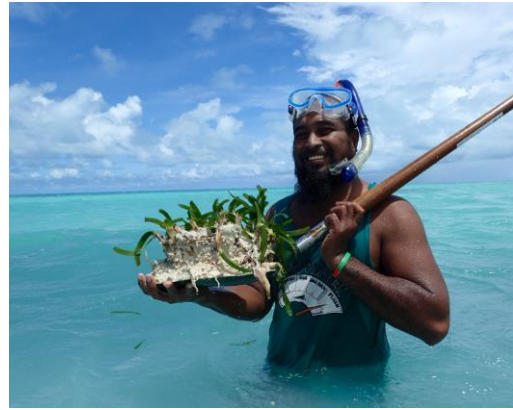
- The use of a small 25x25 cm quadrat (which can be made from PVC pipes or wood) can be helpful when excavating the sods, making sure they are of correct shape and size

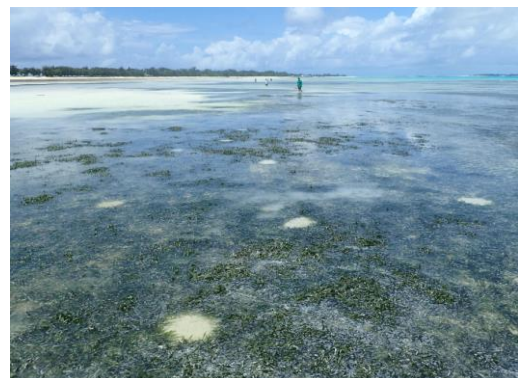
- It is recommended to space out the excavations, keeping them apart at a minimum distance of approximately 3 m (or more), to minimize the impact of the harvesting of seagrass material (i.e. to less than 10% of the donor meadow)

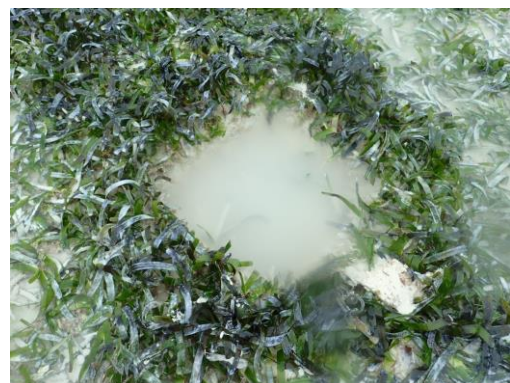
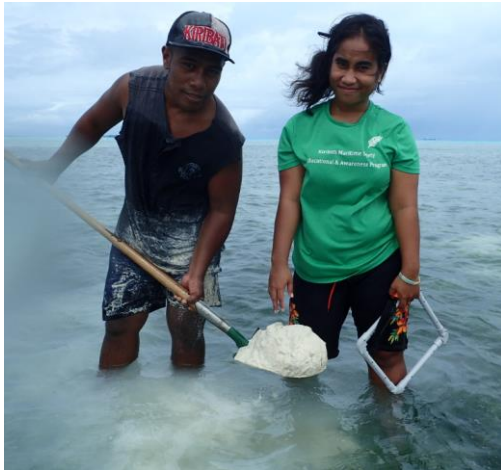
- Backfill the gaps created by the excavation of the sods with sand from the surrounding area to enable the damaged areas of the donor meadow to recover

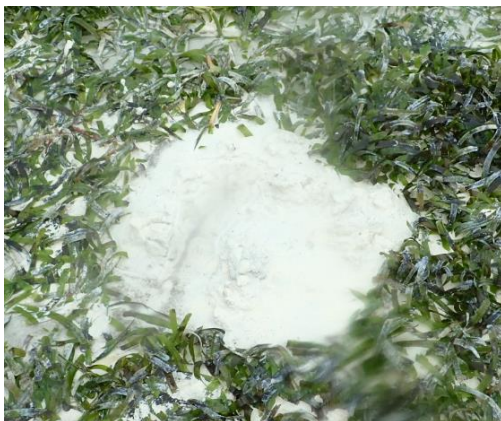
- Small gaps or scars of this size (25x25 cm) also occur naturally (e.g. from storm waves, turtle grazing or bioturbation) and generally 'self-repair' through lateral expansion by clonal re-growth from the surrounding seagrass in 6 months to a year

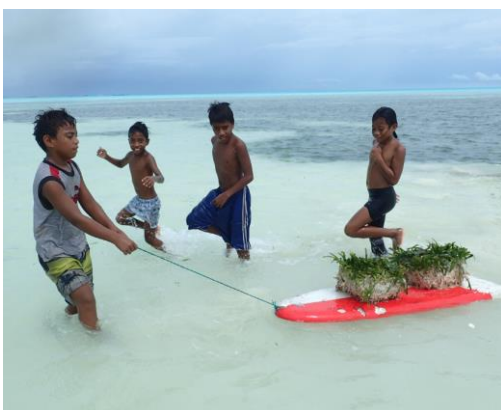
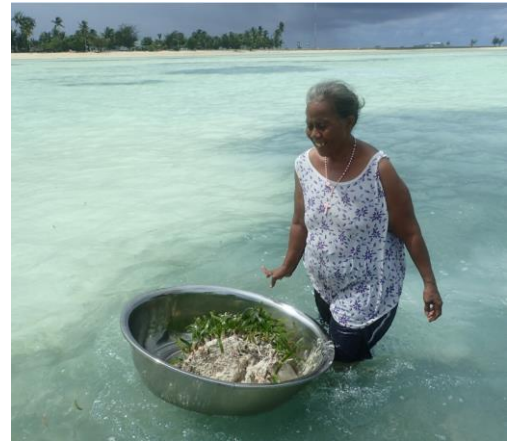
- Transport the sods in large tubs (that can float) or stacked onto a floating object such as a surf board or kayak from donor site to restoration site

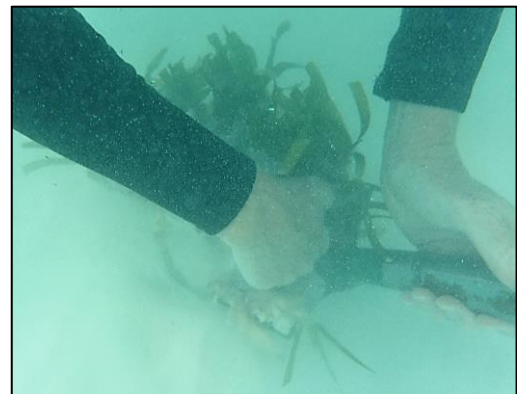
- At the restoration site, dig holes (with the spade/shovel) that are big and deep enough to accommodate a 25x25 cm sod, and then place the sod (it is best to deposit the excavated sand as close to the hole as possible, for later use in sediment infilling)

- Fill in and firmly press and compact sediment along the edges of the sod after it has been placed in the hole
- An optimum spacing of the 25x25 cm sod plantings would be 3 to 5 m (assuming lateral expansion of surviving patches to be in the order of 25 to 50 cm (Marba and Duarte, 1998; Sintes et al., 2006), in either direction, which would translate in the sods expanding and growing together within 3 to 5 years.

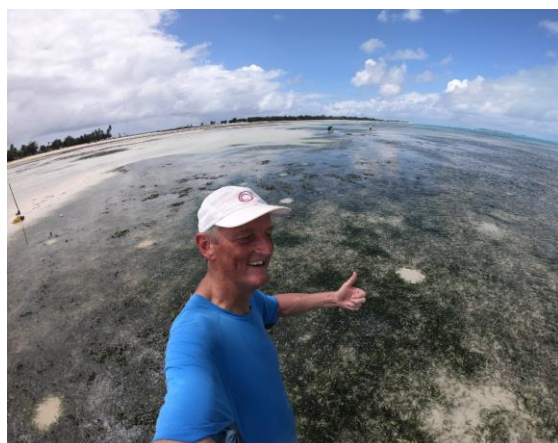
**Figure 8.** Sufficient spacing between subsequent sods (here ~5m apart) when harvesting seagrass material for restoration will minimise damage to donor beds and ensure successful recovery.
